Crash-Test Evaluation of Barriers Installed on a Curved Off Ramp

M.E. BRONSTAD, C.E. KIMBALL, JR., AND C.F. McDEVITT

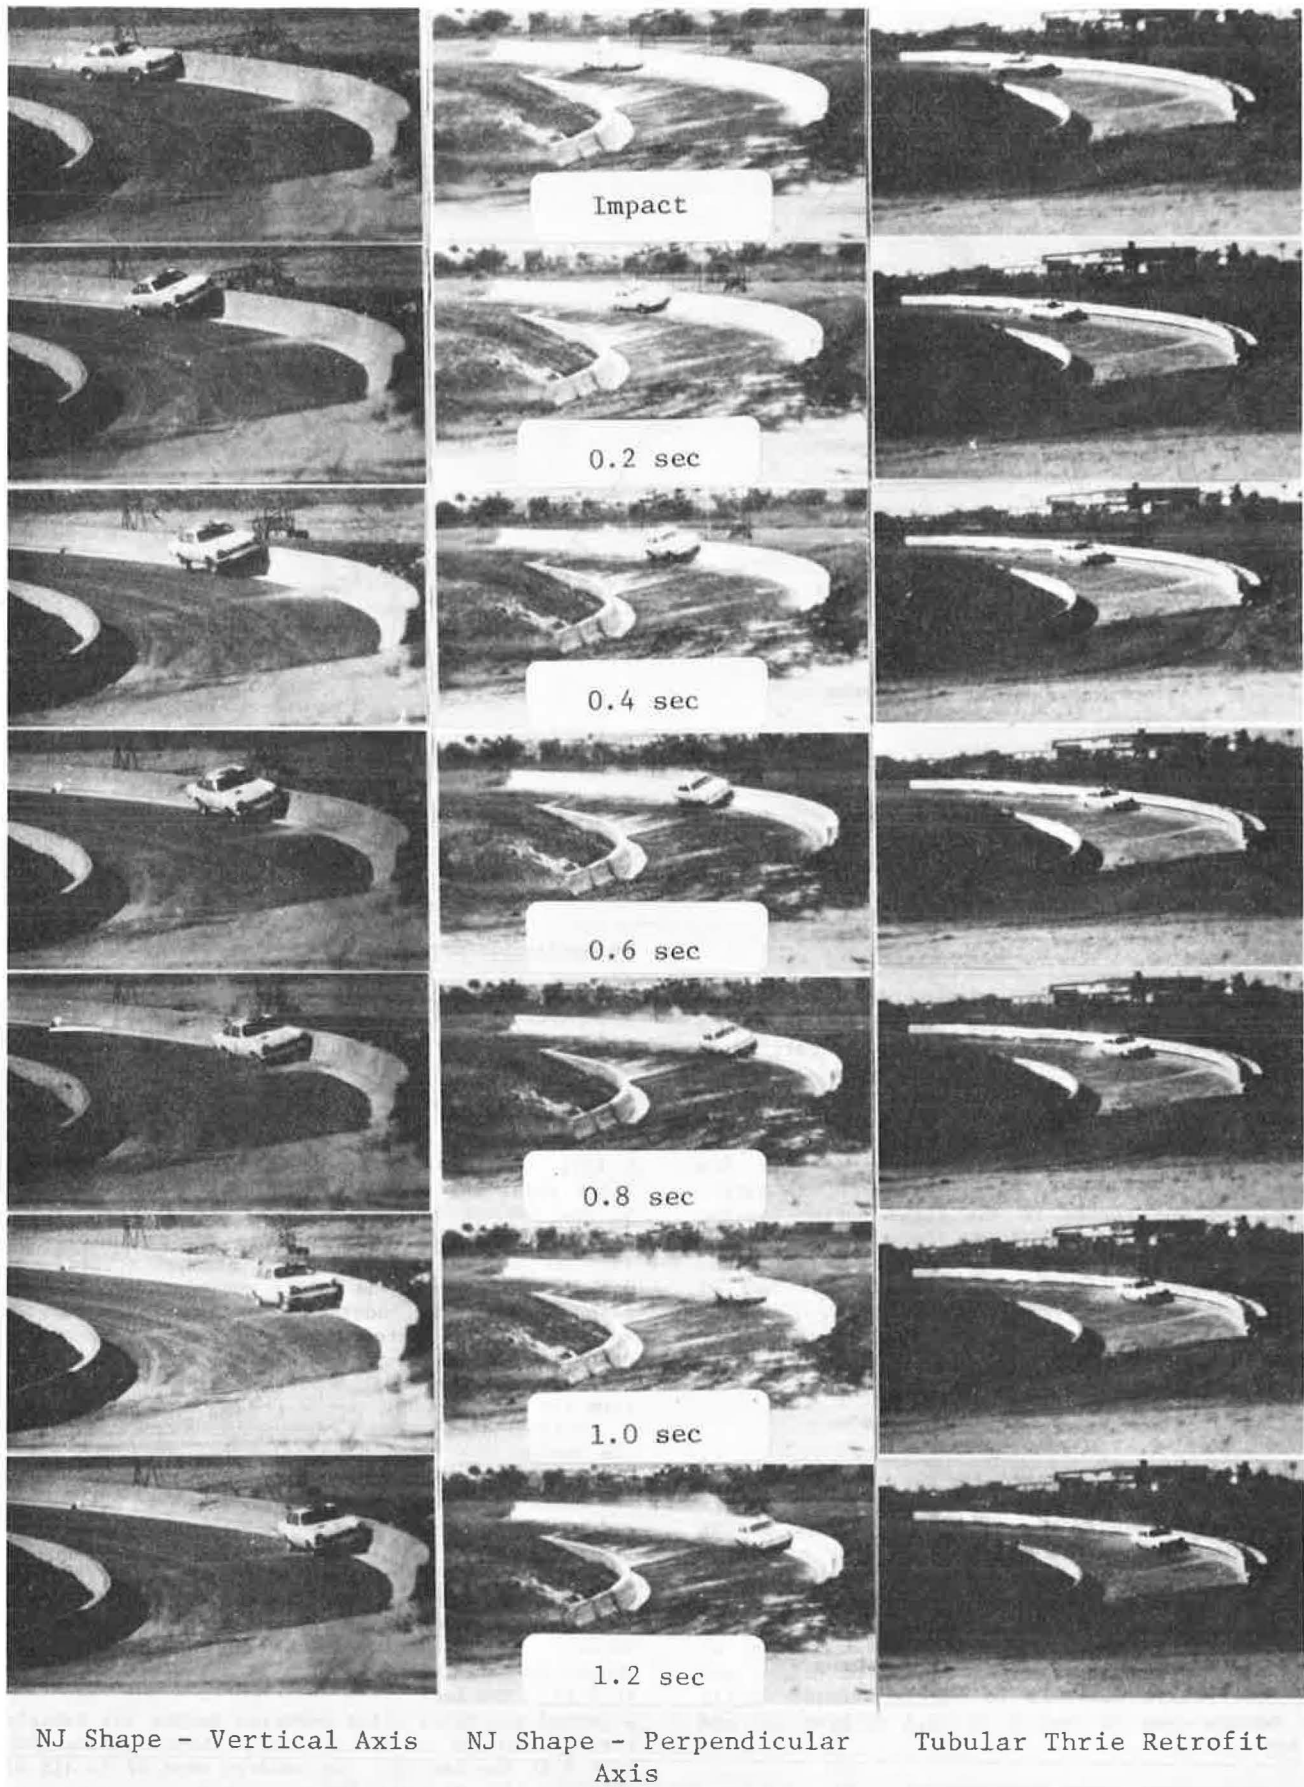
Figure 3. Vega sequential photographs.

A 1974 Vega impacted the barrier at 37.2 mph (59.8 km/h) and an 18.7° angle. As shown in Figure 3, the vehicle front wheels turned into the barrier as it climbed the lower sloped face. Rolling of the vehicle away from the barrier, which is typical of the interaction between New Jersey-shape barriers and vehicles, continued until the vehicle front wheel was near the top of the barrier. The maximum tire climb was 1.6 ft (0.5 m). The vehicle wheels then returned to grade with a continuous cyclic scrubbing of the outside barrier (with less climb at each cycle) until the vehicle left the barrier. The vehicle came to rest 4.5 ft (1.6 m) from the downstream end.

A 1975 Vega impacted the barrier at 38.9 mph (62.6 km/h) and a 14.9° angle. As shown in Figure 3, the vehicle rolled away from the barrier as the left wheels climbed the barrier up to a maximum of 1.5 ft (0.5 m). The left tires returned to grade, and then a second and third climb occurred before the vehicle reached the end of the barrier. After losing contact with the barrier, the vehicle went 42 ft (13 m) past the barrier end before coming to rest.

A 1974 Vega impacted the barrier at 39.4 mph (63.4 km/h) and a 16.8° angle. As shown in Figure 3, the vehicle was smoothly redirected with excellent vehicle stability.

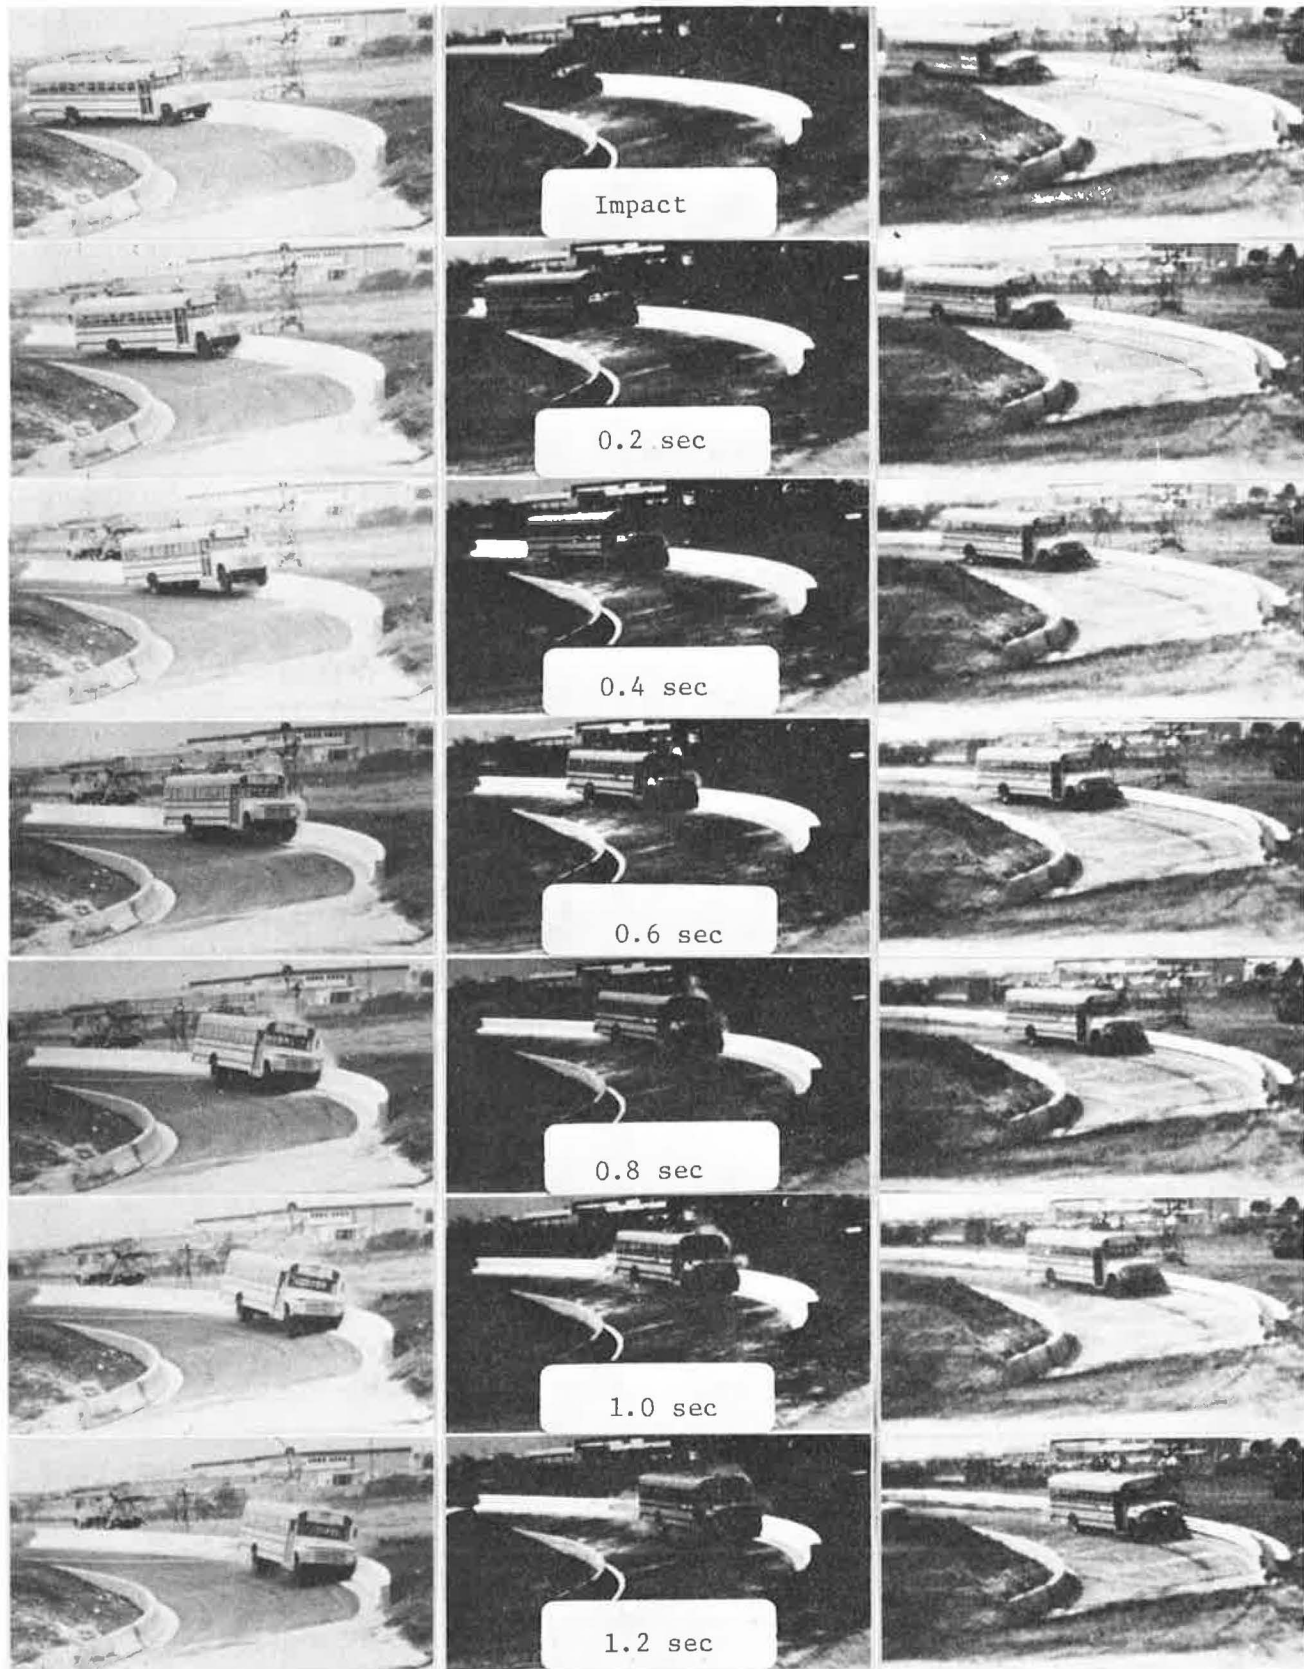
Figure 4. School bus sequential photographs.

The school bus impacted the barrier at 41.8 mph (67.3 km/h) and a 15.5° angle. As shown in Figure 4, the bus rolled slightly away from the barrier as the left front tire climbed up the barrier face a maximum of 1.9 ft (0.6 m) and the front of the bus pitched upward. As the front moved downward from the maximum climb, the bus rolled toward the barrier before returning to a stable position near the installation end. After barrier contact was terminated, the bus turned to the right during braking and stopped about 100 ft (30 m) from the end.

The school bus impacted the barrier at 40.0 mph (64.6 km/h) and a 14.8° angle. As shown in Figure 4, the vehicle front pitched upward as the left front wheel climbed the lower barrier slope. The bus rolled toward the barrier as the front wheels turned left. The bus then returned to a stable

The school bus impacted the barrier at 39.4 mph (63.4 km/h) and a 13.9° angle. As shown in Figure 4, the bus rolled slightly toward the barrier as the front wheels turned left. The bus remained in a stable attitude throughout contact with the barrier until coming to rest 24 ft (7.3 m) past the downstream end.

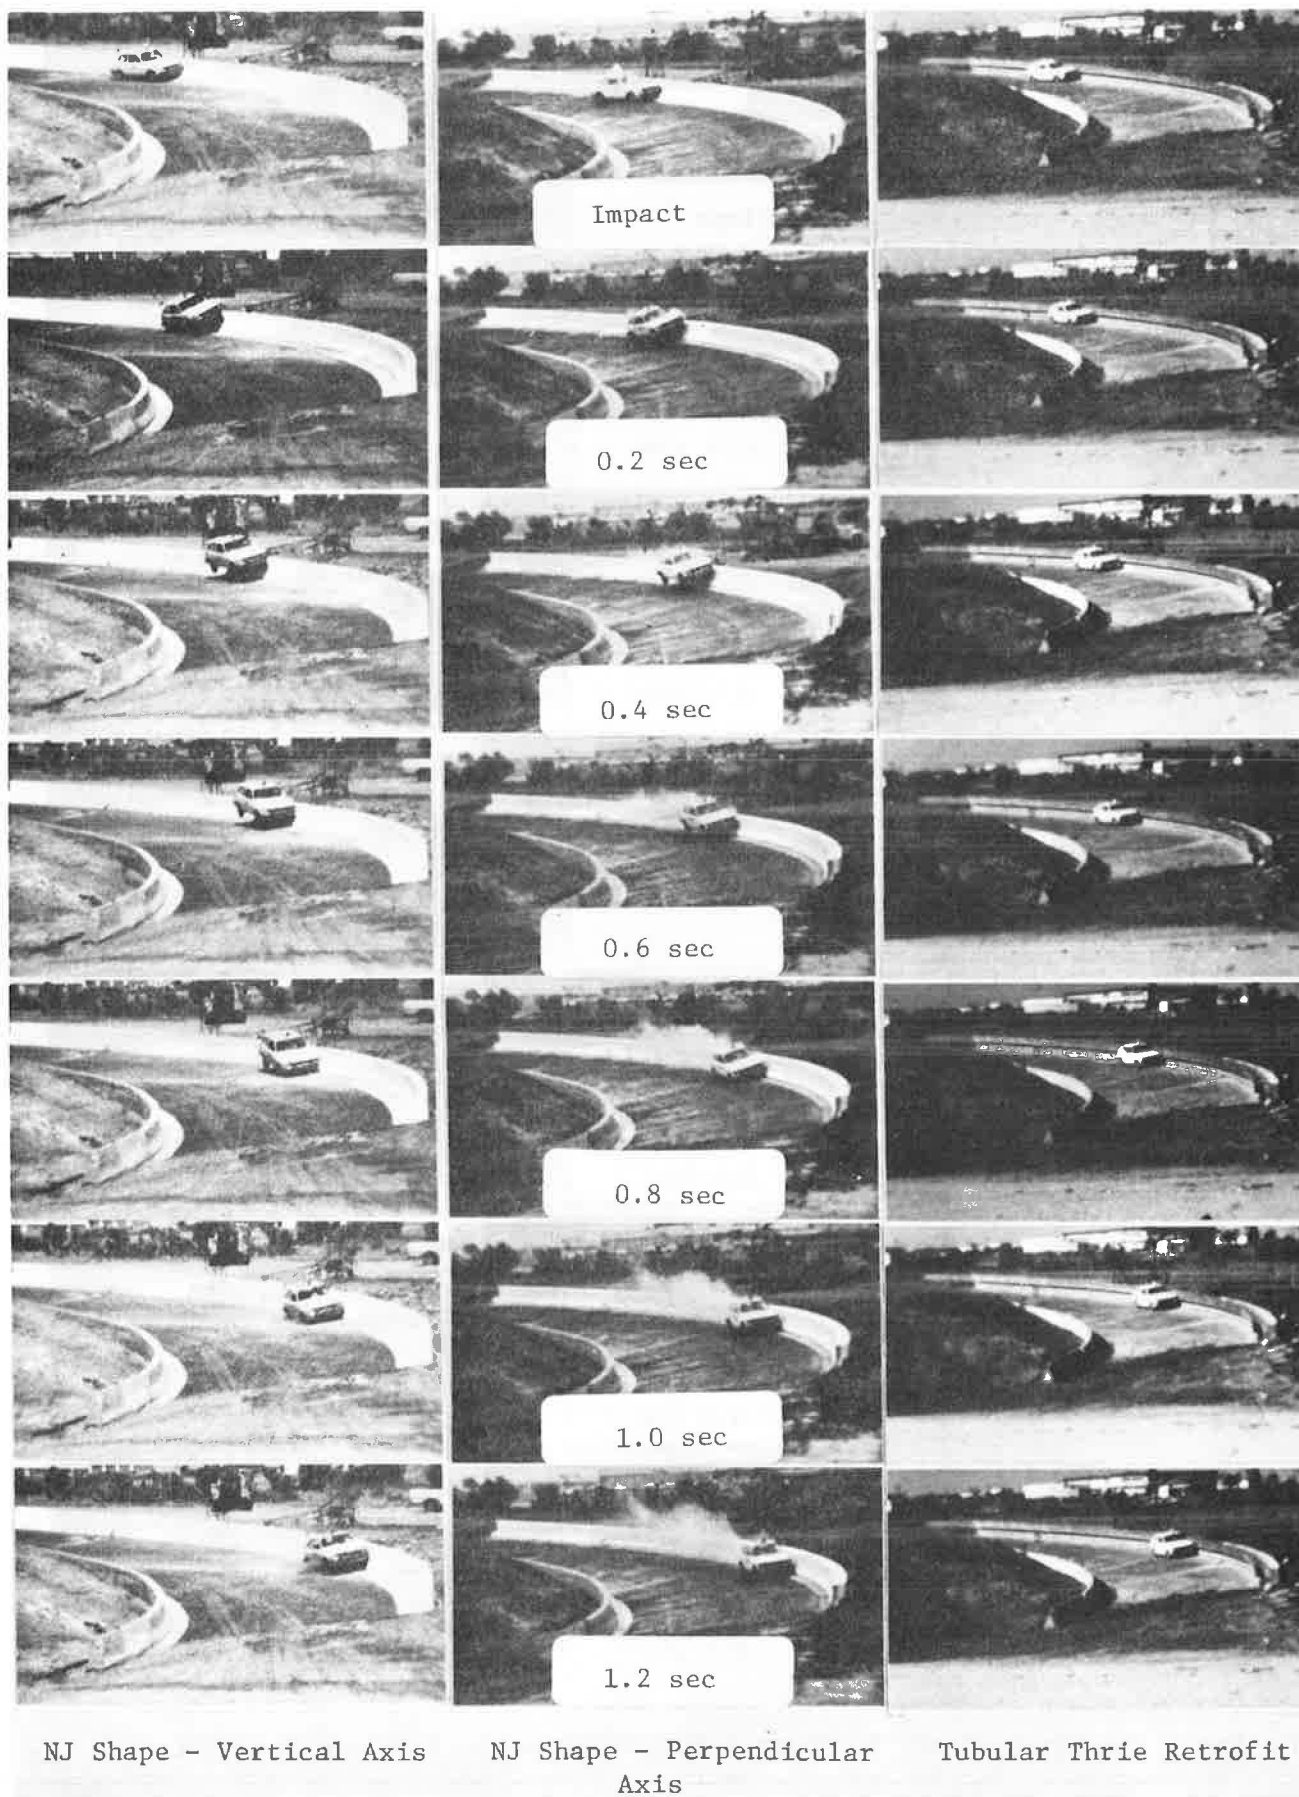
Figure 5. Honda Civic sequential photographs.

A 1976 Honda Civic impacted the barrier at 40.0 mph (64.4 km/h) and a 13.9° angle. As shown in Figure 5, the vehicle rolled away from the barrier as the left front tire climbed the barrier face a maximum of 1.7 ft (0.5 m) and the vehicle front pitched upward. At 0.3 s after impact, the entire vehicle was airborne (tire contact with upper portion of barrier existed) and remained so for about 0.3 s. At this time the right wheels returned to grade, and the left wheels remained in barrier contact until the vehicle came to rest 8 ft (2.4 m) past the end of the barrier.

A 1976 Honda Civic impacted the barrier at 38.9 mph (62.6 km/h) and a 13.4° angle. As shown in Figure 5, the vehicle rolled away from the barrier as the left front tire climbed up to a maximum of 1.7 ft (0.5 m) and the vehicle front pitched upward. At 0.3 s after impact, the entire vehicle was airborne, although left tire contact with the upper barrier was maintained. After the right tires returned to grade 0.3 s later, the vehicle remained in contact with the barrier until coming to rest 1 ft (0.3 m) from the barrier end.

A 1975 Honda Civic impacted the barrier at 38.8 mph (62.6 km/h) and a 15.1° angle. As shown in Figure 5, the vehicle was smoothly redirected with no measurable roll or wheel climb.

Observations of the Honda test on the vertical barrier (CB-3) indicated that the vehicle was near the threshold of riding on top of the barrier. A slightly larger angle or speed could have produced this performance limit.

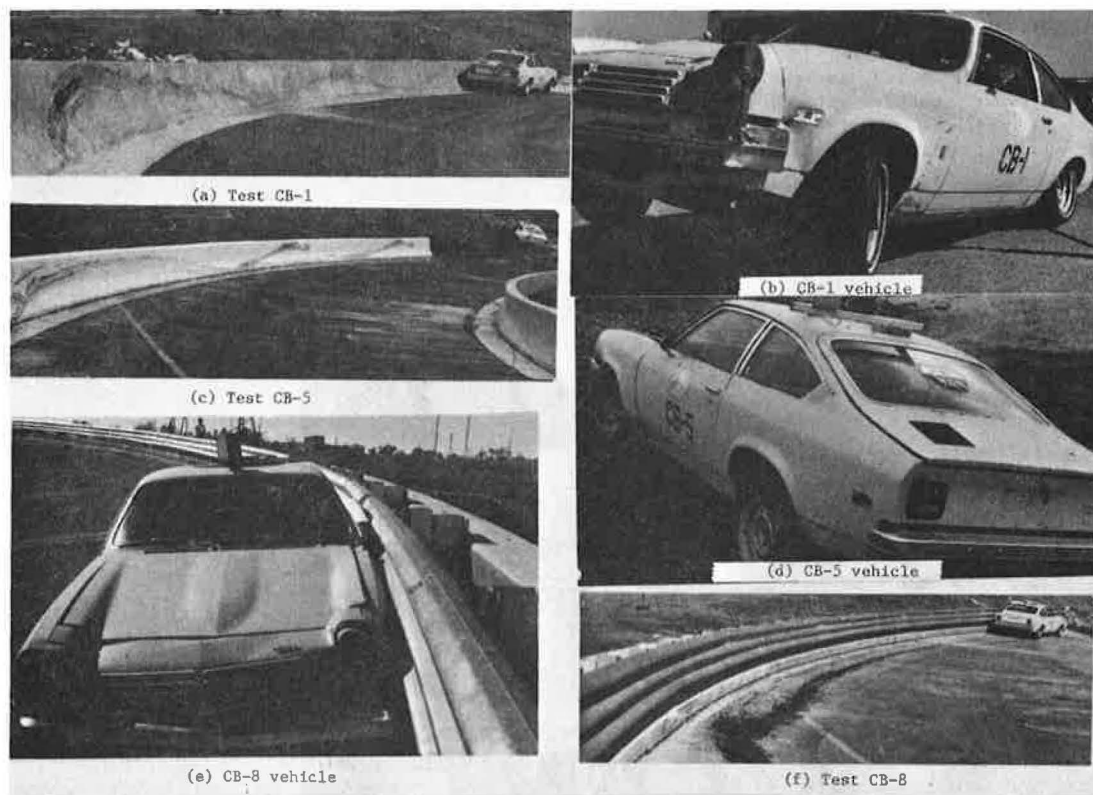
Figure 6. Photographs after Vega tests.

No barrier damage or deformation occurred. Damage to the test vehicle included sheet-metal deformation of the left front fender and some suspension damage.

The unexplained loss of a spindle nut during test CB-5 on the perpendicular safety shape made after-test photographs of the Vega sedan (Figure 6) look much worse than warranted. This spindle nut is a special one used to hold the guide wire flag to the wheel and cannot be considered part of the standard vehicle equipment.

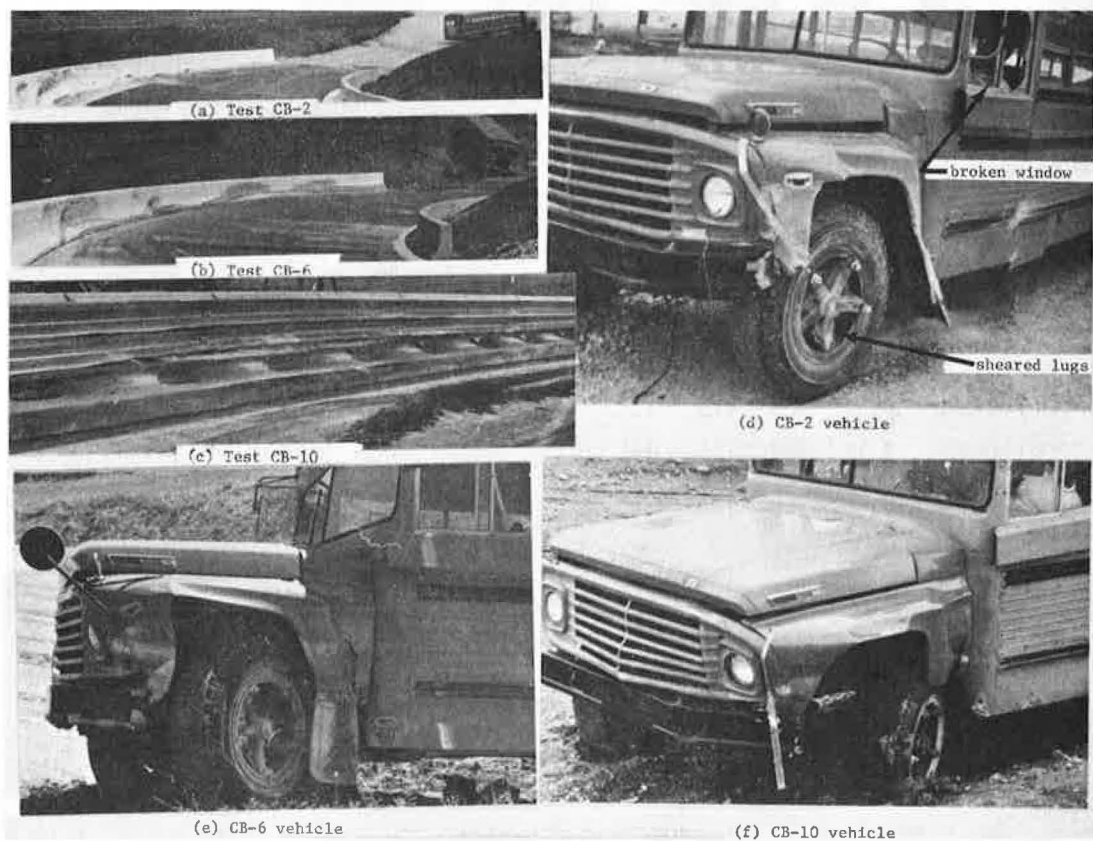
Figure 7. Photographs after bus tests.

Barrier damage consisted of minor scraping. Bus damage included a bent bumper and fender, two of five lug nuts sheared, and two shattered windows, as shown in Figure 7. The window damage was due to driver head intrusion and loose sandbag contact (near the rear end).

Vehicle damage was confined to the left front fender and bumper. Although the left front wheel and tire contacted the barrier, only tire scuffing was observed and no wheel lug damage was noted.

Damage to the test vehicle was moderate. The left front fender and bumper were deformed, and the left front wheel was pushed rearward by the impact, fracturing the shaft from the steering box to the pitman arm as well as the u-bolts that connect the spring to the axle on the right side.

Figures 6, 7, and 8 contain damage photographs after the Vega, school bus, and Honda tests. Installation damage was significant only in test CB-10, where local crushing of the tubular Thrie-beam and some permanent deflection occurred.

The shearing of two lugs from the bus wheel during the vertical safety shape test (CB-2) is cause for some concern. This wheel was tracking erratically after leaving the barrier; a loss of this wheel could have dramatically changed the test results.

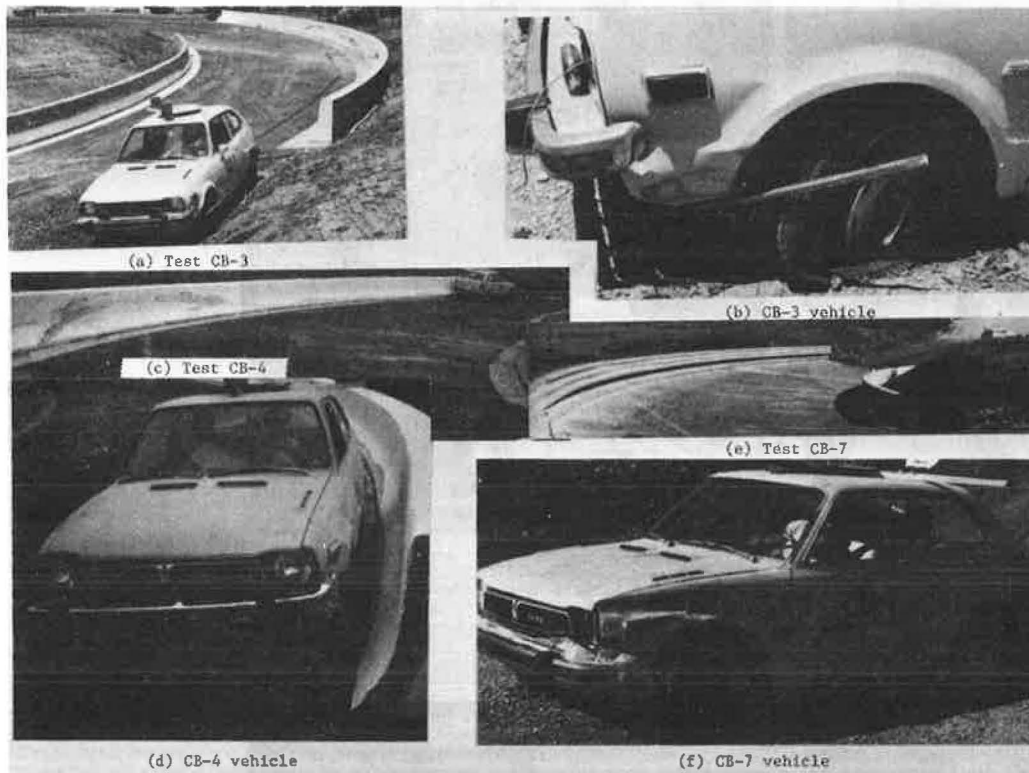
Figure 8. Photographs after Honda tests.

Insignificant barrier damage occurred, and vehicle damage consisted of sheet-metal and left front wheel damage. Although the wheel was bent, there was no indication of air leakage.

There was no significant barrier damage or deformation. Vehicle damage was limited to the sheet metal at the left fender and along the left side.
