Vehicle Impact Tests of Breakaway Wood Supports for Dual-Support Roadside Signs

ROGER L. STOUGHTON, J. ROBERT STOKER, AND ERIC F. NORDLIN

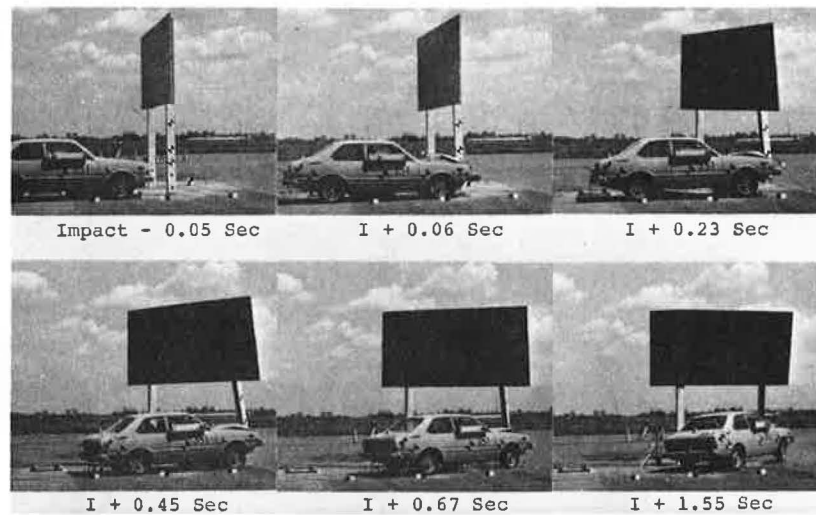
Figure 3. Test 351: impact sequence.

During impact, the post first split between the 2.5-in-diameter breakaway holes, and the split continued down below ground (see Figures 3 and 4). The post was torn off at the upper hole and the split stub below it was loaded because of two independent cantilevers that failed 10 in below ground. These two cantilevered post segments, which were 29.5 in long, stayed together and lodged beneath the

vehicle. The upper section of the post and sign panel were pushed back by the vehicle as it yawed 35°.

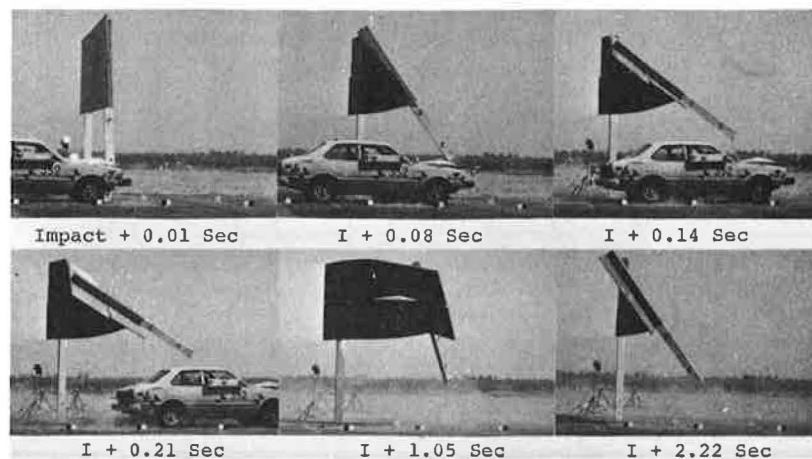
Figure 5. Test 352: impact sequence.

The impacted post failed the same way as the one in test 351 (see Figures 5 and 6). Again, a 28-in post segment separated from the post, lodged under the vehicle, and was dragged by the vehicle until it stopped. The upper part of the post, which was connected to the sign panel, was thrust up in the air while the vehicle passed underneath it and continued straight downstream.

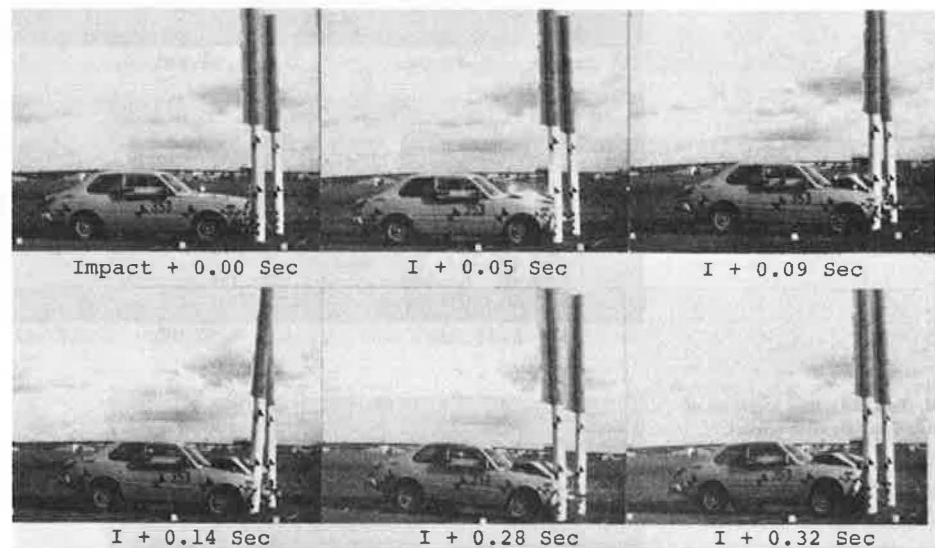
Figure 7. Test 353: impact sequence.

The timber-pole support was virtually undamaged by

the vehicle except for scuff marks. The ground-line movement of the pole was 0.75 in (see Figures 7 and 8).

In tests 353 and 354, the timber poles stopped the test vehicles too abruptly; thus, they did not meet the structural adequacy requirements. In test 355, the fallen sign projected 11 ft laterally beyond the original post location, thereby posing a possible traffic hazard. The switch from through bolts to lag screws for the sign-panel-to-post connection in test 356 prevented pull down of the nonimpacted post. The post pieces in test 356 projected out laterally 15 ft. The 1.5-in-thick pieces were flat on the ground. They would pose a psychological hazard more than a physical hazard.

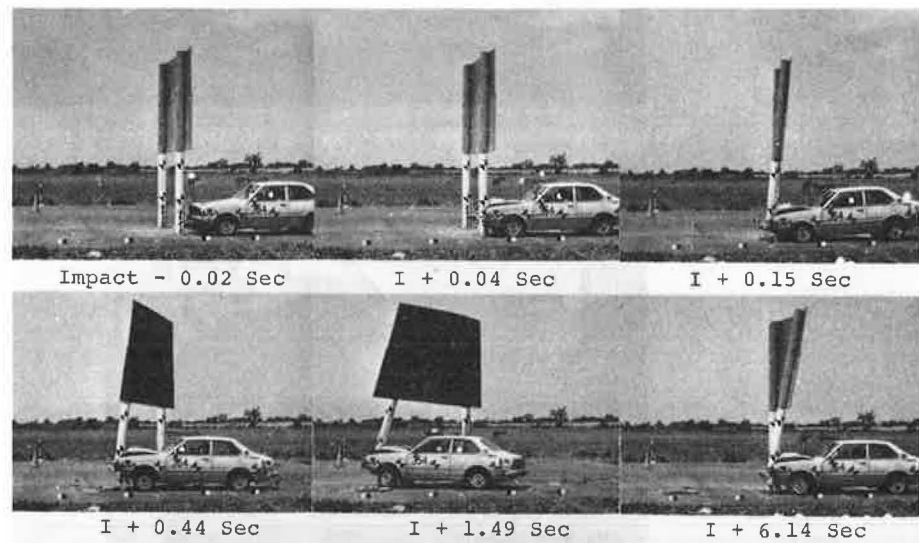
Figure 9. Test 354: impact sequence.

One of four hole patterns met the change-of-momentum requirements. This pattern was used in the timber poles for test 354. In test 354, the vehicle sheared off the pole and pushed it ahead 5.5 ft before stopping and rebounding to a point 1.75 ft beyond the original pole location (see Figures 9 and 10). The segment of the pole between the bored holes separated from the main pole and split into several pieces.

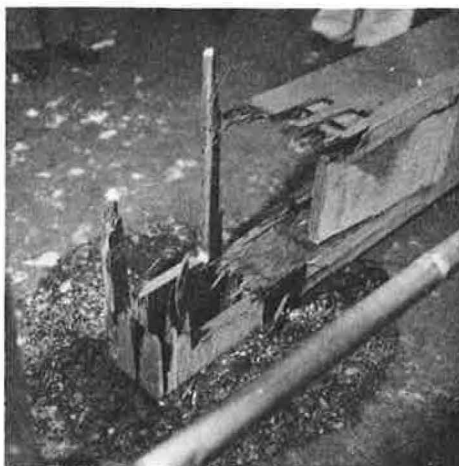
Figure 11. Static-bend test of laminated wood box-section post—broken stub.

Both pendulum and static-bend tests were conducted by SwRI and Caltrans. The final tests in this set showed the box-section posts had good static-bend strength and good impact performance (see Figure 11).

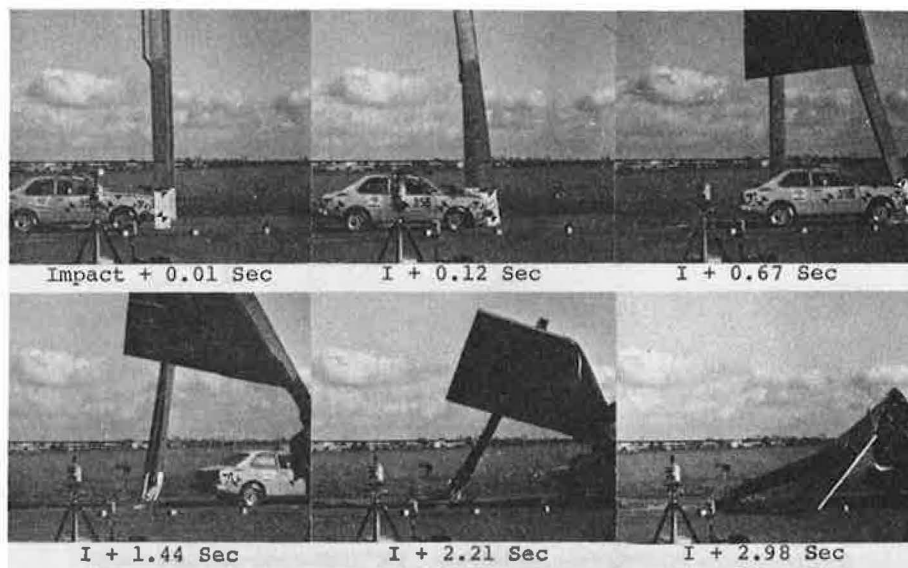
Figure 12. Test 355: impact sequence.

After impact in test 355, the post split between the upper and lower 1-in holes on the upstream side and split to the ground from the lower downstream 1-in hole (see Figures 12-15). Then most of the post sheared off through the lower holes and sawcut. The vehicle moved in a circular path, pushing the box-section post in front of it. When this post was 15° off vertical, cracks appeared in the nonimpacted post. Eventually this post was twisted off at its base through the lower sawcuts. The sign panel remained attached to the posts but buckled in the middle. The vehicle went under the impacted post and stopped beyond the fallen sign.

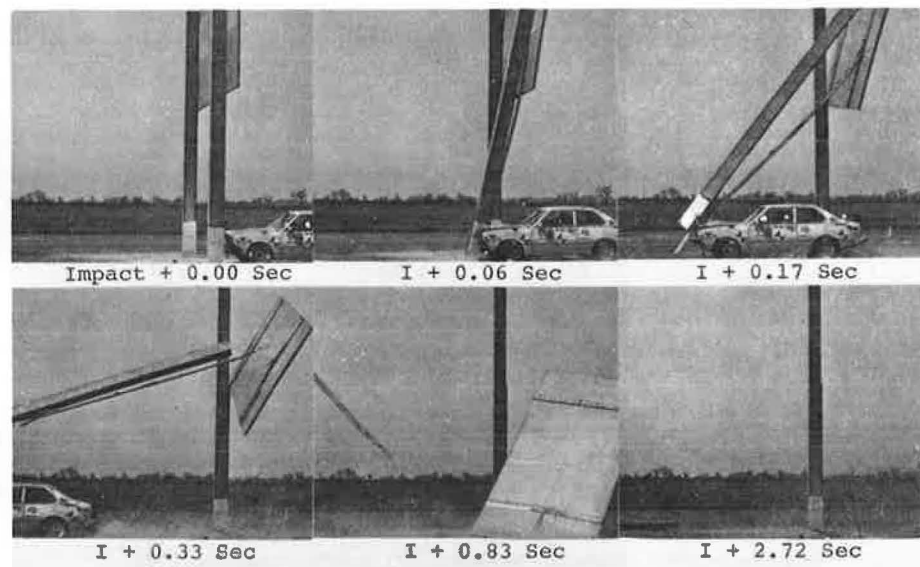
Figure 16. Test 356: impact sequence.

In test 356, the post was torn off through the lower sawcuts (see Figures 16-19). The upstream flange split away from the box section starting at its midpoint; however, the flange stayed attached to the sign panel with lag screws. The separated flange and the rest of the box section were thrust into the air by the vehicle, which passed underneath with no contact. When the partial box section struck the ground, it split into three pieces--two webs and the downstream flange. Meanwhile, the upstream flange

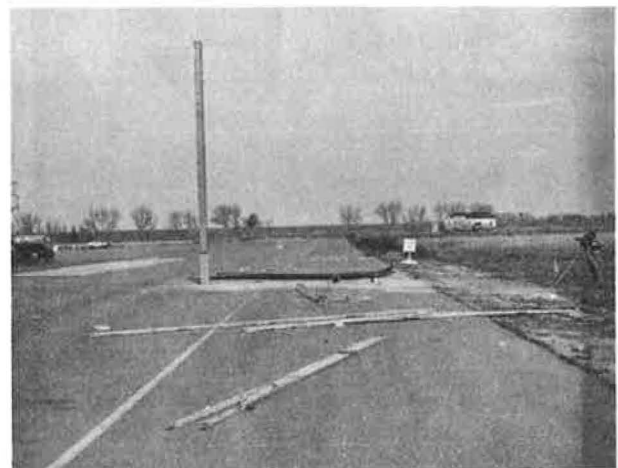
Figure 18. Test 356: final location of sign panel and pieces of impacted box-section post, looking upstream.

of the nonimpacted post split off the box section from the top of the post to the bottom of the sign panel, which rotated and tore off the post. The upper upstream flange piece remained attached to the sign panel by the eight lag screws. The sign panel dropped flat on the ground.
