Abridgment

Crash Tests of Omnidirectional Slip-Base Sign Supports

KENNETH C. HAHN AND JAMES E. BRYDEN

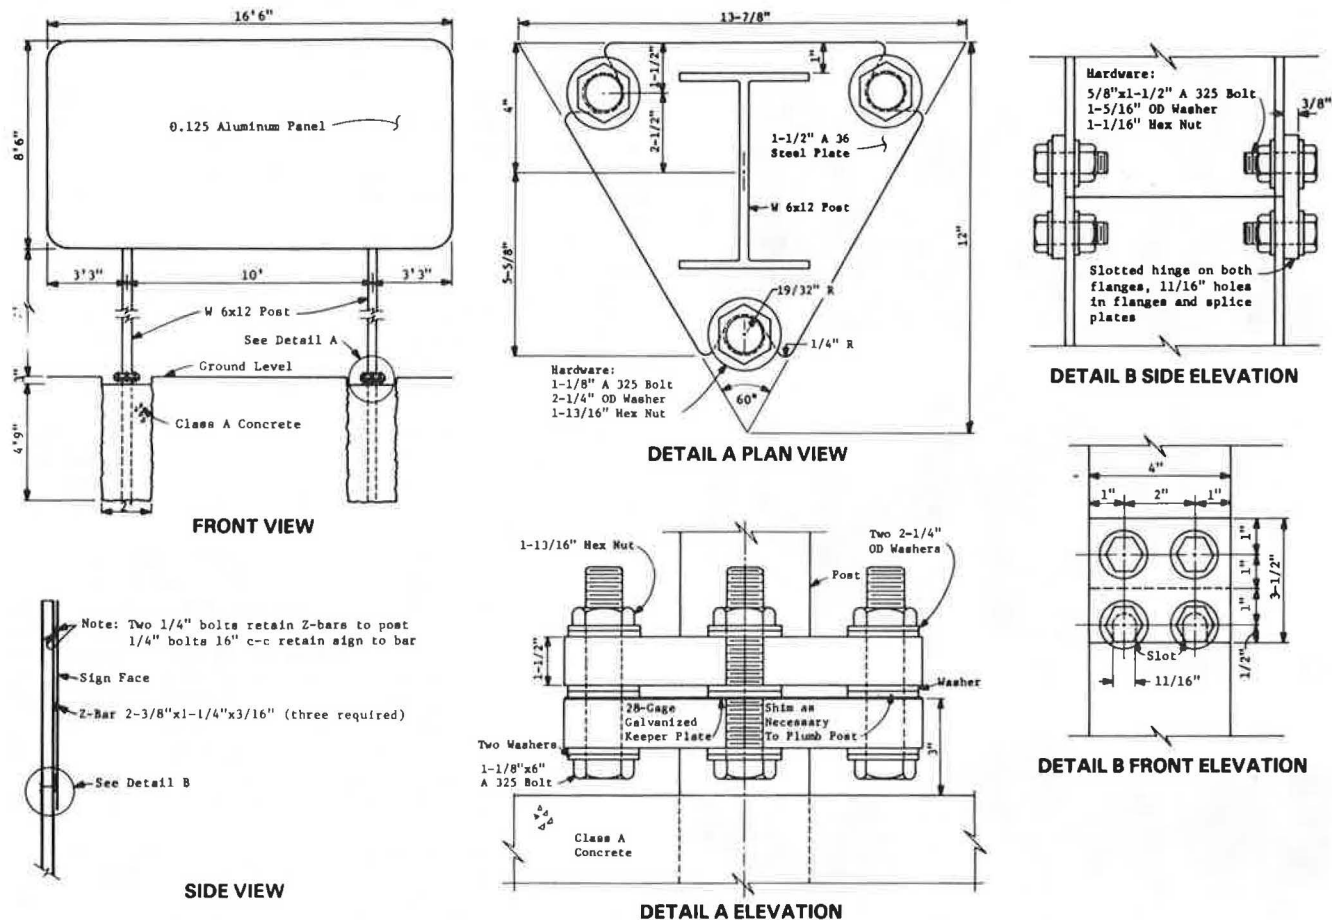
Figure 1. Omnidirectional slip-base sign support.

The support design (Figure 1) included base posts set in concrete, intermediate posts bolted to the base, and upper posts spliced to the intermediate posts (all W6x12 sections). The base posts, each topped by a triangular 1.5-in-thick plate, were set in 2-ft-diameter, 4-ft 9-in deep concrete foundations and had the plate top set flush with the ground line. Intermediate 8-ft-long posts that had matching triangular plates were attached to the bases, and three 6-in-long 1-1/8-in-diameter bolts were torqued to 110 lbf-ft. To permit the sign to be erected at 90° and 30° to the direction of vehicle travel, the left base plate was made circular rather than triangular and had two sets of three bolt slots offset by 60°. Two right bases were installed, also offset 60° from each other, so that the sign could thus be erected in either position. The 7-ft 6-in long upper posts were spliced to the intermediate posts with two 0.375-in-thick hinge plates. These plates were bolted to the drilled upper posts through holes and to the drilled intermediate posts through slots in the plates with 5/8-in bolts torqued to 170 lbf-ft for tests 29 and 30 and 190 lbf-ft for tests 31 and 32. An 8.5x16.5-ft (140 ft²) aluminum sign panel, which had three 2-3/8- by 1-1/4- by 3/16-in Z-bars, was mounted on the upper posts above the splice plates. The bottom of the panel was 7 ft above the ground. The Z-bars were attached to the sign panel with 1/4-in bolts on 16-in centers and to each post with two 1/4-in bolts.

During impact, the triangular plate on the intermediate post slips free of the base and, as the post rotates back, the splice plates bend to form a hinge. As bending continues, the bolts holding the slotted splice plate to the intermediate post pull

free and the intermediate post is separated from the rest of the support.

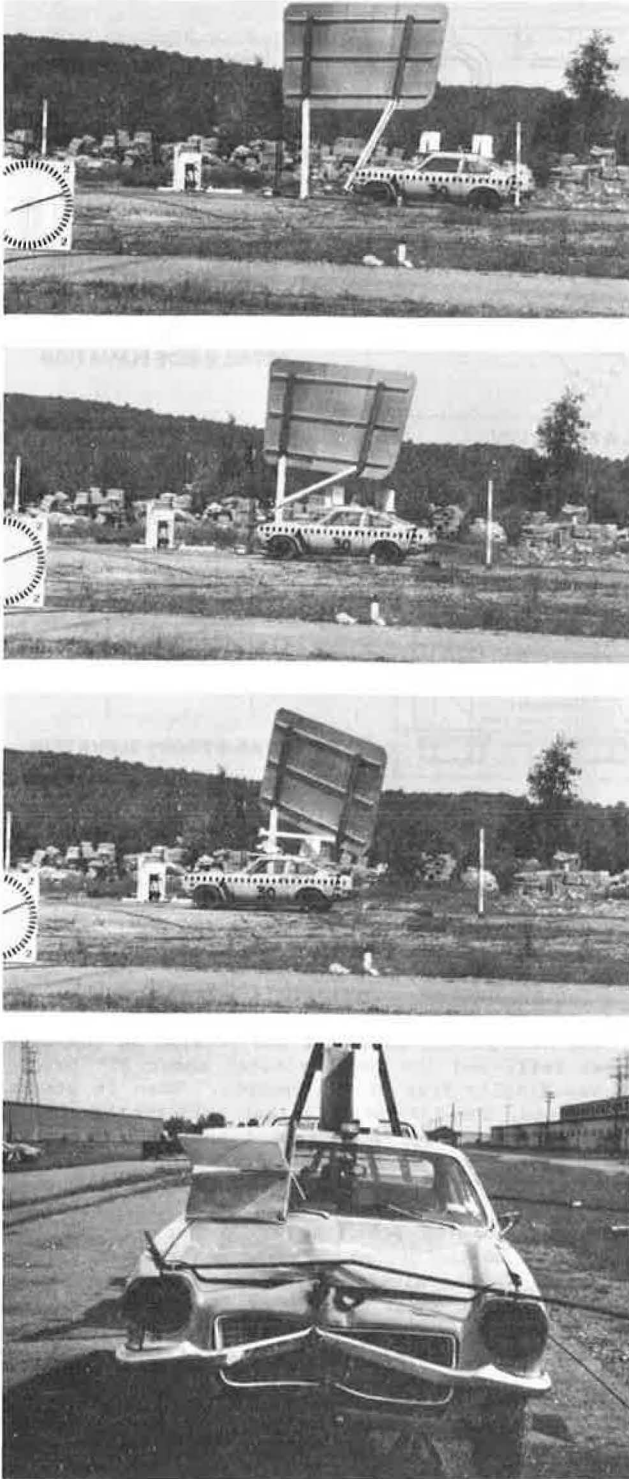
Figure 2. Typical impact sequence and vehicle damage resulting from test 30.

For the second test (test 30), impact was at 30° (nearly parallel to the sign panel) at 21.0 mph, which resulted in a 543-lb·s vehicle momentum change. Both base bolts were torqued to 110 lbf·ft and hinge bolts to 170 lbf·ft; they released as designed, i.e., the base bolts on impact and the hinge bolts after about 1.0 ft of vehicle travel. During that time, the sign bottom dropped only about 3 in and rotated back about 5° (see Figure 2).

After the hinge released, the intermediate post

remained attached to the upper post by the right-hand bolt on the downstream splice plate. The sign rotated about 40° more after hinge release and came to rest still partly attached to the nonimpacted post; it was turned approximately 45° from its original position. The sign panel was undamaged except for the lower left corner being bent when it hit the ground. Both upper posts remained fully attached to the Z-bars. The nonimpacted intermediate post twisted slightly but was reusable for another test.

The impacted intermediate post sustained a small dent in the upstream flange at bumper height and bent flanges at the top of the intermediate section where the splice plates remained almost straight. None of the nonimpacted components sustained permanent damage, and the hinge release resulted from the slotted splice plates simply pulling free of the 5/8-in bolts; there was no bending of the plates.

Vehicle damage was limited to a 9-in-deep, 19-in-wide dent in the bumper, grill, and hood. The car did not deviate from its path and exited along the impact trajectory. Again, vehicle decelerations were not available.
