## Design and Construction of Fabric-Reinforced Retaining Walls by New York State

GARY E. DOUGLAS

The experience of New York State in the design and construction of two fabric-reinforced retaining walls is described. Crushed-stone fill is reinforced by horizontal layers of fabric placed at intervals dependent on the height of the wall, the strength of the fabric, and the internal friction angle of the fill. Design and construction procedures are detailed; the emphasis is on practical construction techniques. The design and construction are based on methods described by the U.S. Forest Service. The construction technique, although not commonplace, can be quickly mastered without special equipment or labor requirements. Instrumentation installed during construction to monitor vertical and horizontal movements indicates satisfactory performance 18 months after completion. The cost of this type of construction at this site compared favorably with alternative designs. Suggestions for cost reductions are offered for future installations, which may include embankment repair, similar to this project, or temporary works, such as construction detours.

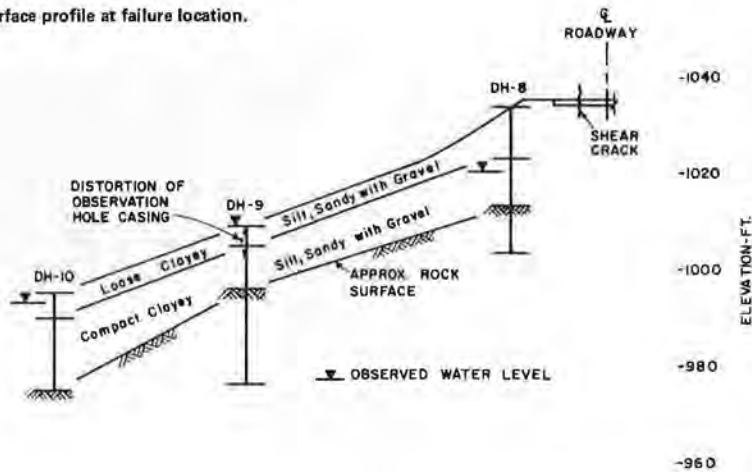
Figure 1. Typical subsurface profile at failure location.

Movements up to 0.2 ft horizontally and 1.2 ft vertically, detected from September 1976 to April 1978, and distortion of observation hole casing at depths of 4-5 ft (see Figure 1) indicated a shallow failure in the loose material rather than a sliding failure along the rock surface. Subsurface water, due to side-hill seepage at area B and a broken box culvert at area A, was the primary cause for failure of the 1 vertical on 1.5 horizontal embankment slopes. This assumption was supported by the existence of 125 ft of unaffected 1 on 1.5 slope between the two failure areas and the natural flattening of

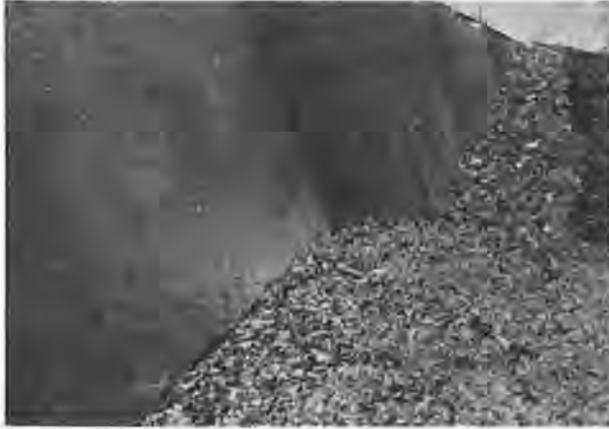
Figure 9. Concrete finish on face of wall.

The fabric was chosen mainly for its strength and permeability, although some resistance to ultraviolet deterioration was also desired. The maximum allowable exposure time for the fabric was specified as two weeks. However, for permanent protection, low maintenance, and protection from vandals, the wall face was covered with a mesh-reinforced pneumatically projected concrete. The reinforcing mesh, specified to be manufactured from No. 12 wires spaced 2 in in each direction, was supported by using No. 3 rebars inserted between layers to a depth of 3 ft. The bars were placed between layers during construction to form a grid measuring 3x3 ft. The mesh was included to minimize possible set-

tlement cracks in the rigid concrete surface of the flexible wall (Figure 9).

The rebar grid set for the reinforcing mesh required the addition of a top and a bottom row. These bars were installed after construction and had a minimal effect on the fabric. Future installations should specify a top and a bottom row of rebars. The 3-ft-square grid should be modified, perhaps by staggering alternate rows of rebars. Construction joints in the concrete face seem desirable to reduce cracking. Vertical construction joints, 50 ft on center, were included in the second wall.

The volume of concrete used on the facing exceeded the estimate by 40 percent, even with the thickness reduced from 3 to 2.5 in. This increase occurred because the ribbed surface of the wall and the wall batter formed a shelf between each lift.

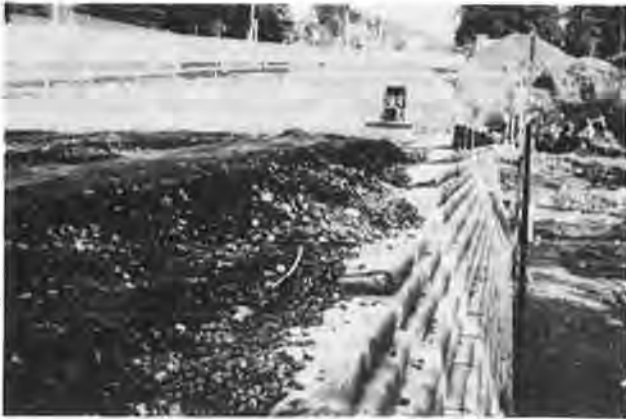
Figure 11. Stepping lifts to follow grade.

Compaction vibrated some stone fill out of the open ends of lower lifts. This loss of fill was prevented by folding the fabric to form a bed corner (Figure 11). Figure 11 also shows how the upper lifts were stepped to follow the grade of the road. At the south end of wall A, each lift was folded to bend the wall back to meet the flatter existing slope (Figure 12). The north end of each wall intercepted the natural slope and was buried with light stone fill after the face treatment had been applied.
