Detecting Deterioration in Asphalt-Covered Bridge Decks

D.G. MANNING AND F.B. HOLT

Information on the condition of bridge decks is required for reasons of safety and to develop a comprehensive program of maintenance, rehabilitation, and replacement. Where the deck has a bituminous surfacing, detecting deterioration in the concrete slab presents serious technical difficulties. In many cases, existing procedures are not adequate to produce reliable information. This paper reports the technical and economic evaluation of the following test techniques: chain drag, sonic reflection, ultrasonic transmission, microseismology, resistivity, electrical potential, radar, and thermography. All of the techniques were investigated under controlled conditions at a full-scale test site. The results were compared with the criteria developed for an ideal test method. Radar and thermography were found to have the most potential for development into routine operational procedures for detecting deterioration in asphalt-covered bridge decks. Also, additional development work needed was identified.

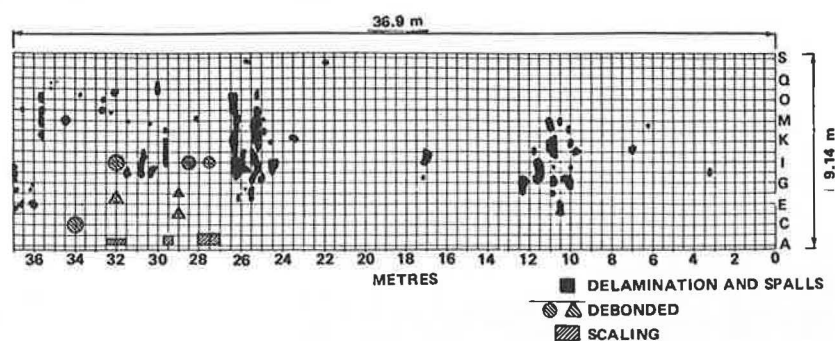
Figure 1. Deck deterioration prior to paving (chain drag).

The condition of the existing deck slab was recorded by measurement of the electrical potential and cover of the reinforcing steel on a 0.5x0.5-m grid and by plotting the delaminated areas and spalls on a site plan. The delaminations were detected by using both a chain drag and a hammer. The spalls occupied 0.2 percent of the deck area and the delaminations 6.4 percent. The locations of the delaminations are shown in Figure 1. They were in the

form of a large number of small delaminations predominantly associated with the reduced cover present over the two piers. Cover measurements were in the range of 17 to 44 mm with an average of 32 mm. Electrical potentials ranged from -0.07 to -0.58 V CSE with 14 percent of the deck area more negative than -0.35 V CSE.

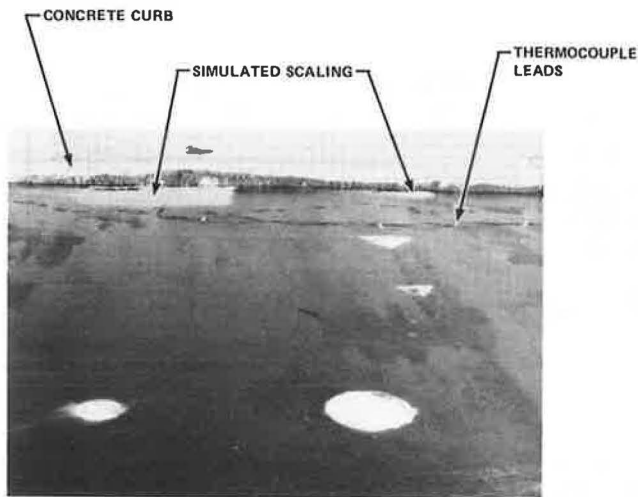
Figure 2. Area of deck showing scaling and debonding after tack coating and before paving.

face. A section of the deck was also selected to simulate the presence of scaling and to introduce lack of bond between the bituminous overlay and the concrete deck slab. The scaling was simulated by placing coarse sand to a thickness of approximately 10 mm at three locations. The debonding was accomplished by attaching circular and triangular masks to the deck at six locations prior to application of an asphalt emulsion tack coat to the entire deck. After the tack coat had cured, the masks were removed and a thin layer of powdered talc was spread directly on the concrete surface. The areas of debonding and scaling are shown in Figure 2. The deck was paved with two 40-mm lifts of bituminous concrete by using conventional materials and equipment. Thermocouples were installed at two locations between the two overlay courses.

Note: Circles and Triangles are Debonded Areas

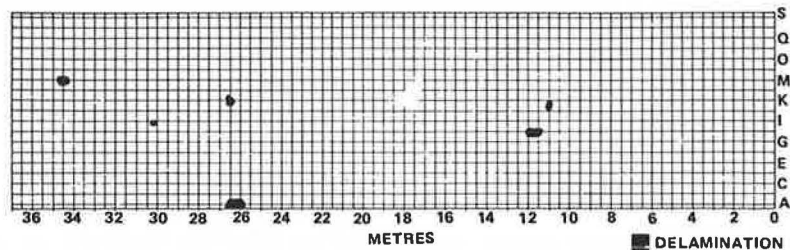
Figure 3. Chain-drum survey.

the deck. The survey results are shown in Figure 3. Six areas were identified as delaminated. Five corresponded to known delaminations, but the areas were smaller than the actual delaminations. The sixth area corresponded with the largest area of scaling, and the technician indicated that the sound was different from the other delaminations but could not explain the difference in terms of physical distress. The five areas of delamination represented 0.5 percent of the deck area, or 13 percent of the known delamination. The areas of debonding were not detected.

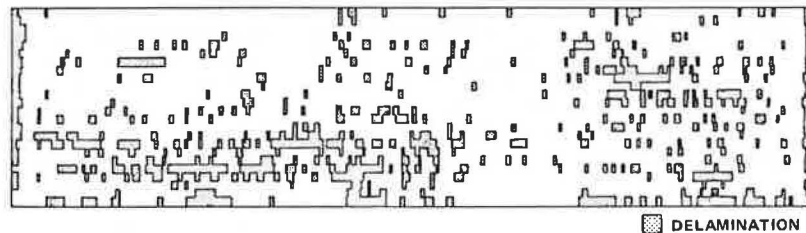
Figure 4. Sonic-reflection survey, August 1980.

The calibration procedure used in the first survey was the same as that used on exposed concrete decks. The results, shown in Figure 4, indicated that 10 percent of the deck was delaminated, but the correlation with the location of the actual delaminations was poor. The lack of precision was attributed to the calibration procedure, which was considered unsuitable because of the different attenuation characteristics of asphalt and concrete.

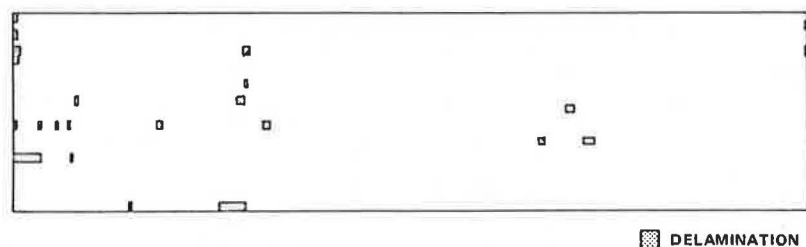
Figure 5. Sonic-reflection survey, June 1981.

In the second survey, the instrument was again calibrated by using the standard bar, and then an operator, who was experienced in working on asphalt-covered decks, adjusted the gain controls to reduce the sensitivity. The results are shown in Figure 5 and indicated deterioration in 1 percent of the deck area, or approximately 16 percent of the known delamination. The correlation between the location of the deterioration indicated and existing was only fair. The instrument could not distinguish between the scaling and delaminations and did not identify the areas of debonding.

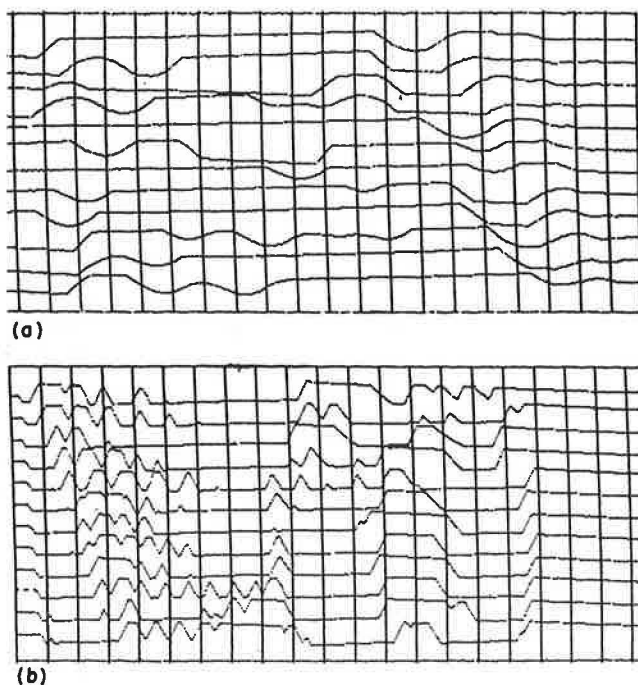
Figure 6. Seismograph output for (a) sound and (b) delaminated areas.

Typical wave traces for the sound and delaminated areas are shown in Figure 6. The equipment was found to be capable of differentiating between sound and unsound areas of the deck. However, interpretation of the data, even with the assistance of seismic experts, was difficult, and it was not possible to define the location of the discontinuities in order to estimate the area of deterioration. It was concluded that, although the test had potential, it was time consuming and not as promising as some of the other procedures evaluated. Consequently, further testing was not undertaken.

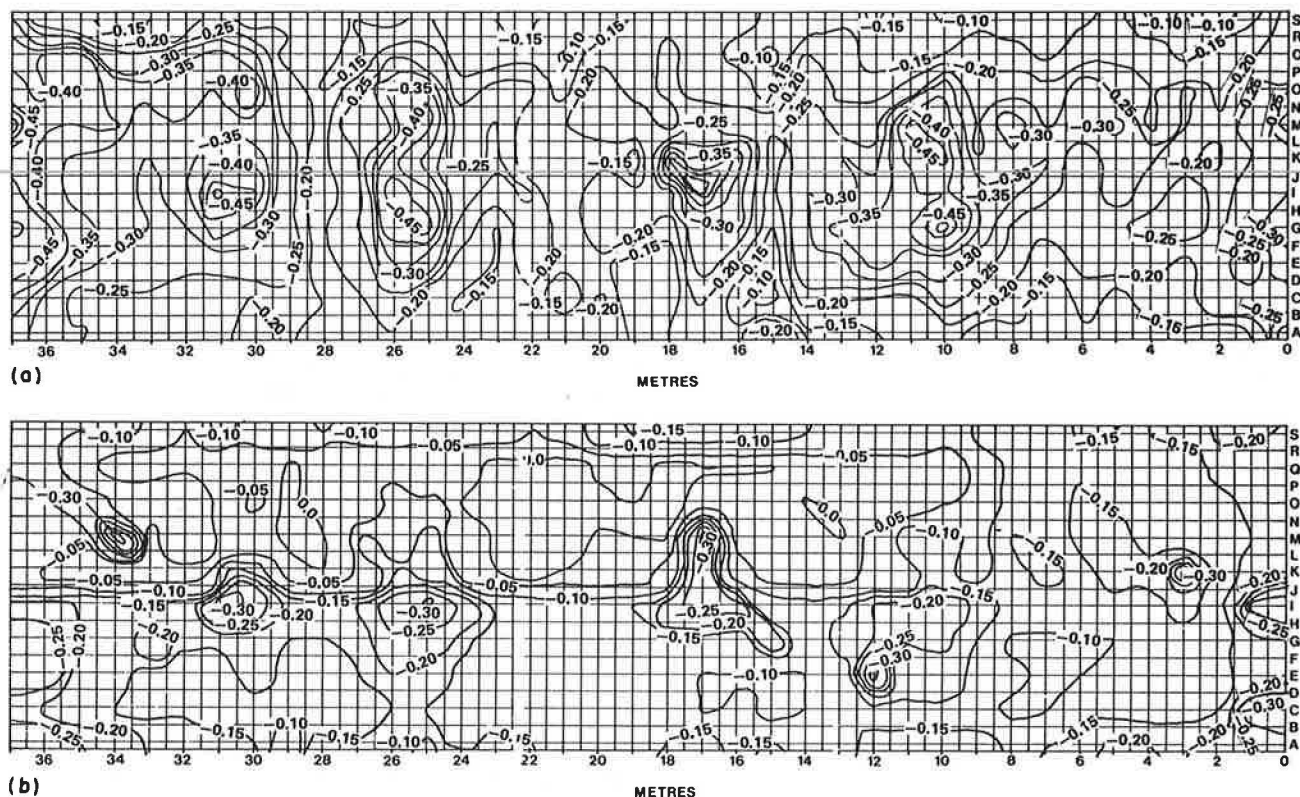
Figure 7. (a) Prepaving and (b) postpaving electrical potentials.

All of the grid points were drilled, the holes were filled with a wetting solution, and the half-cell potentials were measured in accordance with the ASTM C876 test method. The potential measurements were found to be less than those recorded prior to paving, and the range of values was -0.37 to $+0.03$ V CSE. Positive values and low negative values of potential are usually indicative of dry concrete. However, it is not only the absolute value of potential that is important, but the range of values also is important. In this case, the range of 0.4 V indicates the existence of well-developed anodic and cathodic areas in the deck slab. The pattern of the isopotential lines for the prepaving and postpaving conditions is very similar, as shown in Figure 7, although the absolute values are different and may reflect a change in the moisture content of the deck slab. It may also explain why there appeared to be little change in the area of delaminations in the two years after the deck was paved.

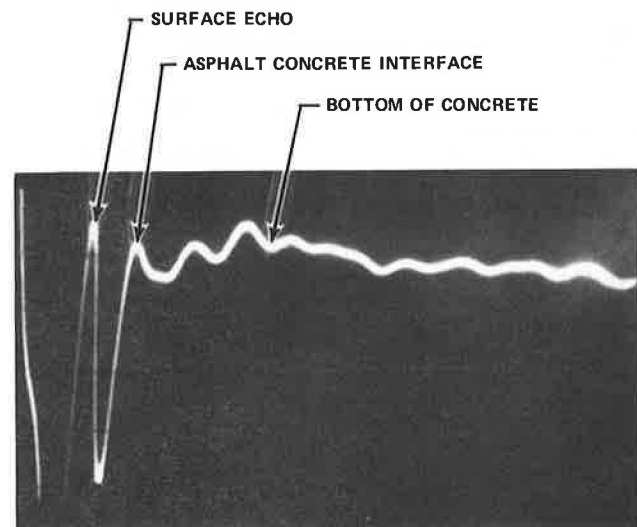
Figure 8. Radar output for sound concrete.

Figure 8 shows a typical radar signal for a sound portion of the deck and Figure 9 shows the signal for a section known to be delaminated. The part of the waveform of greatest interest is that that corresponds to the upper regions of the concrete deck slab and to the interface between the surfacing and the slab. These regions are indicated in Figures 8 and 9 together with the other significant features of the waveform. In areas where the concrete is deteriorated or the character of the interface changes, the amplitude and time of the echo also changes.

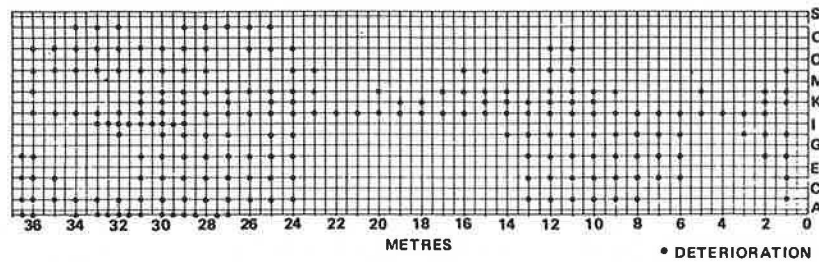
Figure 10. Radar survey.

The radar identified 51 percent of the grid points located over the delaminations and the simulated scaling. It did not identify the areas of debonding, and the operators also falsely indicated numerous grid points to be delaminated, thereby reducing the overall accuracy to 26 percent. The results are shown in Figure 10. However, further examination of the data indicates that the accuracy can be improved considerably. Many of the false readings were actually located close to delaminated areas, and since the radar senses an area of approximately 150 cm^2 , the presence of these areas influenced the waveform. Continuous recording of

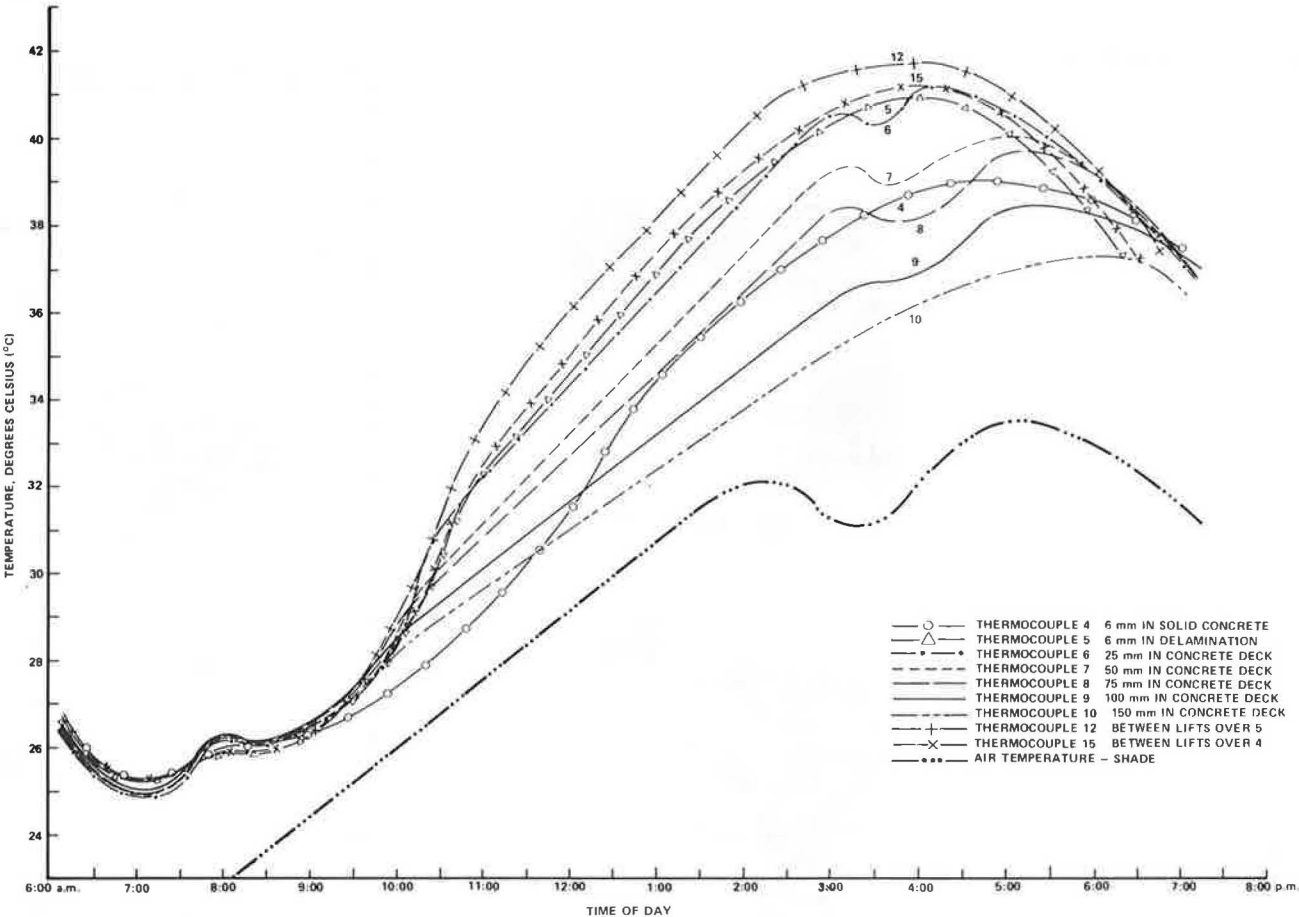
Figure 11. Temperature survey.

Figure 11 shows a temperature profile through the deck on a summer day with minimal cloud cover. The profile is very similar to that recorded on exposed concrete decks (4). In the early morning, the temperatures were sensibly uniform throughout the deck. This represents the transition period as the temperature of the surfacing changes from being cooler than the concrete deck slab during the night to warmer during the day. As the deck began to heat, a substantial temperature gradient developed through the deck. By 11:00 a.m., the difference in temperature between the thermocouples at various levels in the deck was well established. There was also a clear difference between the temperatures measured 5 mm below the concrete deck surface in solid and delaminated areas (thermocouples 4 and 5). This difference was also present, although less pronounced, on the thermocouples (15 and 12) located between the two lifts of asphalt directly above thermocouples 4 and 5 and on the deck surface, as shown in Figure 11 and Table 2. Surface temperature measurements were made with a contact probe. Because the infrared scanner also measures surface temperature, the temperature measurements explain why thermography is capable of detecting delaminations in the concrete slab. The time and power required for the temperature gradient to develop also explains why artificial sources of heat are not feasible. The difference in surface temperatures over the solid and delaminated sections reached a maximum of 2° at 2:00 p.m. and then gradually diminished until it was only 0.2° at 6:00 p.m. This pattern is very similar to that reported for exposed concrete decks through the "window", during which thermography can be used to detect delamination is much smaller on asphalt-covered decks.

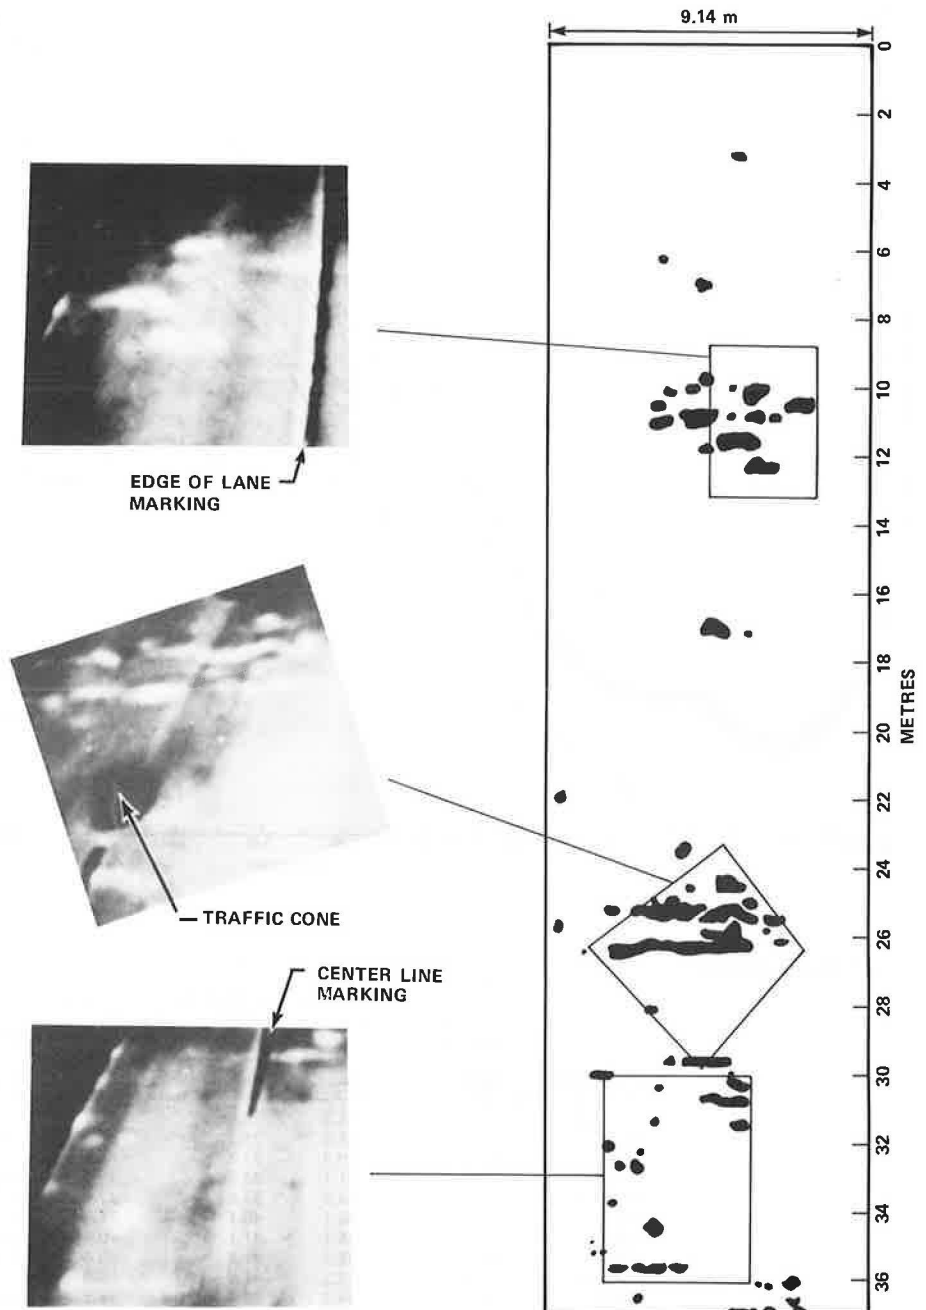
Figure 12. Thermograms for selected deck areas.

Figure 12 enables a comparison to be made in three areas between thermograms taken from the boom

and the delaminations that were present in the deck prior to paving. The delaminations are visible as white or hot areas against a dark or cooler background. The correlation with the prepaving condition of the deck slab was excellent, although the outline of the delaminations was less distinct or "softer" as a result of dissipation of heat in the bituminous surfacing. The delaminations first became visible at 11:30 a.m., and the definition improved until about 3:00 p.m. when the thermograms illustrated in Figure 12 were taken. The resolution then deteriorated until by 6:00 p.m. the delaminations were barely visible. These observations are consistent with the data contained in Table 2. The scanner detected more than 90 percent of the known delaminations, some of which were less than 150 mm in diameter. The areas of scaling and debonding were not visible in the thermal images. Debonding was not detected because the bituminous surfacing and the deck slab were in intimate contact and did not cause a thermal discontinuity. The inability to detect the scaling was ascribed to the fact that the areas were located adjacent to the curbs, and any difference in surface temperature was masked by flares on the image that result from the difference in emissivity between the asphalt deck surface and the concrete curbs. Of the commercial systems that were used, only those that had a full gray scale setting of two isotherm units and a minimum thermal resolution of 0.2°C were found capable of detecting the delaminations.

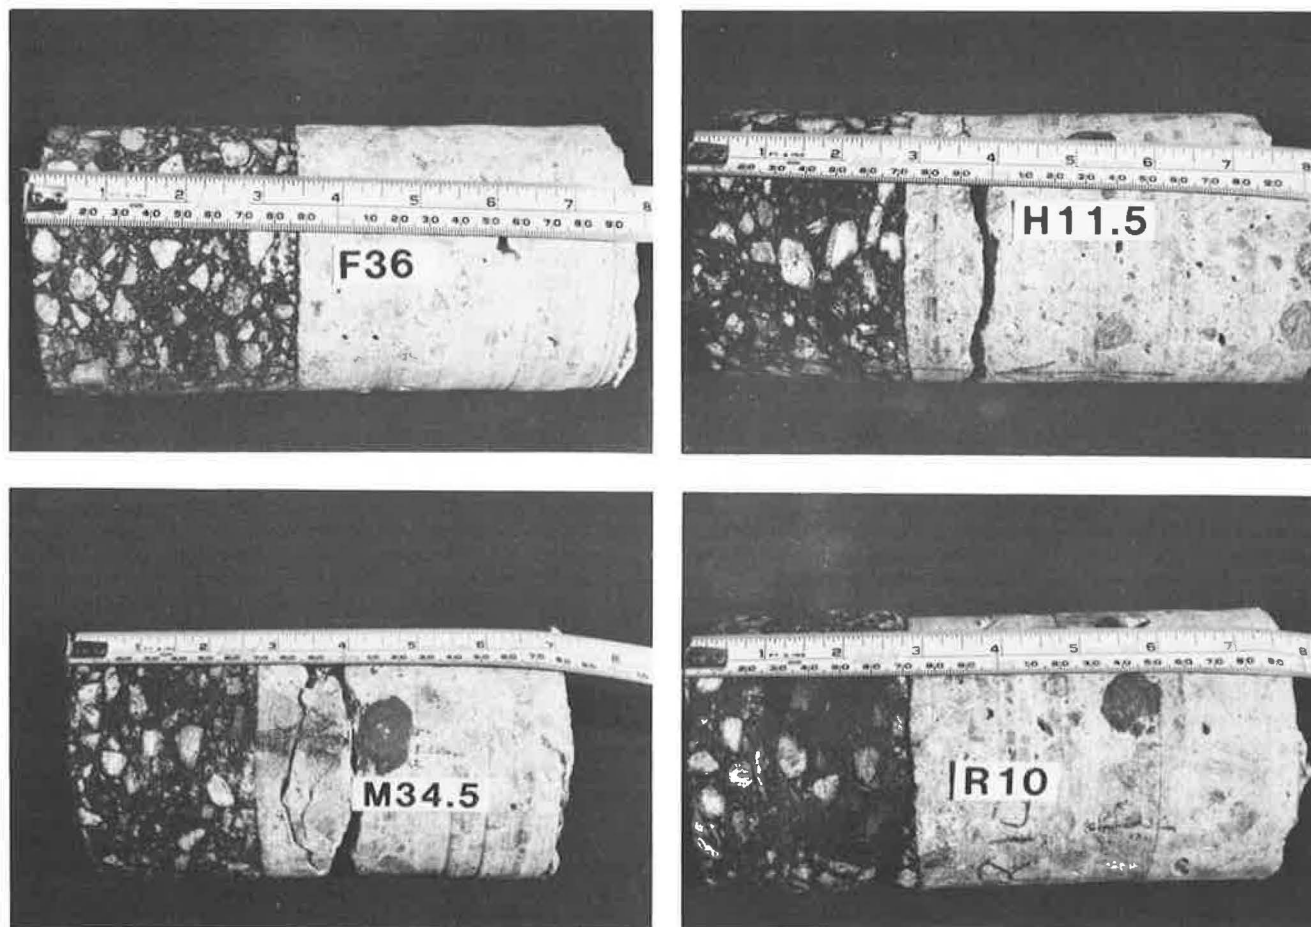
Figure 13. Condition of cores removed from deck.

After evaluation of the different test procedures, cores were taken at selected locations to confirm the existence of defects and to investigate the reason for anomalies identified by some of the test methods. The results are given in Table 3, and the condition of the cores taken at four of the grid points is illustrated in Figure 13.

The cores confirmed the existence of the delamination and scaling known to be present in the deck and the fact that the surfacing was well bonded to the deck except where bond was deliberately prevented. No new areas of delamination were identi-

fied, even where some of the test methods indicated deterioration. Deterioration indicated by the chain drag and themography was confirmed. In all but one of the cores taken in areas indicated as deteriorated by radar, but where no deterioration was present, the anomaly was the result of steel reinforcement at the grid location. Further experience in interpretation of the signal and the continuous recording of data should enable this condition to be recognized. Concrete, and especially reinforced concrete, is a difficult material to analyze because, being heterogeneous, several dielectrics exists and separate waveforms may be reflected in sound material.
