Bridge Rehabilitation Programming by Using Infrared Techniques

RITA E. KNORR, JOHN M. BUBA, AND GREGORY P. KOGUT

Techniques used to determine the needs and characteristics of bridge and roadway maintenance are highlighted. The results imply that the use of infrared equipment for inspections is appropriate to accomplish relatively rapid evaluations. However, limitations of the technology are apparent in observing overlaid surfaces because the distinction between delaminated areas versus debonded bituminous overlaid pavement areas was not reliable. Despite the deficiencies associated with performance as a precise testing mechanism, infrared thermography has an application as a tool to collect historical data and provide a basis for programming rehabilitation projects.

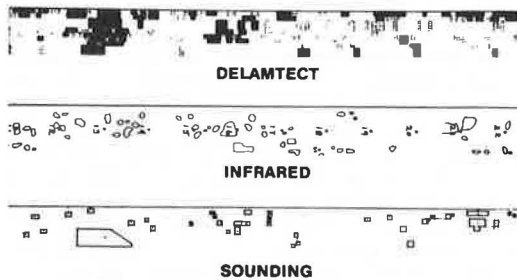
Figure 3. Span 10.

A plot of the sounding survey on the stripped deck shows correlation with the infrared and Delamect survey plots. The sounding displayed fewer delaminations in the steel span (span 10) than the other survey methods. The actual breakout resulted in quantities that were more extensive than those shown on the survey maps. It should be recognized that breakout quantities tend to exaggerate the extensiveness of delaminations and peripheral cracking and do not allow for a thorough comparison of the exact points of deterioration. (The breakout plot includes the delaminated area plus the contiguous exposed regions, which allow for a clean and squared repair site.)
