## Study of Cracking of Composite Deck Bridge on I-75 over Peace River

CLIFFORD O. HAYS, JR., FERNANDO E. FAGUNDO, AND ERIC C. CALLIS

Observed cracking on the Peace River Bridge on Interstate 75 near Punta Gorda, Florida, caused concern about the possibility of high maintenance cost and the structural adequacy of the bridge system. The deck system consists of precast panels resting on soft fiberboard, which serve as formwork for the road surface and later aid in carrying the traffic loads. An investigation has been completed that involved testing of the Peace River Bridge, testing of the FL-776 Bridge (a nearby structure of similar construction), analytic modeling using the finite element method, and limited laboratory testing of beam specimens. The investigation indicates that although the Peace River Bridge is adequate to carry normal traffic, the shear stresses in the bridge deck are substantially higher than those of deck systems that have positive bearing at the ends of the panels. Further experimental studies are under way to determine the shear fatigue life of the bridge. The causes of cracking and separation at the ends of the panels are identified as differential shrinka

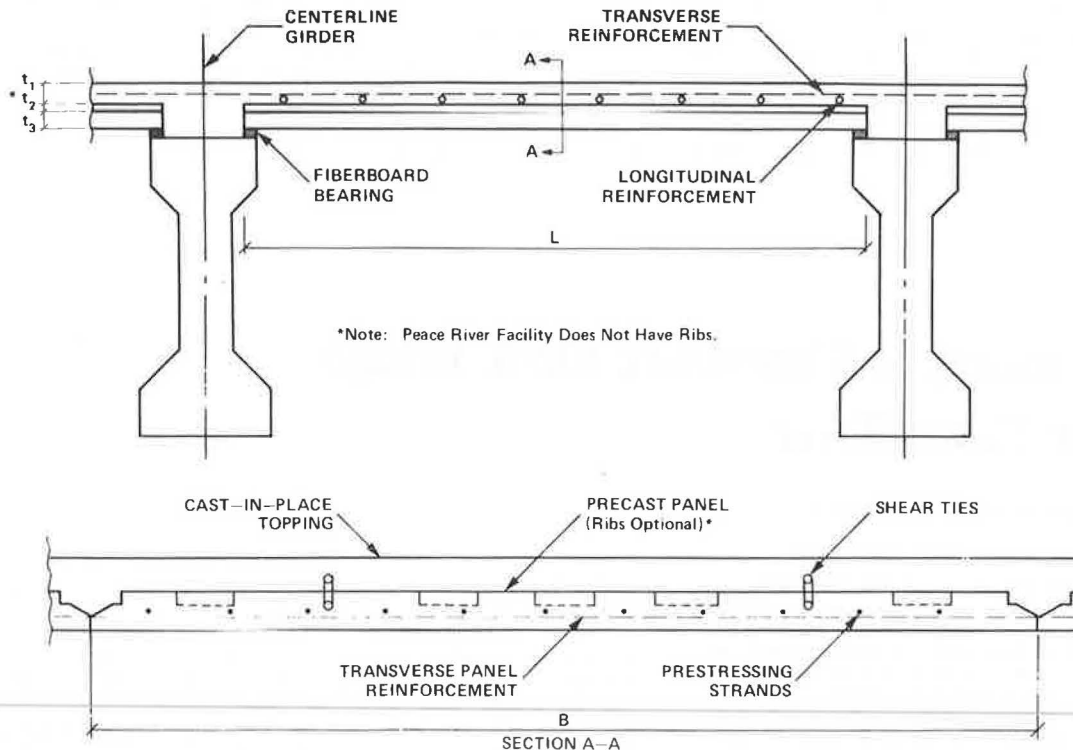
Preliminary studies of the plans for the Peace River Bridge indicated one major difference from details used in other states. On the Peace River Bridge, and other bridge work in Florida, the precast panels are supported, as shown in Figure 1, by fiberboard so that the panels do not have positive bearing on the girders. One series of the Florida panel tests (5) was made without positive bearing for the panels, and satisfactory performance of the panels was observed. However, these test panels had prestressed strands that extended a short distance into the cast-in-place concrete. In addition, these laboratory test specimens were not exposed to temperature, creep, and shrinkage stresses, which aggravate the cracking near the end of the panels under field conditions.

Figure 1. Typical composite bridge panel construction.

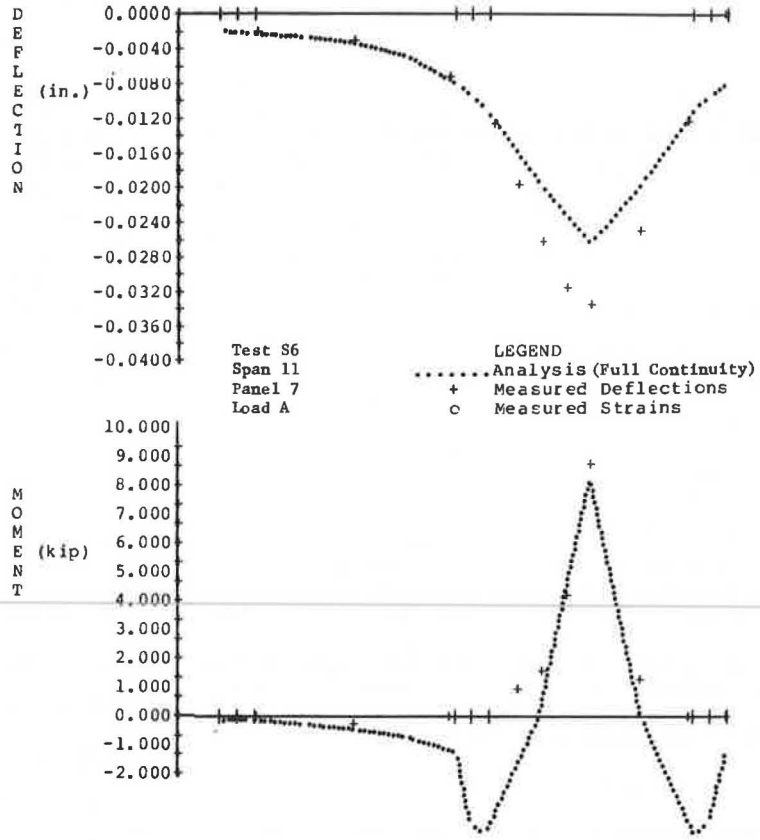
Figure 8 shows the type of behavior exhibited by most of the hydraulic tests of the Peace River Bridge. The analysis made by using the full-continuity model indicates both smaller deflections and positive moments than that based on the field data. Figure 9 shows the same field data as Figure 8 but in comparison with the thin element model. Clearly, the correlation between the model and the experimental data is quite good. This type of behavior indicates that the panels are approaching a simply supported condition.

Figure 8. Deflection and moment profiles from test S6.

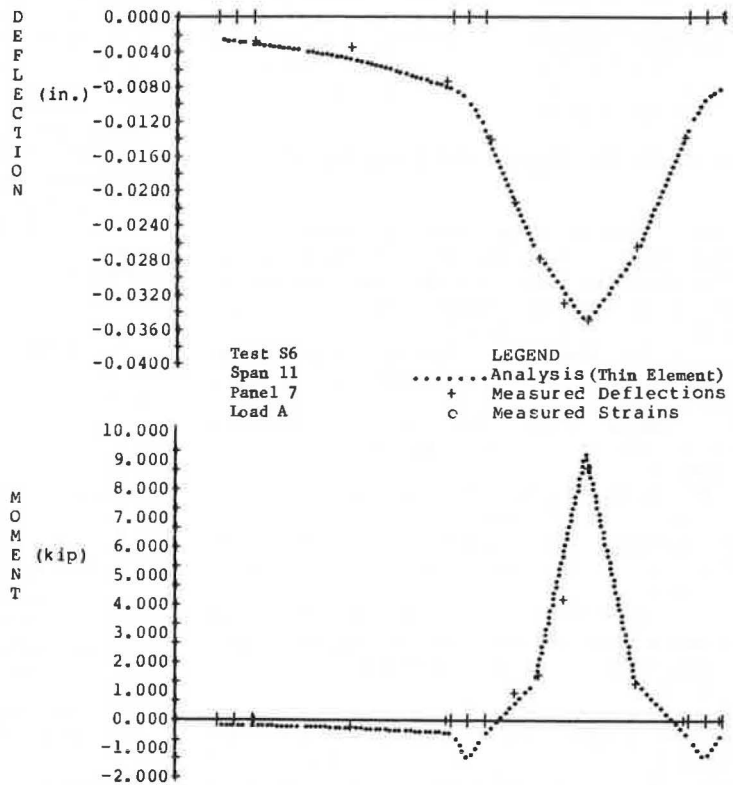
Figure 9. Deflection and moment profiles from test S6 (thin element).

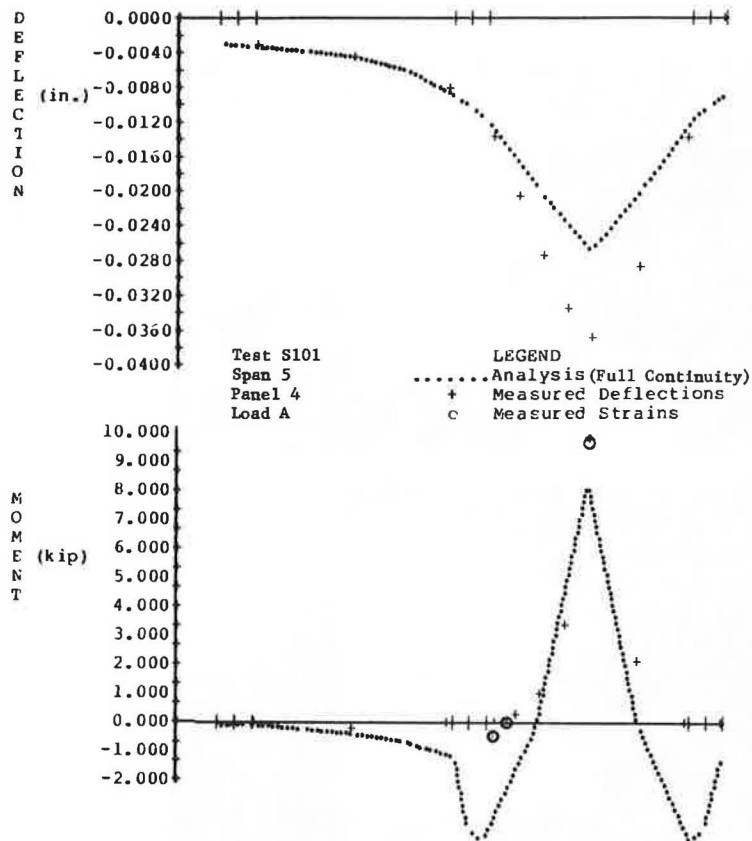
Figure 10 shows results for a test that had strain gage data as well as deflection data. The correlation between the computed moments based on displacement data and those based on strain gage data is quite good.

Figure 10. Deflection and moment profiles from test S101.

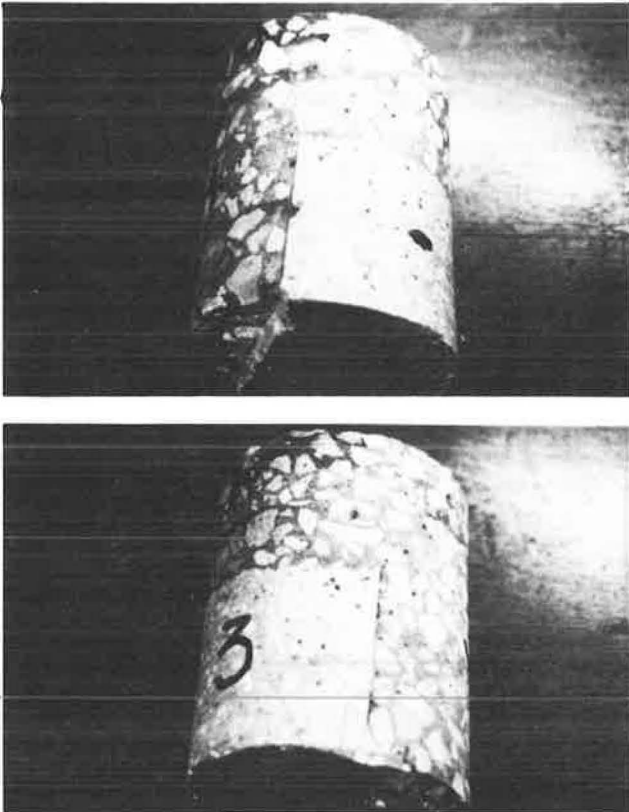
The photograph at the top of Figure 11 shows core 1. The separation at the end of the panel is about 0.01 in. The lower photograph shows core 3, which had essentially full penetration by the epoxy grout. The thickness of the epoxy appears to be about 0.01 in. The thicknesses of the topping of cores 1 and 3 are only 3.5 and 3.25 in, respectively. However, all of the other cores taken from the Peace River Bridge had at least a 4-in topping. It should also be noted that both cores 1 and 3 had hairline cracks extending about 1 in up the panel-topping interface. The fact that these cracks passed through both paste and aggregate indicated that the crack occurred after the topping had cured.

Figure 11. Peace River cores: (top) core 1 and (bottom) core 3.
