Treatments for Reduction of Reflective Cracking of Asphalt Overlays On Jointed-Concrete Pavements in Georgia

WOUTER GULDEN AND DANNY BROWN

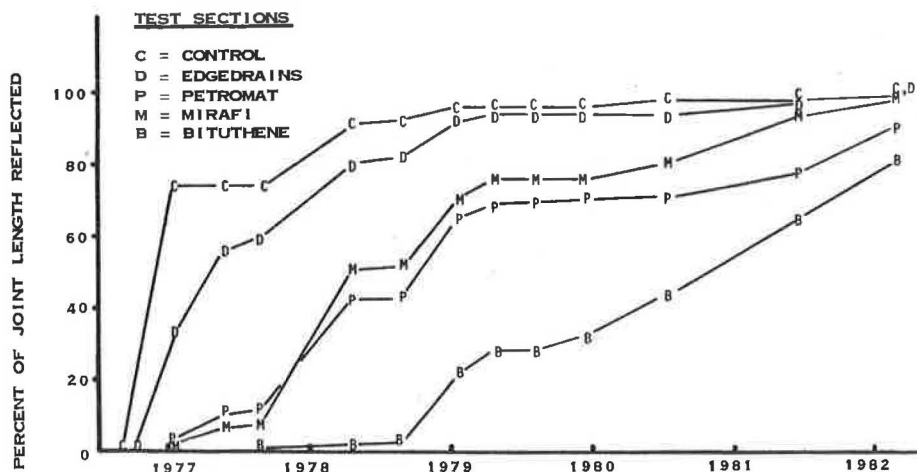
Figure 1. Crack reflection: 2-in. AC overlay, I-85, Gwinnett County.

The amount of cracking for the 2-in. overlay is currently about the same for all treatments. It can be seen from Figure 1 that the fabrics delayed the rapid increase in reflective cracking for about 1 year. The waterproofing membrane showed virtually no reflective cracking for the first 2 years and no significant increases until after the first 4 years.

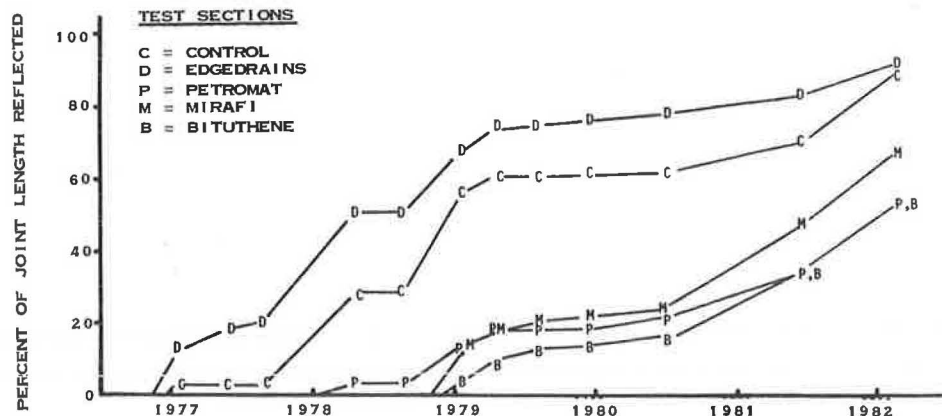
Figure 2. Crack reflection: 4-in AC overlay, I-85, Gwinnett County.

The performance of the treatments with a 4-in. overlay showed only slight differences between the fabrics and the waterproofing membrane. The control sections showed large increases in cracking lengths

during the second and third winters after placement, whereas the treated sections began to show increases after the fifth and sixth winter. The Bituthene and Petromat sections are still significantly lower in reflective cracking than the control sections.

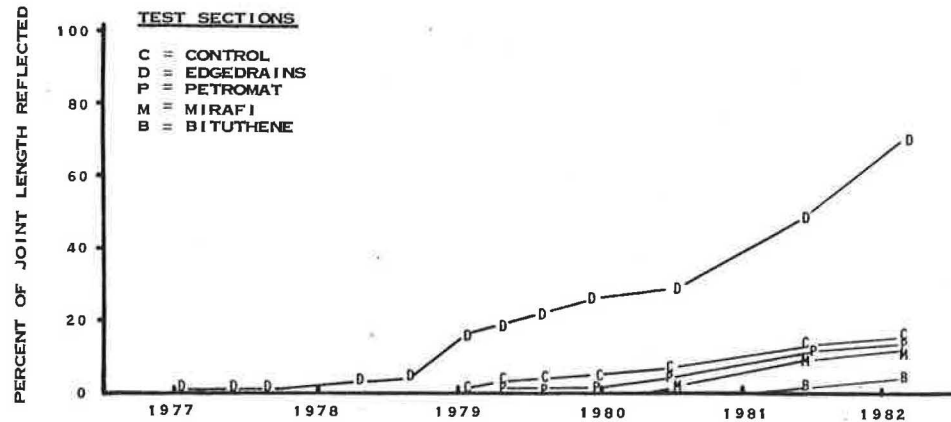
Figure 3. Crack reflection: 6-in. AC overlay, I-85, Gwinnett County.

No definite trends can be seen as yet in the 6-in. overlay area because the sections with fabric and the control section are performing equally well. The Bituthene section has the best performance—a lower crack reflection percentage than the other sections. Of interest is the unsatisfactory performance of the area with edge drains.
