Use of Fabrics for Improving the Placement of Till on Peat Foundation

C. LUPIEN, G. LEFEBVRE, P. ROSENBERG, J. J. PARE, AND J. G. LAVALLE

Observations made during the construction of test embankments, which were built to investigate the possibility of placing till directly on peat, are reported. The test fills were constructed on two test sites that presented different peat properties. Different uses of fabrics were tested at each experimental site: as a separation and reinforcement between the muskeg and the fill, as slope protection, and as reinforcement at midthickness of the fill. For comparison, a few test fills were constructed without fabrics. The observations made during construction describe the difficulties encountered in fabric handling and the effect of geotechnical fabrics on the behavior of the fill material and the peat foundation. Of particular interest was the use of geotextile (used as a fill material) as reinforcement at midthickness of the fill to prevent a loss in the bearing capacity of the till. The use of fabrics as reinforcement of the peat foundation proved to be of little significance when the peat offers sufficient strength.

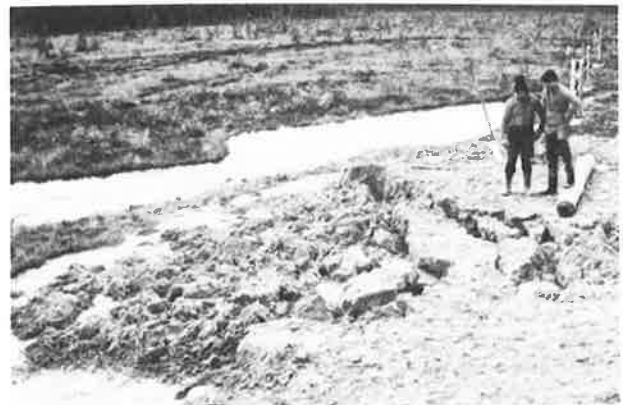
Figure 12. NBR-3 test site: sloughing of slope material.

Sloughing of the slopes with the NBR-3 till was a generalized phenomenon. The slopes were stable immediately after placement of the fill. Then a rise of water level in the slope material was achieved by pore pressure transmission, capillarity, and precipitation. The poorly compacted till near the slopes became unstable under these new water conditions, and sloughing of the slope material occurred. Material losses were important, with resulting slopes varying from 3:1 to 7:1. This phenomenon was especially significant after severe precipitations. Figure 12 shows a typical case.

The differences in the behavior of the two tills are mainly explained by the properties of the fill materials. Both tills were nonplastic, but their grain-size distributions were different. The most significant factor is the uniformity coefficient ($C_u = d_{60}/d_{10}$), which was on the order of 10 and 40 for the NBR-3 and NBR-2 tills, respectively.

The use of geotextiles as a slope protection membrane proved to be of interest at the NBR-3 site where sloughing of the slope material was generalized. In test fill A, which was built by using a type A geotextile for slope protection, the loss of material by sloughing was prevented for the protected material. However, the sloughing of the till over this level occurred.

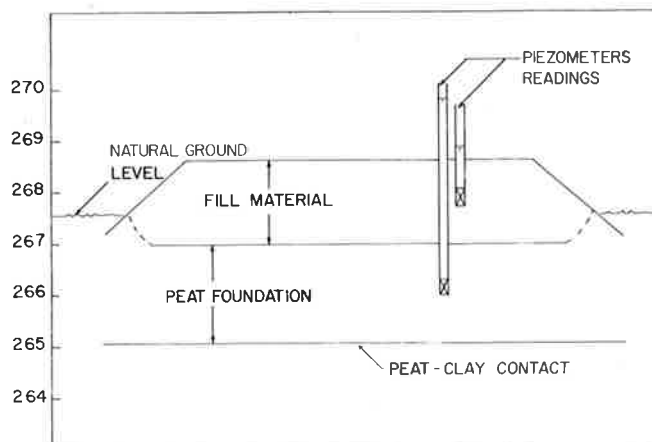
Figure 11. NBR-3, test fill A: maximum piezometer readings.

Figure 11 shows typical piezometer elevations observed within a few hours after placement of the fill within the test fill A area. The significant piezometer response into the fill is indicative of pore pressure buildup and the saturation of most of the fill. Under such conditions compaction of the fill material is made difficult. The movement of trucks on the fill increases the problem because a pumping action is created, which results in a rise of water toward the fill surface. This phenomenon became so significant at a few locations on the test fills and the access road that a complete loss of bearing capacity occurred and construction equipment could not operate on these zones. The addition of fill material did not improve the behavior of the weakened zones. Geotextile was used to strengthen the fill in these circumstances (see discussion later in this paper).

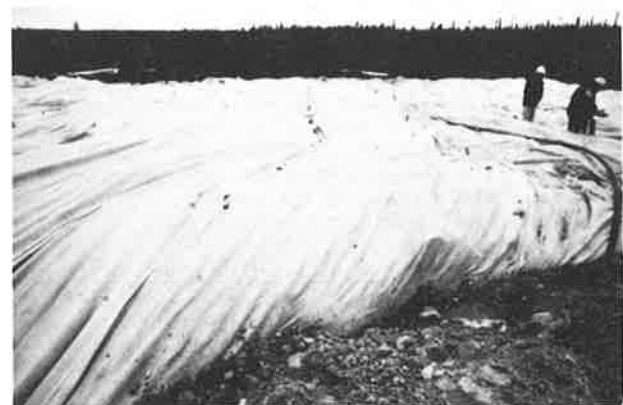
Figure 13. NBR-2, section B: lateral displacement and heave of peat.

both sites. Significant lateral displacement of the peat was observed at the NBR-2 site. The difference in measurements between the settlement plates before and after construction indicated a lateral strain of the peat that varied from 20 to 80 percent. Heave of the peat at the toe and front of the advancing fill (Figure 13) was also observed and was on the

order of 0.7 m. A failure in the peat foundation did occur at section B at this site, which will be discussed later.

With respect to the deformed NBR-2 peat, the behavior of the foundation was different, with the lateral displacement varying from 10 to 80 percent, with an average of 45 percent. For the test fill built with a type C geotextile wrapped around the first layer of the fill material, the lateral deformations registered varied between 40 and 65 percent. The fabric used for this test fill had an elongation at breaking load on the order of 20 percent. Even if there was no evidence of fabric rupture, with the comparison between actual and tolerable elongation as established for this product, it is believed that the geotextile at the peat-fill contact surface was brought to failure.

A foundation failure was observed on this test fill. The rupture was evidenced by a crack at the fill surface and a differential settlement of about 15 cm at the crack level. It was possible to reload the affected area and proceed with construction.

Before the construction period it was not expected that the lateral movement of the peat foundation and the resulting elongation of the peat below the fill would be of that magnitude. It is believed that the use of a nonwoven geotextile with an elongation capability of about 100 percent (with the appropriate strength) would have been more appropriate for this deformed peat.

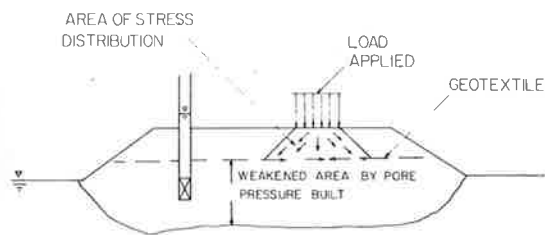
Figure 14. Use of geotextile over a locally weakened fill.

As described earlier, construction difficulties were encountered at the NBR-3 site where softening of the fill material had occurred. In these cases, the addition of fill material over the affected area did not improve the situation. The limited areas so affected were repaired by undercutting the till, placing a geotextile, and refilling with till. This method proved to be efficient and improved the performance of the saturated fill. Both geotextiles--type A and B--have been successfully used for this purpose.
