# Evaluation of Two Geotextile Installations in Excess of a Decade Old

BARRY R. CHRISTOPHER

Many erosion-protection installations for roadway embankments were designed and constructed by using geotextiles during the 1960s. Two such installations constructed in 1969 were studied to evaluate the long-term field performance of the facilities and the geotextile material. These projects were the 79th Street Causeway in Miami Beach, Florida, and the Bahia Honda Bridge in Bahia Honda Key, Florida. The 79th Street Causeway was constructed with a woven geotextile as a filter in a rip-rap revetment-type seawall to protect one of the bridge abutments and a segment of the causeway. The geotextile design was used in place of a conventional granular filter design to prevent erosion of the subgrade soils through the rip-rap. The protected section was designed for 3-ft waves and a 3-ft tidal variation. The Bahia Honda Bridge project was constructed with a woven geotextile as a subgrade-protection filter beneath sand-cement rip-rap-constructed bridge abutments, drains, and seawalls at both ends of the bridge. In this system, a geotextile was used to act as a filter between the rip-rap and underly

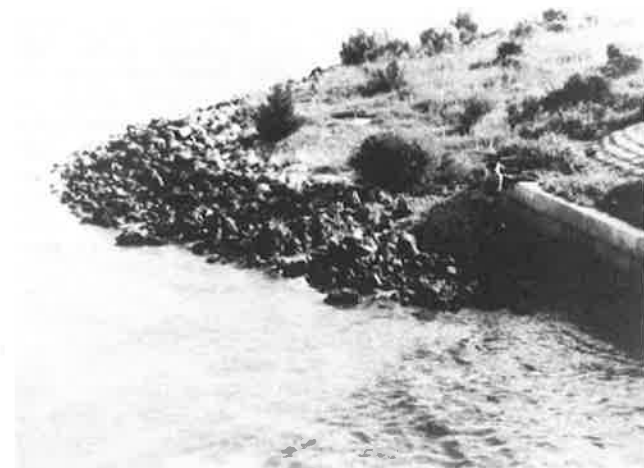
Figure 3. Limestone rip-rap covering fabric at site 1.

At site 1 an area approximately 3x12 ft was excavated with the limestone rip-rap and other materials removed by hand down to the fabric. Figures 3 and 4 show the area excavated. The surface rip-rap consisted of fossiliferous limestone boulders that had a mean diameter of 12 to 18 in. The surface rip-rap used throughout the site was highly weathered limestone, which was rough and had many sharp edges. (As an example of the abrasiveness of the rip-rap, the subsequent excavation of the rip-rap for this project resulted in the destruction of several pairs of work gloves due to abrasion.)

Beneath the large surface rip-rap a 1-ft layer of 6- to 12-in.-diameter rip-rap was encountered. Beneath the total depth of rip-rap a 3-in. layer of coarse sand and gravel was underlain by approximately 0.25 to 0.50 in. of fine to medium sand. Note that the 3-in. cushion layer of sand and gravel was not shown in the proposed design (Figure 2). The sand was located directly on the surface of the geotextile and was probably the result of sand being washed down from the upper slope above the protec-

The exposed surface of the fabric was gently washed with water to remove the sand from the surface. The fabric appeared to be in excellent condition, and no large tears or punctures were observed. Small perforations and punctures were present, which probably resulted from the placement of the rip-rap during construction. On average, two to three 0.125- to 0.25-in.-diameter holes were noted for each square foot of material. Some smaller holes were also observed. Little abrasion from sliding of the rip-rap was apparent, even though the relatively light wave action during the visit was sufficient to move rip-rap as large as 6 in. in diameter.

New fabric was placed over the excavated area with an overlap in excess of 1 ft over the old fabric. Then gravel and rip-rap were replaced in the proper order.

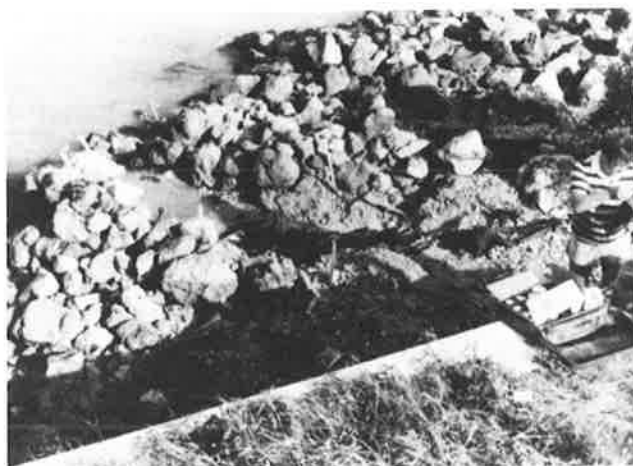
Figure 4. Excavated section at bridge abutment corner at site 1.

The geotextile was cut and carefully peeled off the underlying soils. Light was readily seen through a section of the fabric. Some particle retention was noted in the fabric; however, water was observed to readily flow through the fabric. Samples of the fabric were returned to the STS laboratory for testing.

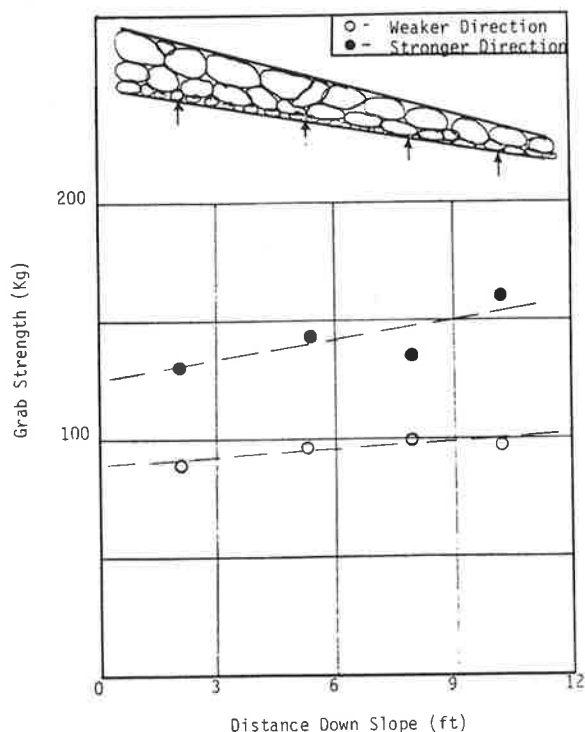
Figure 6. Strength of fabric versus position on slope at site 1.

The data in Figure 6 indicate that strength variations at site 1 may exist due to the location of the test specimens at the site. These data are based on limited testing and may be influenced by nonuniformities in the test specimens (such as perforations). Product variation may also have contributed to the relatively small variations observed. Nevertheless, the grab strength appears to increase with location in the downslope direction. The relation appears to occur for both mutually perpendicular test directions. This general pattern indicates that the observed strength differences are due to tidal fluctuations, which result in differences in exposure to water, air, and temperature.

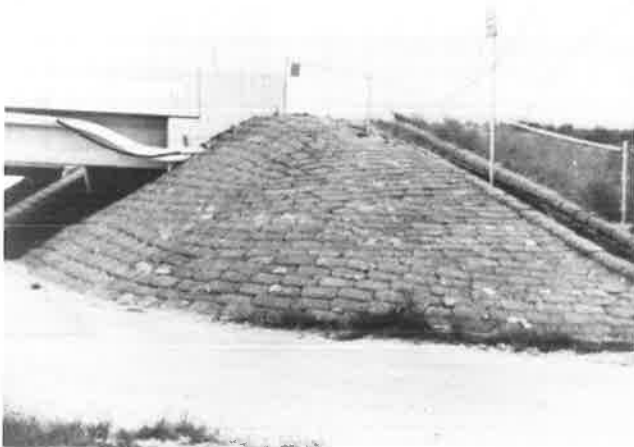
Figure 12. Armoring system: bridge abutment and drain, Bahia Honda Bridge.

stability of the sand-cement constructed facilities, as shown in Figures 12 and 13. No erosion problems were apparent at any of the drains, slopes, and seawalls protected by the sand-cement armoring system, which indicated that the installation was functioning as designed. The armoring, in most cases, has held up completely. Some surface wear was noticeable; however, no washouts of the rip-rap were observed.

Fabric could be seen in several sections protruding from beneath the rip-rap at the edge of the structures. The rip-rap, and in two cases the underlying fabric, had been removed in several areas. Two sections of rip-rap, one at each end of the bridge between the two lanes of the bridge, were recently removed for construction of a future pipeline. Other areas that had been removed were possibly the result of vandalism. Exposed fabric was observed in the abutments, drains, and seawall. In all cases, the fabric appeared to be in excellent condition and could not be distinguished from new fabric.

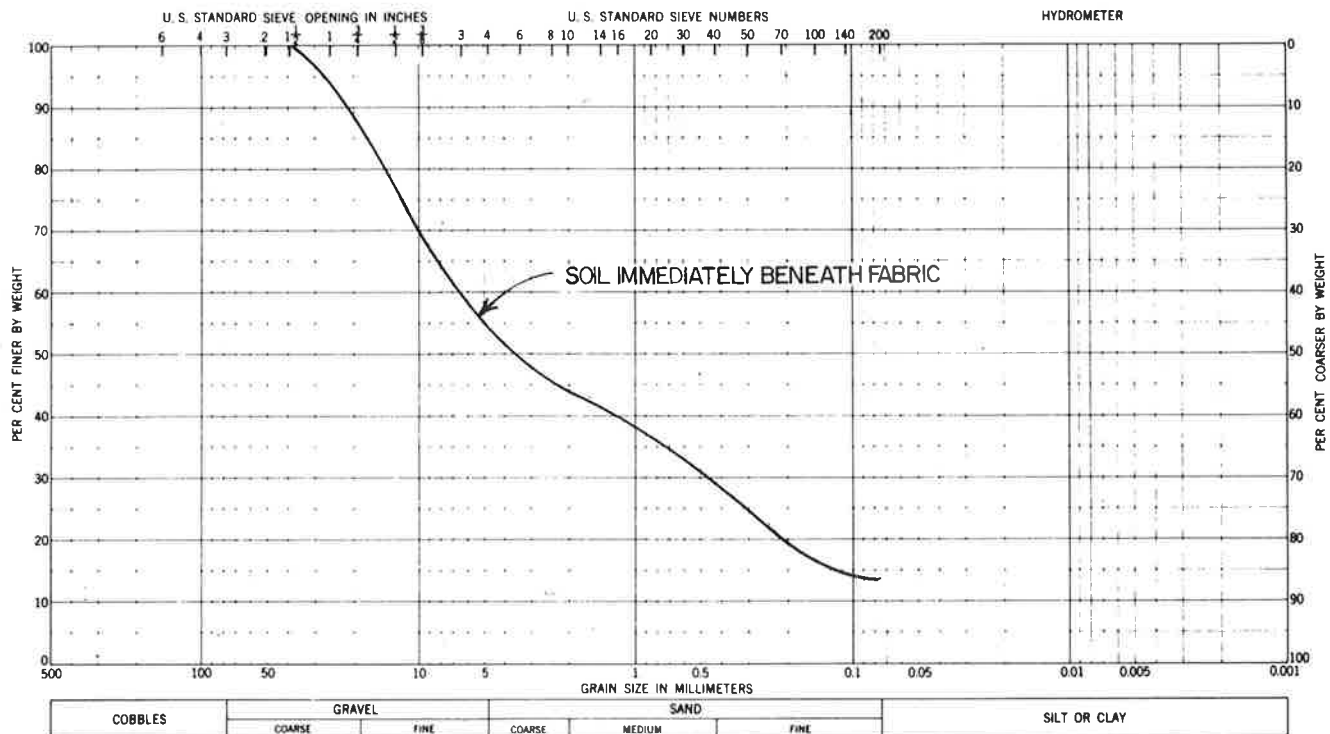
Figure 14. Grain-size distribution of soil immediately beneath fabric in bridge abutment.

The grain-size curve for the material retained by the fabric is shown in Figure 14. The fabric was generally found to retain medium- to fine-sand-sized particles, with up to 15 percent silt. The Poly-
