# Construction of Thin Bonded Concrete Overlay

RICHARD H. OBUCHOWSKI

In 1981 a bonded concrete overlay 3 in. thick was placed on I-81 north of Syracuse under a contract with the New York State Department of Transportation. I-81 is a six-lane divided Interstate highway that has an annual average daily traffic of 23,000 with 8 percent trucks. The existing concrete pavement was overlaid for a length of 3 miles in all northbound and southbound lanes. Two lanes in each direction were closed to traffic while the overlay was placed. Traffic was maintained on the third lane and a thickened asphalt-concrete shoulder. The concrete overlay was placed to remedy widespread longitudinal and transverse joint deterioration caused by porous coarse aggregate in the existing concrete pavement. The freezing and thawing of water in the coarse aggregate caused a surface spalling problem and layered cracking beneath the surface similar to D-cracking. Deteriorated pavement at the joints was removed to a 3-in. depth by using a milling machine. A nominal 3-in.-thick concrete overlay was bonded to the existing pavement with a cement-sand grout after scarification, sandblasting, and cleaning. The resulting

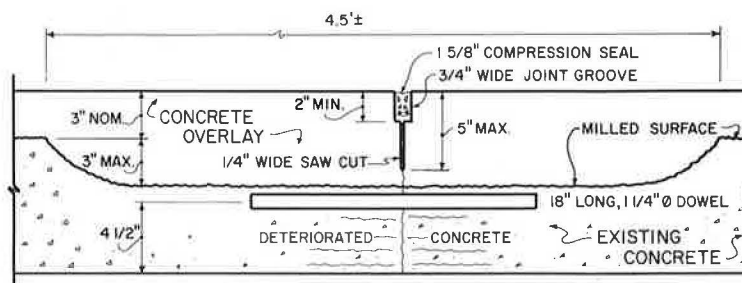
had occurred at the transverse joints, it was assumed that enough dowel embedment in solid concrete and dowel strength existed to provide load transfer. Figure 1 shows a cross section of the thickened section.

Figure 1. Transverse contraction-joint cross section.

Sealing of the new transverse and longitudinal joints, which were reestablished by transverse saw-cutting over the existing joints, was accomplished by specifying a preformed neoprene compression sealer. Dimensions of the transverse joint sealer are given in Figure 1.

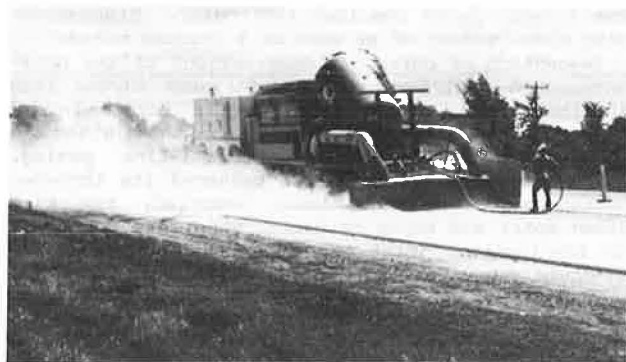
Figure 2. Pavement sandblasting machine in operation.

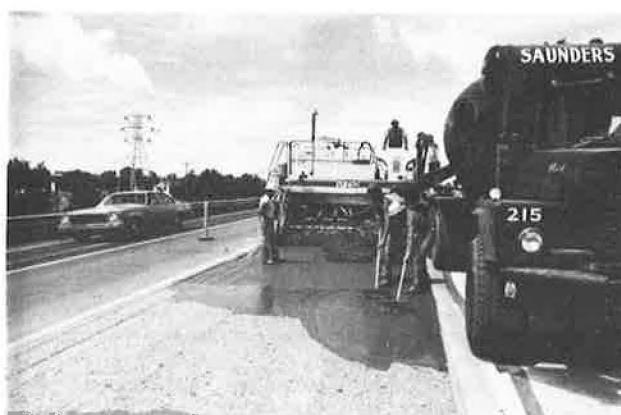
Figure 3. Middle-lane grouting and paving adjacent to previously overlaid median lane.
