Portland-Cement Concrete Inlay Work in Iowa

GEORGE CALVERT

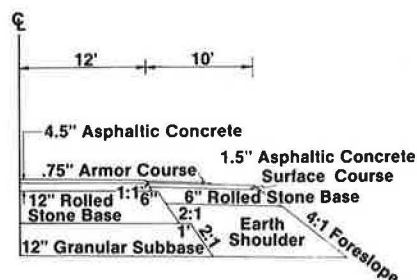
Figure 1. Interstate construction, 1958.

During the height of Interstate construction in Iowa in the late 1950s, a section of Interstate approximately 13.7 miles long was constructed through Adair, Dallas, and Madison Counties by using existing design practices for the construction of asphalt pavements. This section of roadway was constructed by using 12 in. of crushed-stone granular subbase overlaid with 12 in. of rolled-stone base followed by 3 in. of asphalt binder material and 1.5 in. of asphalt surface course. This construction was completed in 1959 and opened to traffic in 1960 (Figure 1).

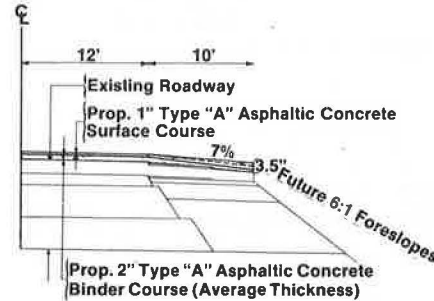
Figure 3. Additional overlay of Interstate pavement, 1970.

These premature failures the second time caused a desperate attempt in 1970 to remedy what appeared to be a bad situation. Still more asphalt was placed on top of this section—an additional 2 in. of binder course and a 1-in. surface course (Figure 3). By this time the mainline roadway was approaching a thickness of about 13 in. of composite asphalt, a reasonable design section for the traffic volume. The problem was that each of the layers had broken up before being overlaid, so the composite thickness was not nearly so impressive as it should have been because each succeeding layer had failed at an early date.

Again this 3-in. asphalt overlay lasted a few short years and the roadway started to show failures due to the underlying 4 in. of 1.5-in. mix. There was insufficient asphalt overlay over this material to support the heavy truck loading, and continual stripping of this aggregate in the saturated condition caused failures to work through the surface.

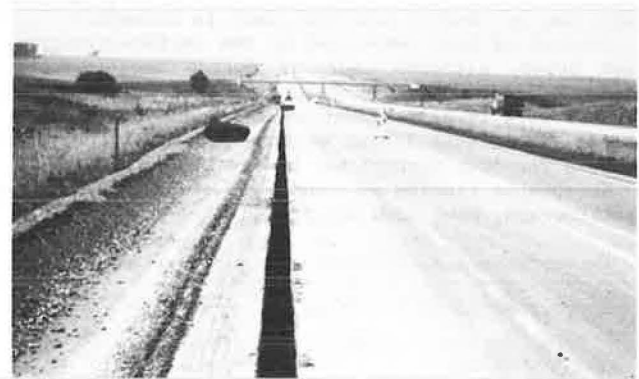
Figure 4. Trenching 42 in. deep for placement of longitudinal drain.

There was some disagreement on a permanent low-maintenance repair, but the staff was unanimous that the water problem must be solved first. A part of any repair instituted would involve installation of longitudinal drains in porous backfill, which would drain the bottom of the lower lift of crushed stone. The plan called for cutting a trench from the surface to the bottom of the crushed stone approximately 42 in. deep and 10 in. wide as the first stage of construction on this project. This trench was to be located under the outside edge of the slab for the full length of the project (Figure 4). The material removed with the trenching operation was to be placed over the outside 10-ft shoulder edge to form a rock fillet in this area. The longitudinal drain was then to be placed 3 in. above the bottom of the trench and the porous backfill was placed over it to near the lower surface of the roadway. This proved to be a satisfactory method of lowering the water table and keeping it to a much more acceptable level under the roadway surface (Figure 5).

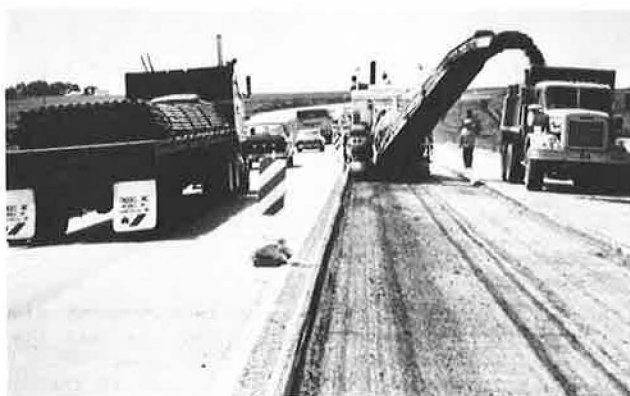
Figure 6. Milling asphaltic concrete 10 in. deep and 12.5 ft wide.

This project was constructed under traffic. The contractor was required to restrict operations to the trenched area plus 2 ft of adjacent roadway and to keep construction traffic on the 10-ft shoulder (Figure 6). This worked well and brought about a real cost savings. Where traffic volumes are as low as they are on this section--approximately 12,000 vehicles/day with 27 percent trucks--this procedure is adequate.

top 9 in. of the asphalt now in place down to the bottom of the questionable 1.5-in. maximum-size particle mix that had caused problems because of stripping and shoving. This made a trench 24 ft wide and 9 in. deep for the 6-mile project from the Redfield interchange west to the Stuart interchange. Nonreinforced concrete paving was then placed in this trench area to a depth of 10 in. Load-transfer devices were placed in joints at 15-ft intervals. The asphalt-concrete material removed was stockpiled for recycling on other projects in the area.

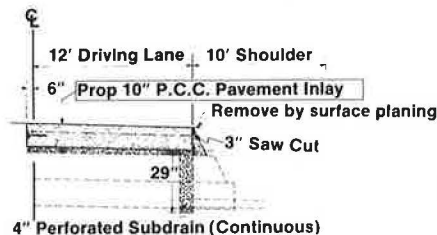
Figure 7. Construction of inlay, 1981.

The project began at the western termini of the 24-ft inlay at the Stuart interchange and extended west of the I-25 interchange, a distance of slightly more than 8 miles. In this instance, it was decided to inlay 10 in. of concrete 12.5 ft wide. This extended the new concrete inlay over the centerline joint 6 in. and, it was hoped, would mitigate the problem of maintaining the centerline joint. This time 10 in. was milled and removed in order to match the centerline joint and the shoulder profile (Figure 6). It was planned to true up the longitudinal profile of the 10-ft shoulder edge and the centerline before the 12.5-ft trench 10 in. deep was milled and removed. This proved to be a good operation also and made it much easier for the padline of the paver to run on a good profile surface. A longitudinal drain was again placed under the outside shoulder of the slab to drain water from the base and subbase sections. The end product again provided 24 in. of crushed stone topped by 3.5 in. of old asphalt and 10 in. of portland-cement concrete. This total thickness is more than adequate to provide a roadway section that will require minimum maintenance in the future (Figure 7).

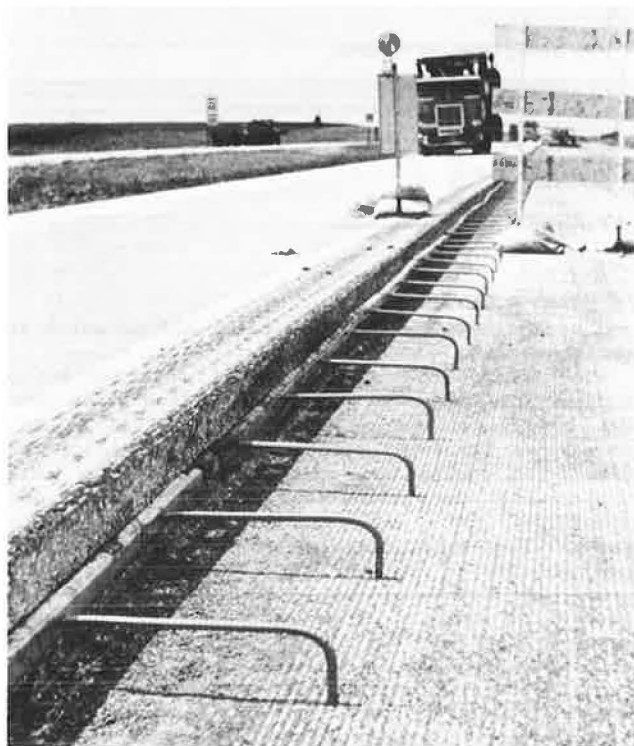
Figure 8. Tie bars in key and dowel assembly at centerline.

To provide for possible future replacement of the inside lane, a keyed tied joint was placed the full length of the project near the centerline of the new pavement. If the passing lane needs to be replaced in the future, it can be milled out and replaced and the tie bar can be straightened out on the keyed tied joint assembly to tie in the two lanes of roadway (Figure 8).

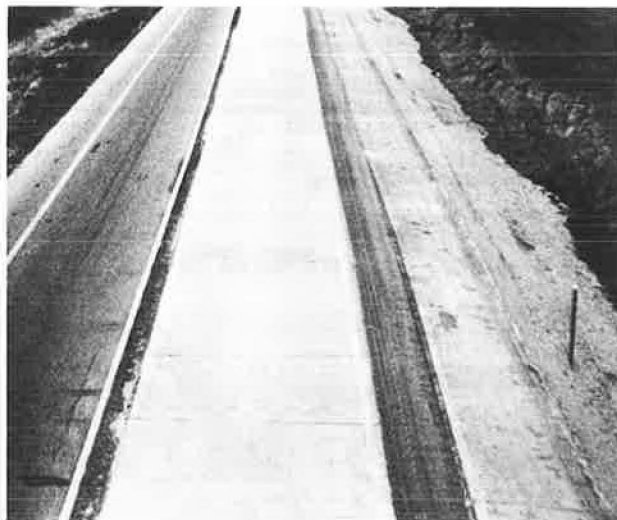
Figure 9. Finished portland-cement concrete inlay.

Traffic control is costly when a full 24-ft roadway is being replaced. The ease of doing this under traffic with minimum disruption to the traveling public has been demonstrated on this project; the technique will be used on other projects with the cooperation of FHWA. The replacement of only the 12-ft traveled lane on other sections of Interstate is being considered in Iowa. Such sections may be replaced with materials other than portland-cement concrete through the recycling process (Figure 9).
