Rehabilitation of Amtrak Baltimore and Potomac Railroad Tunnel in Baltimore, Maryland

RICHARD P. HOWELL

Rehabilitation of the National Railroad Passenger Corporation (Amtrak) Baltimore and Potomac (B&P) Railroad Tunnel in Baltimore, Maryland, built between 1871 and 1873, was undertaken by Amtrak and funded by the Northeast Corridor Improvement Project (NECIP). Planning of the project was undertaken jointly by Amtrak, FRA, and De Leuw, Cather/Parsons and Associates (DCP). Construction management services were provided by DCP. The tunnel rehabilitation effort, planned improvements, and problems encountered and action taken to overcome them are described. The double-track tunnel is a vital link in the Washington to New York freight and passenger main line and its deteriorated condition made its rehabilitation a primary goal of NECIP. After field inspections and engineering analyses were completed, the repairs agreed on were to (a) rehabilitate the existing invert, (b) repair the tunnel lining, (c) rebuild the gunite casing of the arch and walls, (d) install 140-lb continuous welded rail, (e) install a new gantlet track, (f) grout the invert, and (g) clean and improve the drainage sy

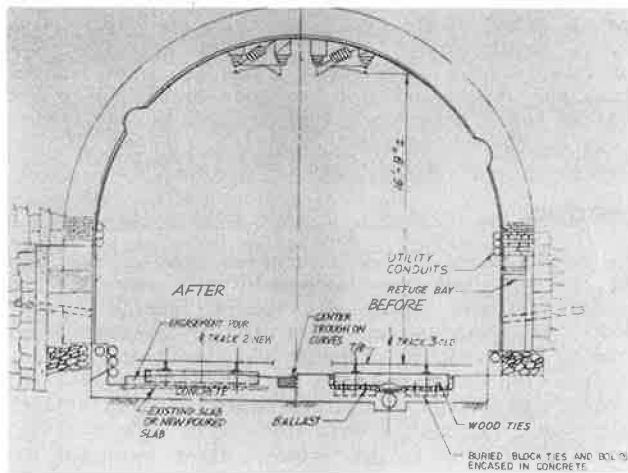
Figure 2. Cross section of B&P Tunnel; proposed track structure cross section on right.

The renewal plan encompassed the placing of a new wood crosstie track structure on either a totally new concrete slab invert or shaved-down parent slab and then encasing it in concrete (Figure 2).

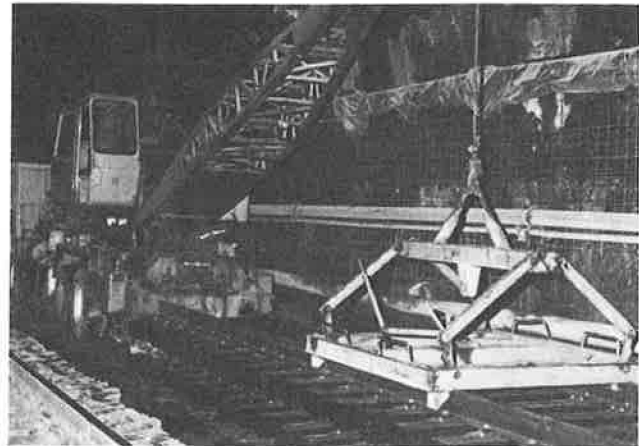
Figure 3. Placement of track panels on track 2.

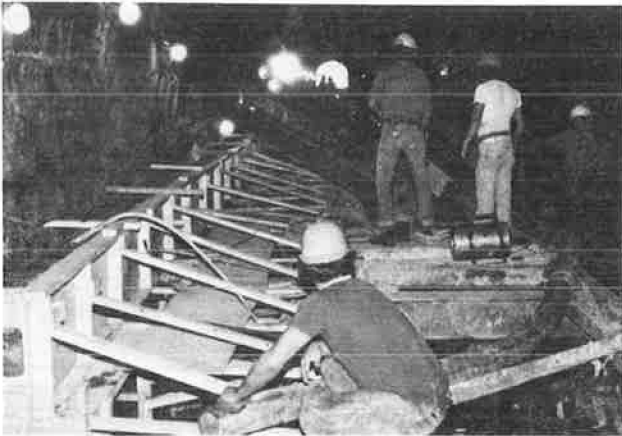
of the tunnel structure action, particularly reaction to the construction disturbance. Although precautions, including such methods as strutting at the base during slab removal, were taken to maintain stability as the work progressed, a severe wall displacement occurred in May 1982 in the Wilson Street Tunnel. The tunnel wall on the track 2 side in the vicinity of the soil-rock transition area moved inward more than 5.5 in. within a few hours. The wall moved as a unit, although some horizontal cracking was experienced. Both short- and long-term actions were taken to arrest the movement and determine a permanent fix that would stabilize the wall and prevent future movement.

Figure 4. Casting in place of restraining beam.

In the meantime, engineering analysis deemed that the portion of buckled wall should be restrained permanently. A tieback system to restrain the wall was designed by DCP and installed by a separate contractor. The tieback essentially consists of a reinforced concrete whaler beam, 1 ft 2 in. by 2 ft 0 in. by 132 ft long cast in place, and held by tendons spaced every 7 ft, anchored in the soil to a distance of 35 ft behind the wall. The installation procedure consisted of installing an independent track system for the machinery, drilling and augering through the wall and soil, placing and anchor grouting the cable tendons, and forming and casting in place the restraining beam (Figure 4) with the embedded tendon anchors post-stressed. The width of the beam created a clearance problem and a revised track alignment through the area had to be engineered. Fortunately, the 6-in. bulge and beam width could be negotiated within the existing envelope.
