# Box-Beam Guardrail Terminal Section

EUGENE L. MARQUIS AND ROBERT T. PETERSON

## BOX-BEAM GUARDRAIL TERMINAL SECTION

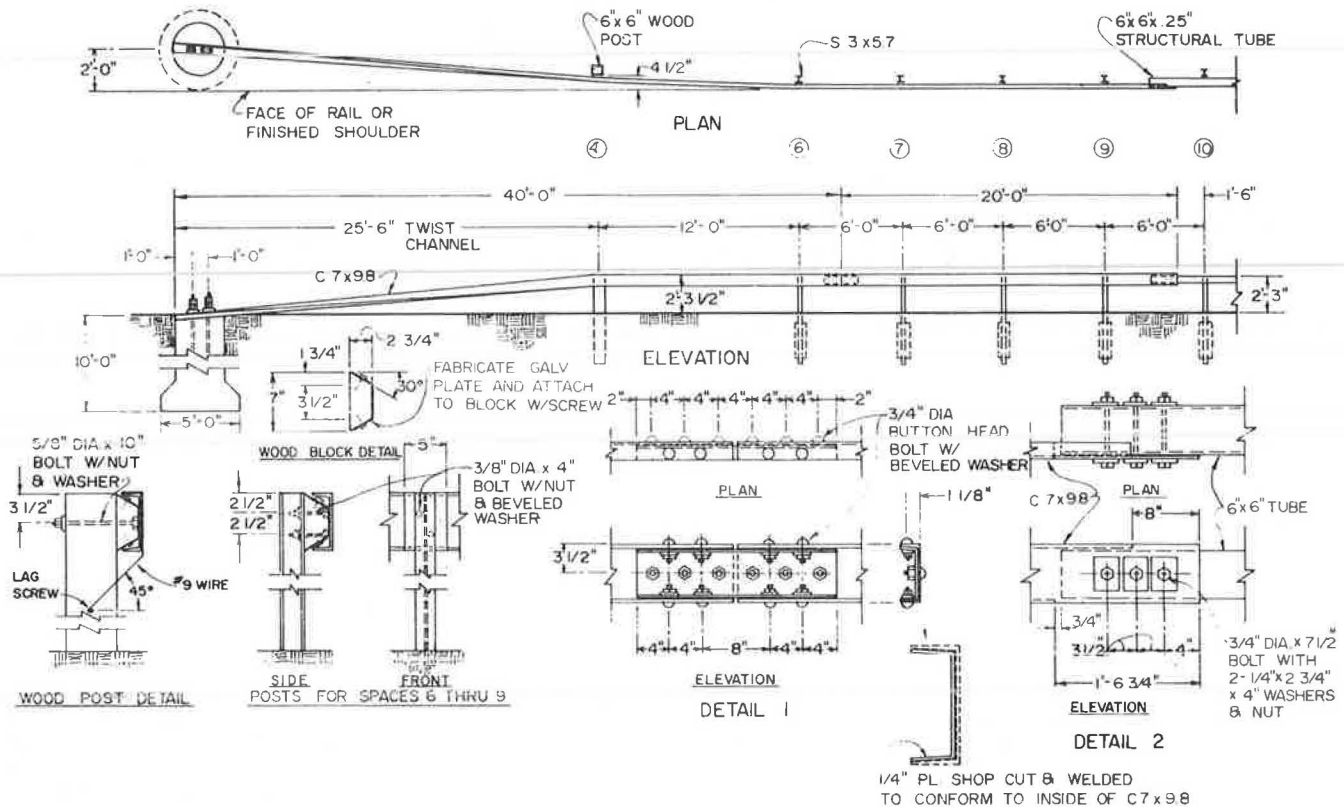
Figure 1. Modified turned down end using standard C-section.

Test 1 was conducted by using a box-beam drop-down as an extension of a North Dakota standard box-beam guardrail. This test was unsuccessful in that the vehicle was partly redirected, vaulted, and rolled. A detailed review of test 1 led to the final recommended design shown in Figure 1. The principal changes involved changing the first 56 ft

(17.1 m) of rail started at the upstream anchor from box beam to C7 x 9.8 and changing the first post from an S3 x 5.7 steel to a 6 x 6 wood. Crash tests 2, 3, 4, 5, and 6 were conducted on the final recommendation except that tests 2 and 3 were conducted using a welded splice between channel sections and tests 4, 5, and 6 were conducted using the recommended bolted splice. Tests 2, 4, 5, and 6 were successful and verified that the recommended design of Figure 1 will meet the safety evaluation guidelines of Circular 191 (2).

Before test 2 several changes were made to the guardrail and terminal as a result of the lessons learned in test 1 and testing previously accomplished (3,4) (see Figure 1). Approximately 56 ft (17.1 m) of the box beam from the terminal end to midway between post positions 9 and 10 were replaced with a like length of steel channel C7 x 9.8. The 24 ft (7.32 m) between the terminal end and post position 4 were twisted 90 degrees in the shop before installation. Two sections of the channel were butt welded between posts 6 and 7. The S3 x 5.7 post at position 4 [24 ft (7.32 m) from the terminal] was replaced with a 6-x 6-in. (140-x 140-mm) wood post, and the post at position 5 was removed

The final design uses a 6- x 6-in. (140- x 140-mm) wood post 24 ft (7.3 m) from the anchor. The next post is spaced at 12 ft (3.66 m), and all remaining posts are spaced at 6 ft (1.83 m). The end treatment and next 30 ft (9.14 m), for a total of 54 ft (16.46 m), of rail were replaced by a C7 x 9.8 rolled section, of A36 steel. The channel is held to the wood post by a no. 9 wire clip. There is no positive attachment of the channel to the steel posts. The box beam is attached to the first three posts by 3/16-in. bolts and thereafter by two 3/8-in. bolts. The length of need begins at the wood post.

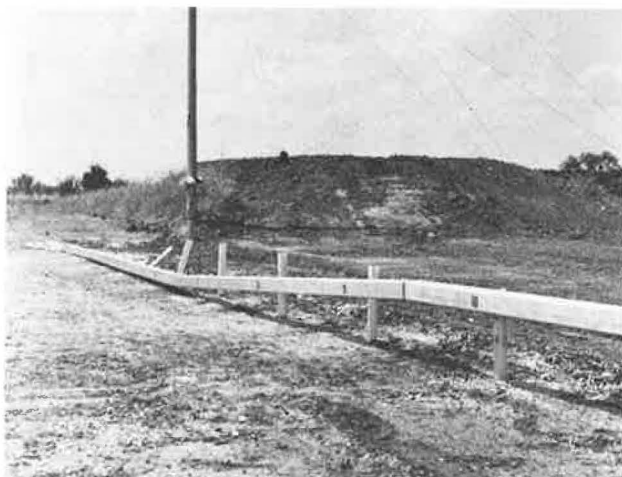
Figure 2. Rail after test 1.

Test 1 was unsuccessful in that the vehicle was redirected, ramped, and rolled over several times, violating the traffic lane. Test 3 was unsuccessful in that the weld at the splice parted, which allowed an unwanted penetration of the guardrail. No data were collected for test 3.

Within 10 msec after impact, the 3/16-in. bolts that attached the rail to the post had sheared and the rail had started to fall as designed. The front fender in contact with the rail collapsed, the tire compressed, and at approximately 34 msec the vehicle began to redirect. Penetration was not achieved. The bumper, which was higher than the box beam at impact, appeared to be in contact with the rail. As time progressed the rail was falling but also the rail was launching the vehicle. At 239 msec three wheels were off the ground. At 300 msec all four wheels were off the ground. The rail fell to the ground at approximately 0.5 sec. After the vehicle became airborne no additional time displacement data were developed. However, the vehicle rolled, hit on its roof, then cartwheeled to a stop 190 ft (58 m) from the impact point and 20 ft (6.1 m) on the traffic side of the rail. The test was not successful. Pictures of the rail and vehicle after the test are shown in Figures 2 and 3.

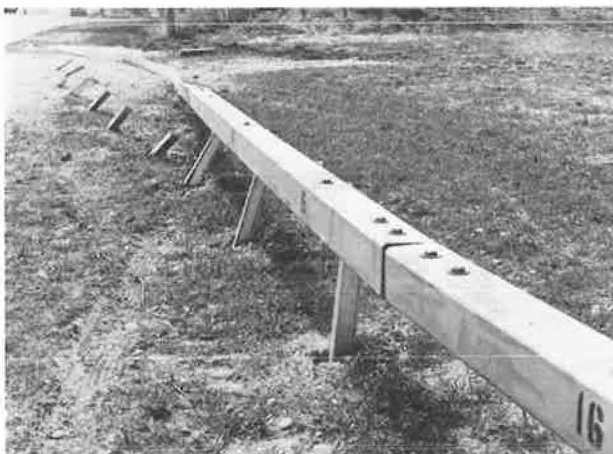
Figure 4. Rail damage after test 4.

The test conditions were similar to those in test 3. A 1974 Plymouth weighing 4,500 lb (96.5 kg) impacted the rail at 56.1 mph (90.2 km/h). The point of impact was at the wood post or at the beginning of the length of need. The impact angle was 28 degrees. The rail deflected laterally 9.1 ft (2.77 m) and began to redirect the vehicle as it reached the first metal post at 0.179 sec after impact. The maximum 0.050-sec average longitudinal and transverse accelerations began about this time; they were 2.7 and 4.0 g, respectively. The right rear side of

the vehicle came in contact with the rail at 0.350 sec and was parallel at 0.426 sec. The exit angle was approximately 7 degrees and the exit velocity was 42.1 mph (67.8 km/h). Damage to the left front tire and the application of brakes caused the vehicle to yaw to the left and come to a stop 210 ft (64 m) downstream from the point of impact and 15 ft (4.6 m) from the traffic face of the rail. The rail height was maintained throughout the collision and the reduction performance of the rail was considered good.

The results of this test are presented in Table 1. Rail damage is shown in Figure 4.

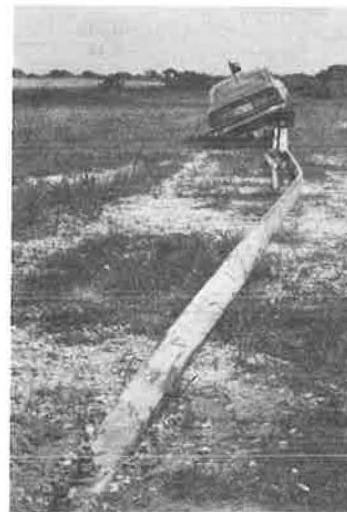
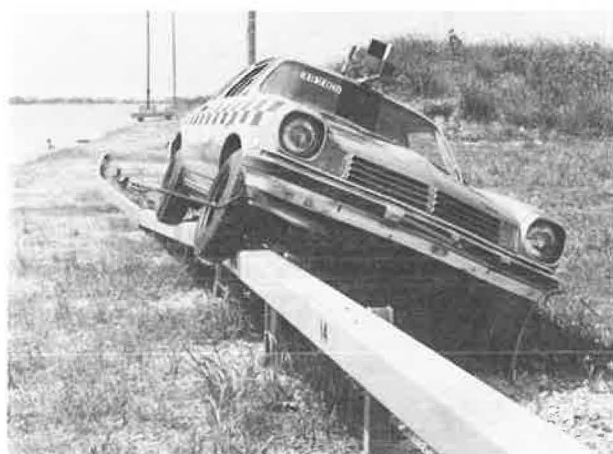
Figure 5. Vehicle and rail after test 5.

The test consisted of a 1974 Vega impacting the terminal head-on with respect to the straight portion of the rail. The vehicle weighed 2,350 lb (1066 kg) and was traveling at a speed of 29.9 mph (48.0 km/h) when impact occurred. The point of impact was the anchor with the vehicle straddling the rail. The vehicle raised slightly just before impacting the wood post, but the wheels did not leave the ground at this point. The rail disengaged from the wood post and then from posts 6 through 13 in

sequence. The wood post fractured at the ground line and was deflected behind the rail. Posts 5 through 12 were bent out of line. The vehicle came to rest just past post 12 while straddling the rail and resting primarily on the back side of the rail. The maximum vehicle roll angle was 6.5 degrees. Figure 5 shows the vehicle and the rail after the test. The rail was rebuilt by replacing the eight posts and straightening the kink at the splice between the channel and the box beam.

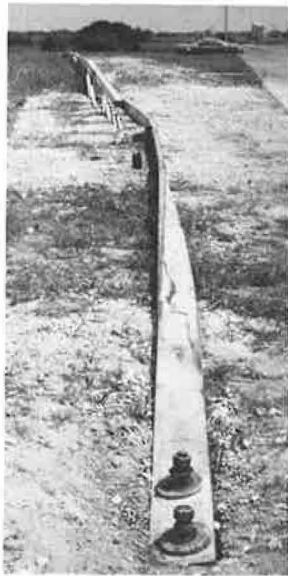
Figure 6. Rail after test 6.

The test consisted of a 4,500-lb (2043-kg) Plymouth traveling 61.1 mph (93.4 km/h) impacting the terminal head-on. The point of impact was the anchor with the vehicle straddling the rail. The vehicle rode the rail 168 ft (51 m) before jumping off the rail on the traffic side near post 28.

The vehicle was stable, and the maximum roll angle reached 38.3 degrees. A roll angle of 55 degrees or more is required before this vehicle will roll over. The vehicle did not stop of its own ac-

cord or slow down sufficiently, and remote-controlled brakes were applied after the vehicle left the rail and before it was involved in a secondary impact with another test facility +300 ft (90 m) from the point of impact. Had this been a real-life accident then in all probability the engine compression would have acted as a braking force and slowed the vehicle to a reasonable speed before it reached the end of the rail installation. The maximum 50-msec deceleration was 2.97  $g$ . Figure 6 shows the rail after the test. Figure 7 shows the vehicle after remote-controlled brakes were applied after the test.

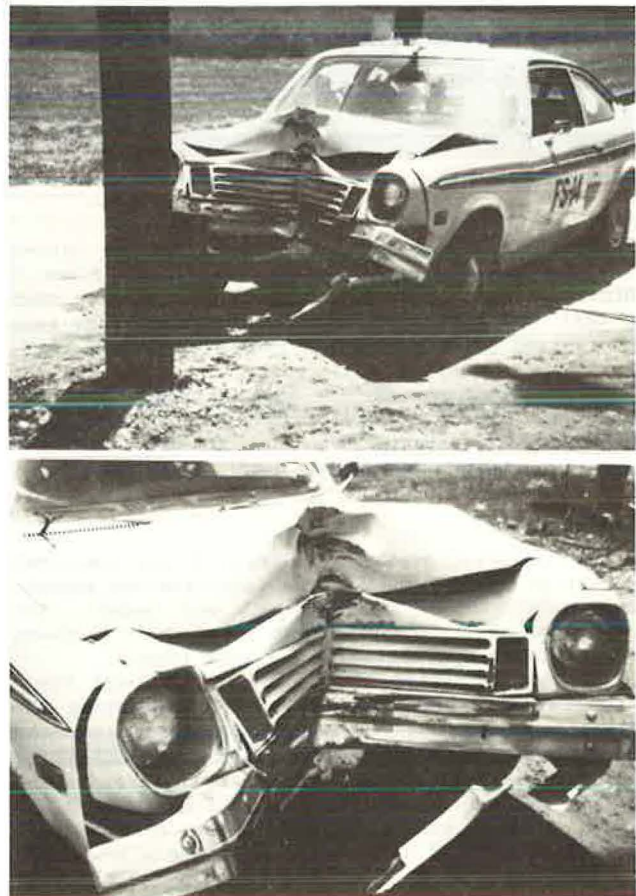
Figure 1. Unmodified pole crash test at 49 km/h.

Timber poles are not designed to be breakaway structures. Figures 1 and 2 illustrate the result of subcompact cars colliding at 49 km/h (30 mph) and 97 km/h (60 mph) with such poles. In both cases the vehicles sustained substantial damage, but damage to the pole was not appreciable. Accident statistics reveal the frequency and severity of this type of collision. According to the National Highway Traffic Safety Administration (1)
