# Durability of Asphalt Coating and Paving on Corrugated Steel Culverts in New York

WALLACE W. RENFREW

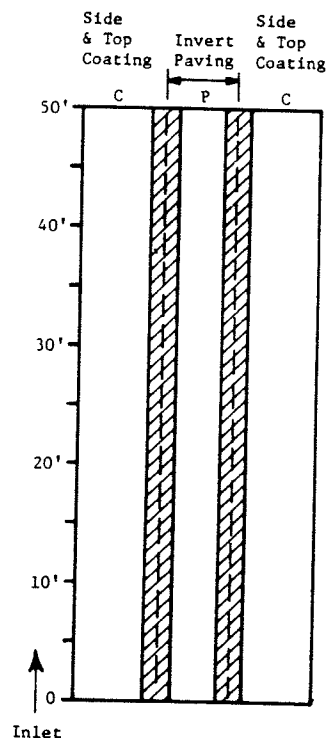
1. Example 1 (Figure 1): A common occurrence was loss of both coating and paving at the flow line (often at the coating-paving interface) for the entire length of the culvert. This would be 100 percent loss of coating. Paving loss in this example is more difficult to define because the loss at the coating-paving interface may be due only to the thin

FIGURE 1 Coating and paving removed at interface.

feathering out of the paving, as discussed earlier. Interpretation of this case will be discussed in detail later in this paper.

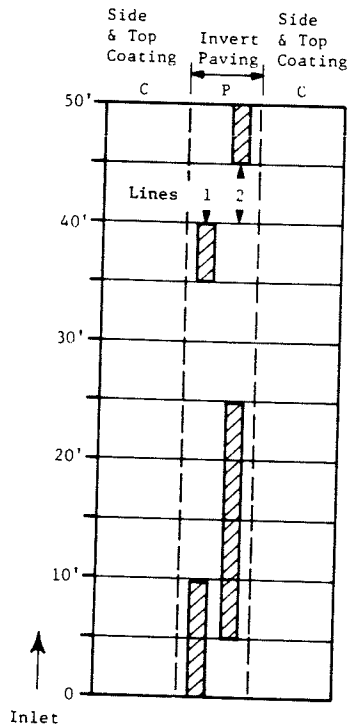
2. Example 2 (Figure 2): Paving removal may not be continuous and may not be in the same longitudinal line throughout the length of the culvert. In this case none of the coating is removed, but paving is removed in two distinct longitudinal lines. Line 1 is removed from 0 to 10 ft and 35 to 40 ft, and Line 2 is removed from 5 to 25 ft and 45 to 50 ft. Combining the two lines, the paving is removed from 0 to 25, 35 to 40, and 45 to 50 ft, or a total of 35 ft of the 50-ft length. This would be reported as a 70 percent loss of paving.

FIGURE 2 Only paving removed.

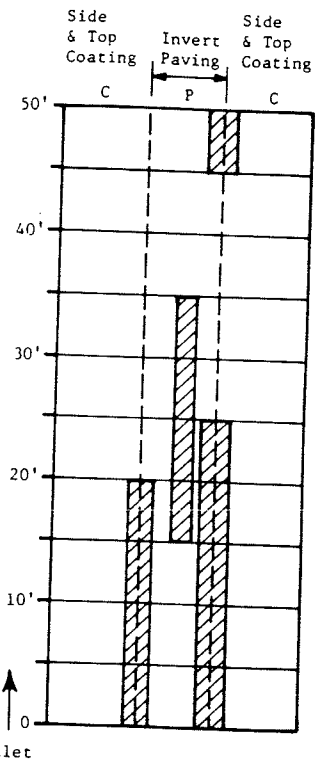
3. Example 3 (Figure 3): Some cases have both paving removal in the invert area and coating-and-paving removal in the interface areas. Applying the rules outlined earlier, coating is removed from 0 to 25 ft and 45 to 50 ft, or 30 ft of the 50-ft length (60 percent loss). The combined paving loss is from 0 to 35 ft and 45 to 50 ft, or 40 ft of the 50-ft length (80 percent loss).

FIGURE 3 Combination of both types of loss.
