Bacterial Corrosion of Steel Culvert Pipe in Wisconsin

ROBERT PATENAUDE

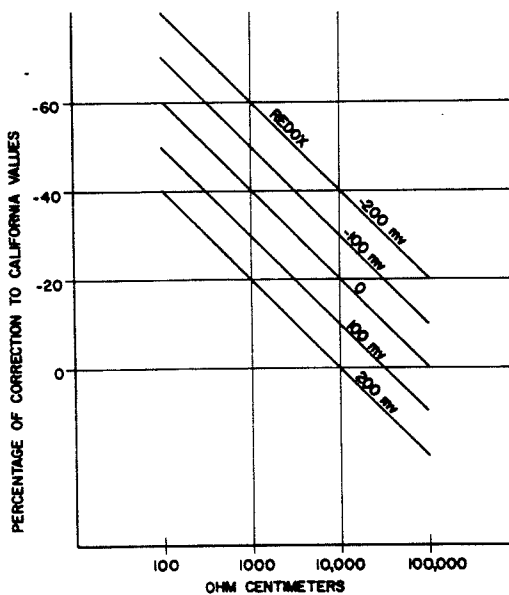
The effect of anaerobic bacteria appears to be greater in clayey and silty soils that have low electrical resistance, whereas similar redox values in higher resistance soils appear to be associated with less dramatic shortening of time to pipe perforation. In spite of the imprecision involved, a tentative chart that relates redox and electrical resistivity values to a correction to the predicted times to perforation by the California method is shown in Figure 1. This chart is used for soils that have provided a positive test for sulfide using dilute HCl and lead acetate paper. The chart is empirical and is based on field observation, and additional studies will probably indicate a continuing need for modification to the chart.

FIGURE 1 Redox correction to California method for sites with positive sulfide test.

Where anaerobic sulfate-reducing bacteria are active in the soil at the site of a steel culvert pipe, the potential for corrosion may be reduced by removing the organic soil and by surrounding the pipe with at least a foot of crushed limestone or clean sand. The use of geotextiles may help prevent mixing of the fill with natural soil. This should extend the service life of steel culvert pipe at sites where these bacteria are active in the soil, as indicated by redox values and H₂S tests.
