For Want of Air, a Drainage System Was Nearly Lost

CARL F. CRUMPTON, GLEN M. KOONTZ, and BARBARA J. SMITH

The omission of entrained air from a concrete pipe end section in 1972 set up a chain of events that could have been much more destructive. Freezing and thawing, which were aided and abetted by salty melt-water from de-icing salts running over the exposed invert of the end section, caused the pipe to scale. By the end of 10 winters the scaling had worked completely through the pipe invert, allowing runoff water to erode beneath the end section and the adjacent concrete ditch liner. The end section and a large portion of the ditch liner were lost. Minor slides and soil slumping at the toe of the fill began. The damaged end section and portions of the ditch liner were removed and replaced in 1983. Had corrective action not been taken, a much larger portion of the drainage system and the fill could have been lost. To paraphrase Ben Franklin

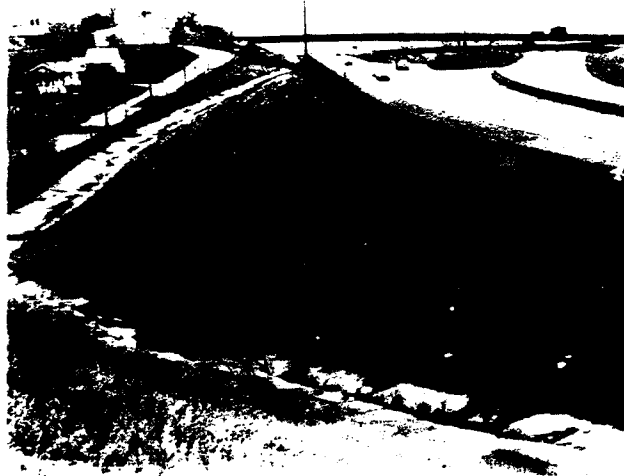
The grief continued. Erosion undercut the concrete ditch liner, which broke and dropped into the newly eroded ditch (Figures 6-8). The erosion would have been much worse, except that some of the concrete ditch liner was resting on the weathered top of bedrock. This ledge of rock, partially observable at the base of the ditch liner in Figure 8, slowed and controlled the progress of erosion in a critical area. Figure 9 gives an overall view of the fill, showing the erosional scar in the toe of the fill slope a few weeks before repair activities began in late spring 1983. Had repairs not been made, most of the ditch liner would have been lost. Fill slides would have increased because erosion was moving toward the thicker part of the fill, as seen in Figure 9.

FIGURE 9 General view of fill showing erosional scars before repairs.

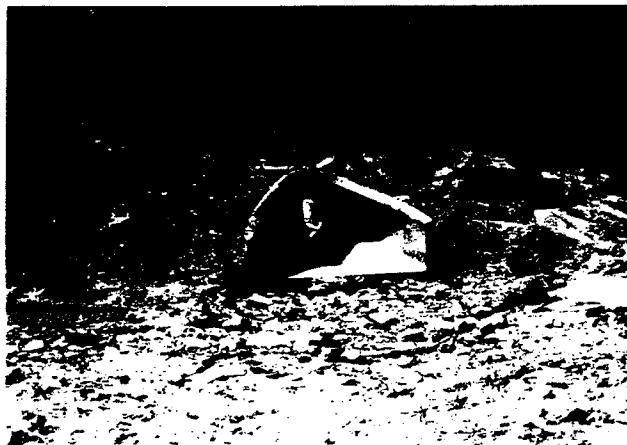
FIGURE 10 A used end section in place.

Repair involved removal and replacement of the damaged end section. The damaged and undercut portion of the concrete ditch liner was also removed and the eroded ditch was filled in with recycled concrete, bricks, and limestone rubble (Figure 10). (Note that unsized rubble lines the ditch.) An overall view of the repair in the same general perspective as Figure 9 can be seen in Figure 11, where it may be noted that all of the erosional scars were not yet corrected.

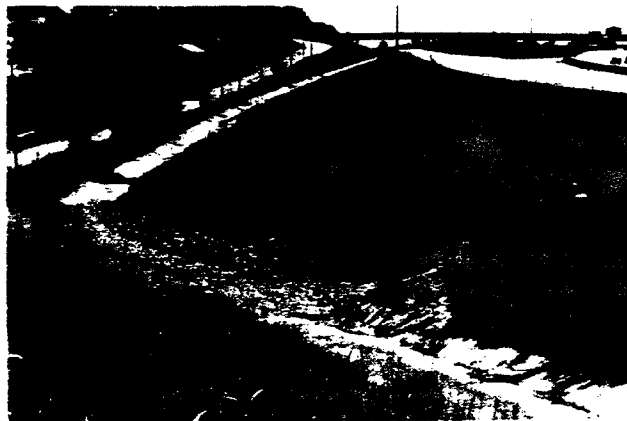
FIGURE 11 General view after repair from same perspective as Figure 9.
