Innovated Repair of a Large Failing Structural Steel Plate Pipe Arch Culvert

CHARLES R. DUNCAN

A value-engineering team studied alternatives to replacing a failing structural steel plate pipe arch culvert 14 ft x 9 ft 8 in. x 260 ft long. Their proposal consisted of rolling a slightly smaller asbestos-bonded asphalt-coated pipe through the existing culvert and grouting between them. The cost was \$169,957, which represented a savings of \$92,000, or 54 percent of the cost to replace the culvert. The contractor's procedures, the problems encountered, and recommendations for future projects of this kind are discussed herein.

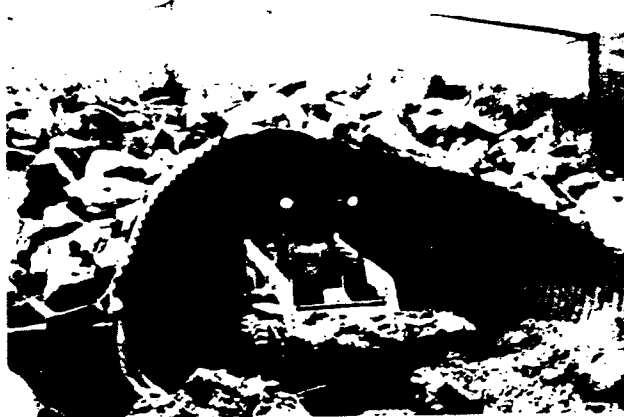
FIGURE 2 Removing muck with small loader.

1. The contractor used a small loader and hand labor to remove the 1.5 ft of muck (Figure 2).

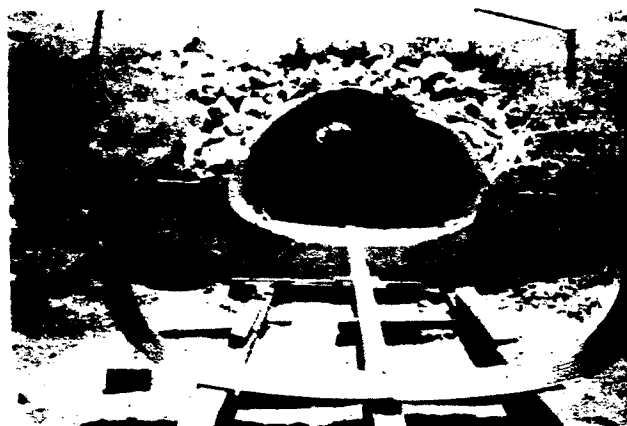
FIGURE 4 Assembly area and channel guide in place.

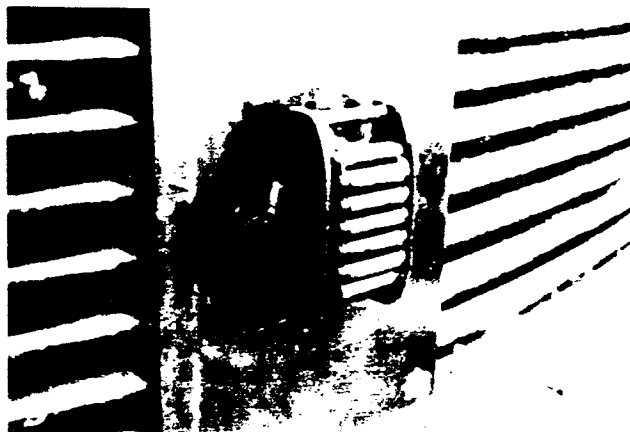
FIGURE 5 Roller system.

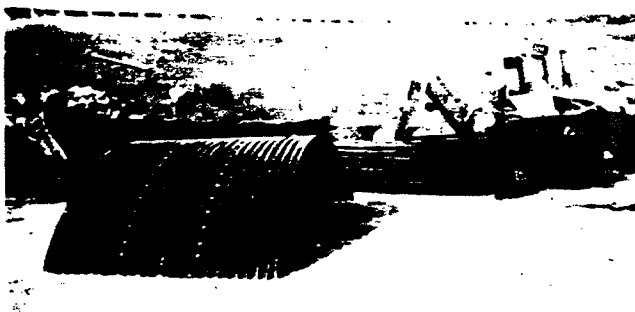
FIGURE 7 Assembly of pipe.

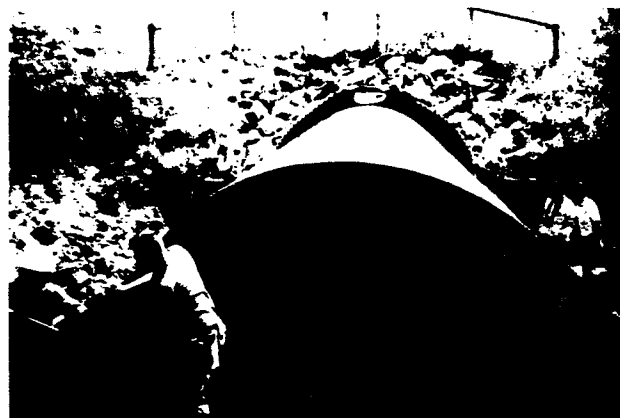
FIGURE 10 Partly completed pipe assembly.

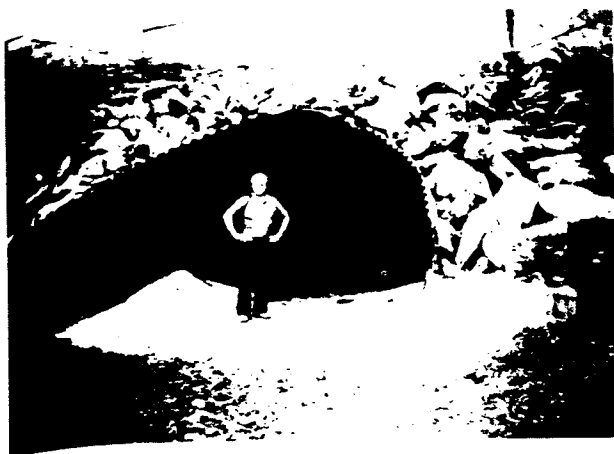
FIGURE 11 Finished SSPP arch culvert.
