Invert Replacement of Corrugated Metal Structural Plate Pipe

STEPHEN R. IKERD

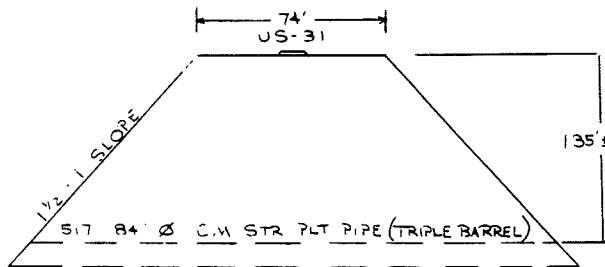
The triple line of pipe is located in an area known as Hurricane Hollow on US-31 at Hurricane Creek in Cullman County, Alabama. The structural plate pipes are each 517 ft long and are located under a roadway fill of approximately 135 ft. In periods of heavy rainfall the pipes operate under headwater depths of 40 ft or greater (see Figure 1).

FIGURE 1 Cross section of roadway fill.

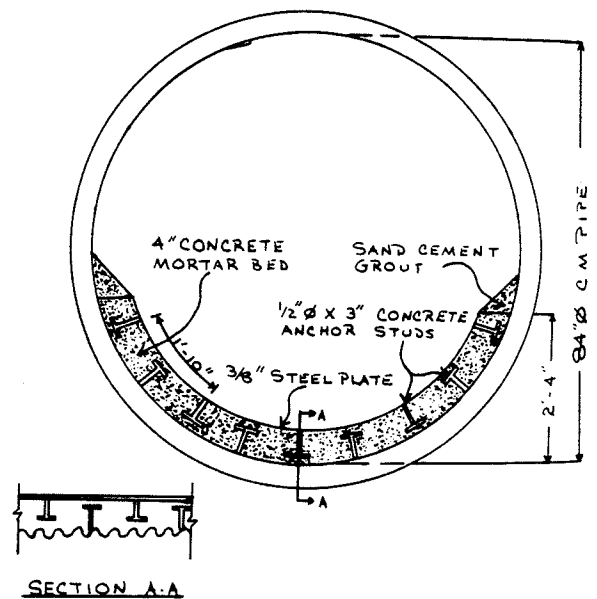
FIGURE 2 Armor plate—typical section.

In 1973 the Alabama Highway Department let a contract to repair the deteriorated inverts with steel armor plating. The contract specified the installation of a shaped, 0.1875-in. steel armor plate in the existing pipes. The invert armor plate and the existing pipes were to be provided with concrete anchor studs (KSM or Nelson Studs) with a concrete mortar bed to bond the pipe and armor plate together (see Figure 2). The length of armor plate sections and handling procedures were left to the contrac-

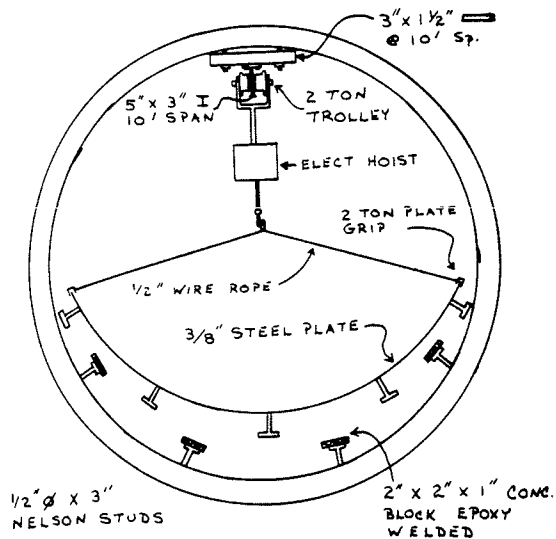
FIGURE 3 Method of installation.

Initial construction consisted of attaching an overhead monorail system to the crown of the pipes for transporting the steel armor plates. The plates were 0.375 x 90.75 x 98 in., each weighed 945 lb, were preshaped, and were fitted with the required number of studs. The monorail system provided an efficient means of transporting the plates within the 84-in.-diameter pipes (see Figure 3).
