# Renovation of the Third Avenue Bridge in Minneapolis

DAVID O. MILLER and RICHARD D. BECKMAN

## ABSTRACT

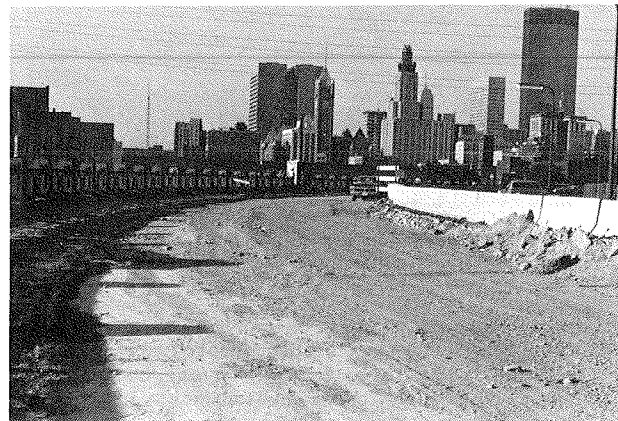
FIGURE 8 Sand layer removed.

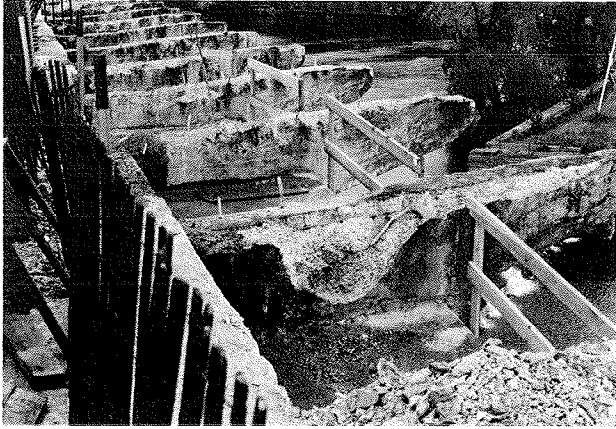
FIGURE 9 Deterioration of cap.

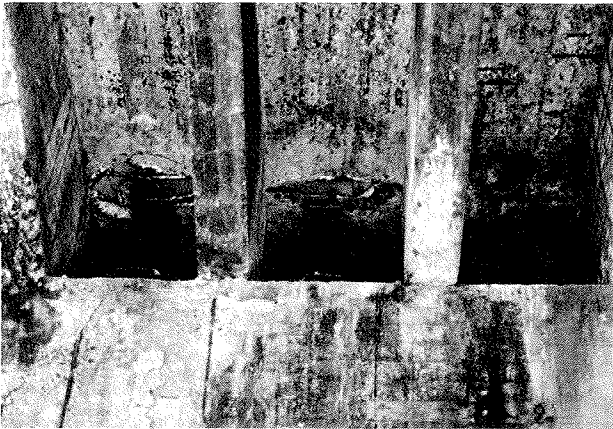
FIGURE 10 Holes in structural slab.

northeast approach spans, which had been underpinned, portions of the slab disintegrated leaving fairly large holes (Figure 10). On one occasion the tire of a front-end loader, which was removing the sand layer, fell through the structural slab (Figure 11). Another question was how the substructure would react to the unloading of just half of the

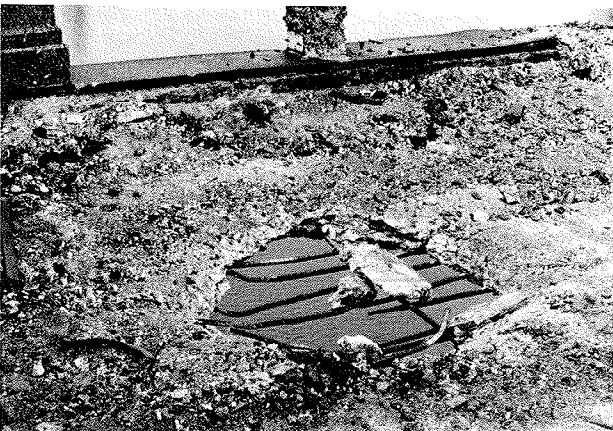
FIGURE 11 Hole opened by tire of front-end loader.

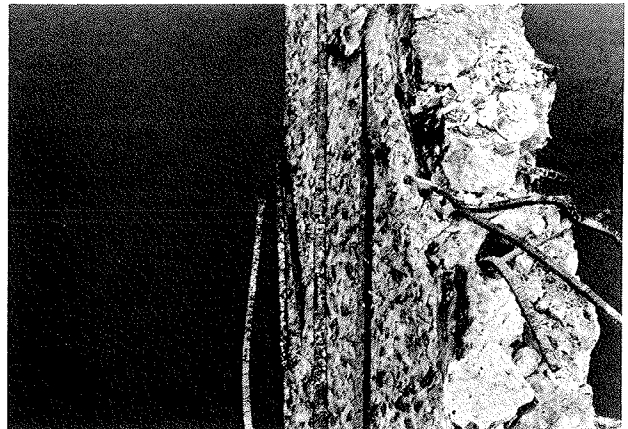
superstructure. The plans suggested that a certain sequence be followed. Experience on a previous project indicated that the sequencing would create no problems. Traffic was still carried on the upstream half, and whether that half would hold up became a concern. In addition to the poor condition of the structural slab, it was found that some of the spandrel columns had deteriorated to the point where they were only half as wide as they should have been (Figure 12). The strength of the remaining concrete was questionable. At that point all trucks and buses were banned. The inspectors were on a continual lookout for signs of fatigue or failure. At one time Ames dials were installed, and it was found that the freeze-thaw in the "punky" concrete was causing it to move but that the movement was not progressive.

FIGURE 12 Spandrel cap deterioration.

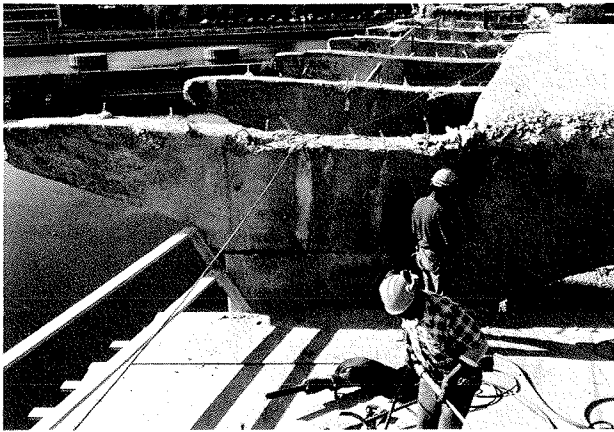
FIGURE 14 Spandrel removal.

similar way (Figure 14). Holes were drilled at the elevation to be cut, and splitters and torches were used so that large sections could be removed at a time. These methods helped control the rubble problem. The contract stipulated that rubble not be dropped into the river. Immediately after these removals the contractor built a false deck below the elevation of the new deck. This served not only as a replacement for safety nets but as a work platform to increase efficiency and to catch rubble. The removal operations continued around the clock until well into the winter when the contractor determined that the removals were no longer a factor affecting the efficiency of the daytime rebuilding crew.

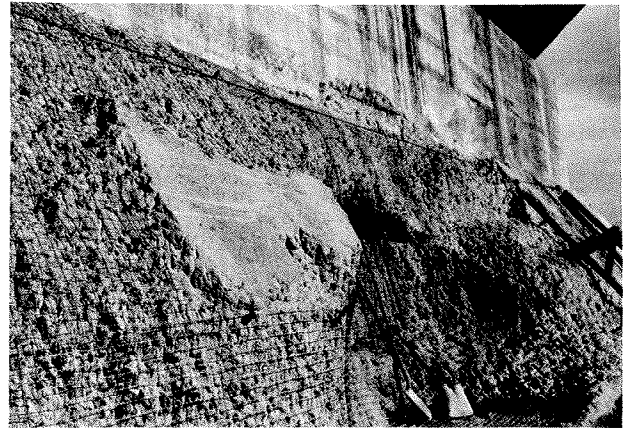
Another area where it was difficult to determine which type of repair to use was the pier repair. The piers near the water line were in quite bad shape. The experience on the spandrel columns showed that the strength of the shotcrete was quite high. Strengths of 8,000 to 9,000 psi were experienced in just a few days. The low-slump concrete used on other deck repairs had given strengths of 6,000+ psi on 28-day tests. Considering that, it was determined that near the waterline shotcrete rather than forming and pouring should be used. The shotcrete method would also give a tighter bond that would be more resistant to freeze-thaw cycles and the water action of the river. During the repair of the piers, in many instances not just a few inches but several feet of bad concrete were removed (Figure 15). The shotcrete was applied in layers as specified.

FIGURE 15 Pier repairs before shotcreting.
