Rehabilitation of Steel Deck Girder Bridges

STANLEY W. WOODS

Two 12-span bridges composed of two steel plate girders with a floor system were constructed in 1960. These were the first all-welded girder bridges built in Wisconsin. Plans were prepared to widen these bridges to carry a third lane and replace the existing deck. Several flaws that required repair were discovered in the welded girders. Before construction a transverse crack in the flange was found under the gusset plate used to attach the lower lateral bracing. The gusset plate was welded longitudinally and transversely to the bottom flange. During construction several other flaws were found: cracks under tack welds on the flanges, fatigue cracks in floor-beam webs, web butt welds with incomplete fusion, poor flange-to-web fillet welds, and improper termination of welded covered plates. These flaws were repaired to extend the life expectancy of the bridge by (a) removing the welded gusset plates, grinding the flange smooth, and bolting on new gusset plates; (b) removing the tack-welded piece and grinding out the cracks in the flanges; (c) removing the stringer-to-floor beam welded web connections, reattaching with bolt

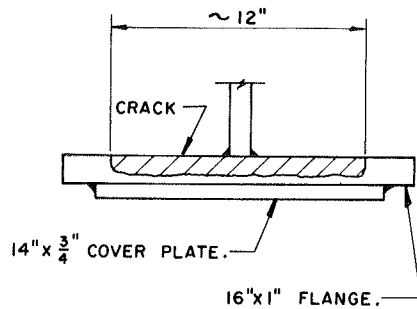
In March 1981 bridge maintenance personnel reported that the bottom flange of one of the main girders was cracked, resulting in a 75 percent loss of section. Traffic was rerouted until a bolted splice was placed on the flange. Further investigation revealed that the crack initiated where the bottom lower lateral system was attached to the gusset plate, which was welded to the bottom flange. Although the shop plans showed the gusset plate attached with longitudinal fillet welds, the plate was welded both longitudinally and transversely. The transverse fillet welds were believed to be the initiators of fatigue cracking. Because this detail was repeated at every lower lateral connection, the plans were modified to remove all these welded gusset plates and replace them with bolted plates in the positive moment areas. After the contract had been awarded and rehabilitation work had begun, several more problems with the steel girders were discovered. The repair of the gusset plates and the newly discovered problems are discussed in this paper.

FIGURE 4 Crack location in bottom flange.

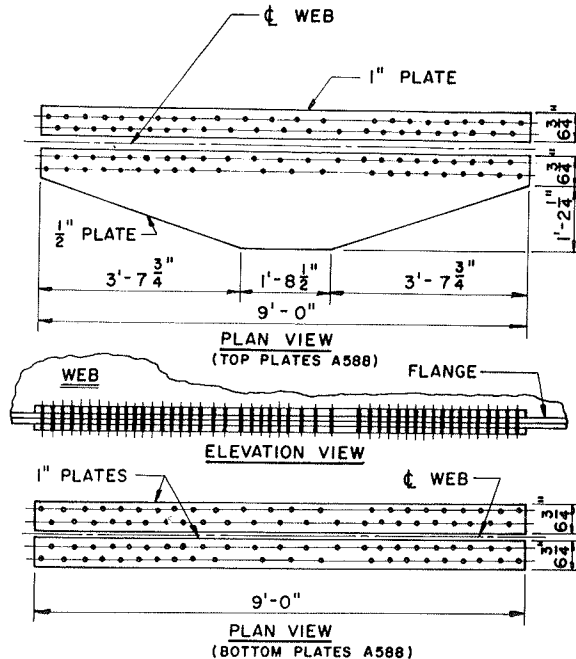
FIGURE 5 Bolted splice detail.

was drilled at the web-flange intersection to prevent crack growth into the web. The fillet welds connecting the cover plate to the flange were removed for 1 in. on both sides of the crack centerline to prevent crack growth into the cover plate.

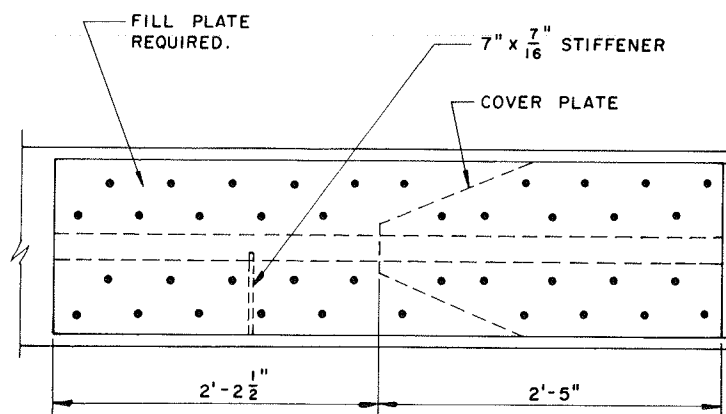
The original plate girders had been fabricated with cover plates welded to the flange plates. This had been done to take advantage of the higher allowable stress for A242 steel with thicknesses of 0.75 in. or less. Because fatigue cracks were not found at the termination of these cover plates but stress levels were high enough to cause them, retrofit plans were prepared to reduce the chance of fatigue cracks starting.

FIGURE 6 Splice detail at end of cover plate.

Bolted splice plates were designed to connect both sides of the flange plate at the cover plate termination (Figures 6 and 7). It was assumed that the plane of failure for the flange would occur in this area. These full-strength splices were provided in the tension areas on both top and bottom flange plates to reduce the stresses at these locations and thus provide a longer fatigue life. If fatigue cracks develop in the flange the bolted splice plates will provide the required strength.

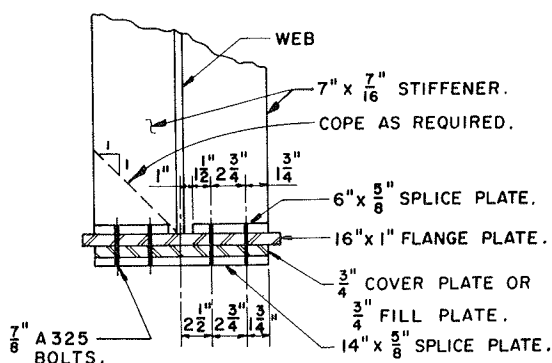
FIGURE 7 Cross section of cover plate.

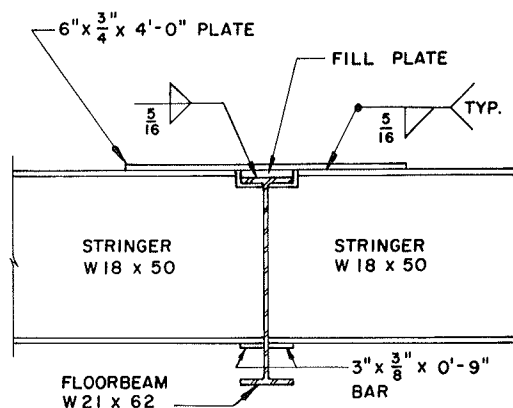
Inspection of these connections revealed fatigue cracks beginning to form in the floor-beam webs where the stringers were continuous over them. These cracks were apparently caused by out-of-plane bending in the web caused by live load stresses. At the end floor beams where the stringers terminated, several fatigue cracks in the web had already propagated to the bottom flange (Figure 10) because there was more deflection occurring here due to lack of restraint because the stringer was not continuous.

FIGURE 8 Stringer-to-floor beam connection.

To correct these flaws the stringers were removed from the floor beams by flame cutting the stringer flange and web adjacent to the fillet weld connections. The remaining material on the floor-beam web was ground smooth. The stringers were re-attached to the floor beams with clip angles (Figure 11), and studs were placed on the flanges to make the stringers composite with the slab. The composite action reduced the simple span stresses enough to

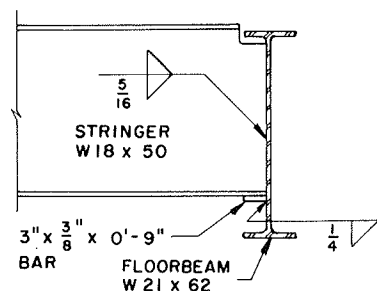
FIGURE 9 Stringer end-to-floor beam connection.

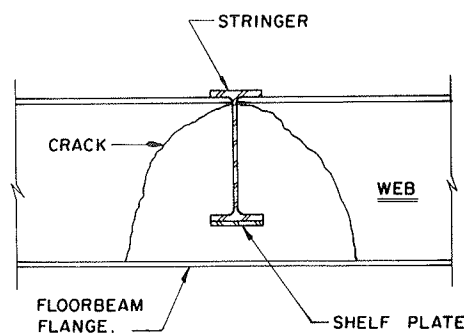
FIGURE 10 Floor-beam web fatigue cracks.

compensate for the loss of continuity. Stop holes were drilled at the crack tips on the floor-beam webs.

Even though fatigue cracking had grown more than a few inches into the web, full-bolted web splices were also made. These areas will have to be checked closely in future bridge inspections, but there is redundancy in the number of floor beams to provide a margin of safety.

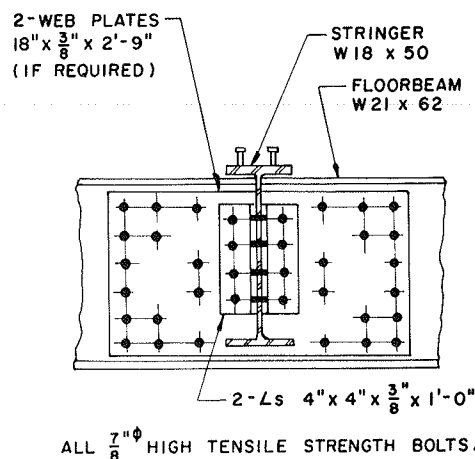
FIGURE 11 Stringer-to-floor beam repair attachment.

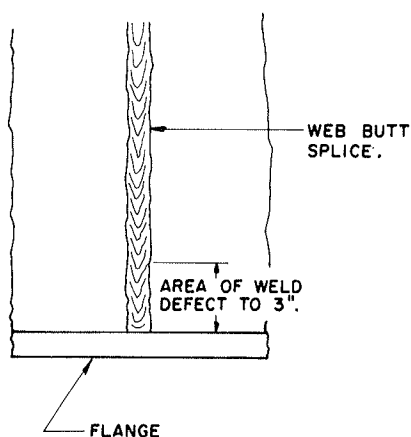
Weld flaws were discovered at the web-to-flange intersection where the webs were butt welded together (Figure 12). Apparently the flanges were attached to the web before the web butt welds were made. As a result weld flaws were made during fabrication where the web butt weld terminated near the flange.

FIGURE 12 Web butt weld flaw.

Two 1-in. round holes were drilled through the web on each side of the weld at the base of the flange (Figure 13). The area between the holes was removed by sawing and the cuts were ground smooth. The portion of the web above the saw cut was checked with dye penetrant to be sure the flaw was completely removed. Further inspection of these web butt welds indicated that some of them had areas with cracks due to lack of fusion at the time of fabrication. A bolted web splice was provided at 33 out of 80 potential locations where the lack of fusion was more than 1 foot long. There was no indication that these flaws were growing but, where no splices were made, they will be checked during future inspections.

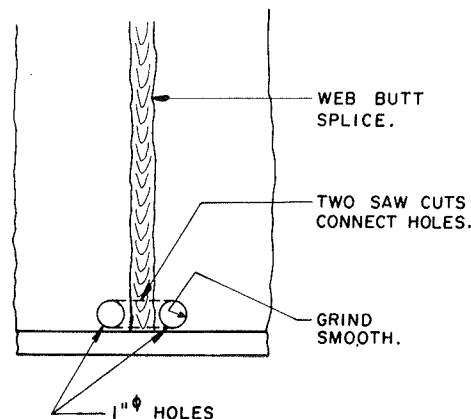
FIGURE 13 Web butt weld repair.
