Effect of Water Infiltration of Penetrating Cracks on Deterioration of Bridge Deck Slabs

TAKEAKI KATO and YUJI GOTO

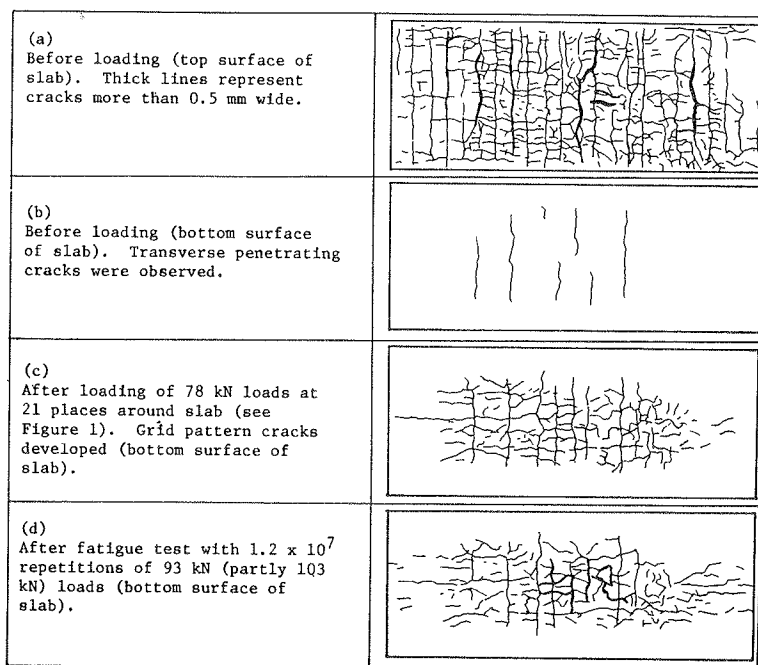
FIGURE 2 Change in cracks of slab specimen.

construction, these cracks had grown wider because of shrinkage of the concrete and restriction of the steel girders as shown in Figure 2(a). Some of the transverse cracks are more than 1 to 2 mm in width. Figure 2(b) shows that wider transverse cracks reached the bottom surface of the slab, and during rainfall some free lime with water leakage could be observed.

Figure 1 shows the loading apparatus, the positions of the moving load, and the water that was ponded on top of the slab during fatigue loading of the top surface of the slab. As a preliminary loading, approximately 2,000 78.4-kN repeated loadings were applied to points 1 to 23 to produce a gridlike pattern of cracks over the entire bottom surface. Consequently, cracks occurred and finally crack density reached 10 m/m^2 (total crack length per unit area) as shown in Figure 2(c).

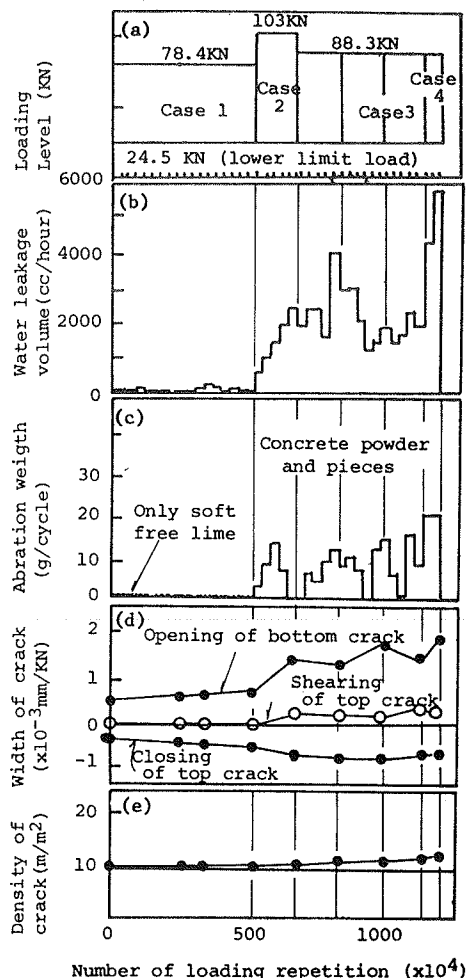
FIGURE 3 Progress of deterioration caused by loading repetition.

Figure 3 shows how the deterioration of the specimen progressed under repeated loading from case 1 through case 4. Figure 3(a) shows the loading process (one unit of the abscissa indicates one cycle or 0.3 million repetitions of load). In case 1 tensile strain of the bottom reinforcement was $400 \sim 500 \times 10^{-6}$ and the change in crack width was about 0.1 mm. Water leakage volume was slight and little deterioration occurred except for the flowage of some white, soft, free lime. In case 2 the upper limit of tensile strain of the reinforcements was arranged to be about 900×10^{-6} so that fatigue failure of the reinforcements would not occur, and the upper load level was increased to 103 kN. The result was that the volume of water leakage from cracks suddenly increased to 1000 to 2000 cm³ per hour and abrasion weight during one cycle of loading reached 5 to 10 gm. The change of crack width due to loading was more than twice as large; clearly, deterioration was remarkably rapid [see Figure 3(b), (c), and (d)].

Because the tensile strain on the bottom reinforcement increased as deterioration progressed, the upper load was decreased to 88.3 kN and repeated loading was continued. As shown in Figure 3, deterioration progressed even as the load level was dropped to 88.3 kN.

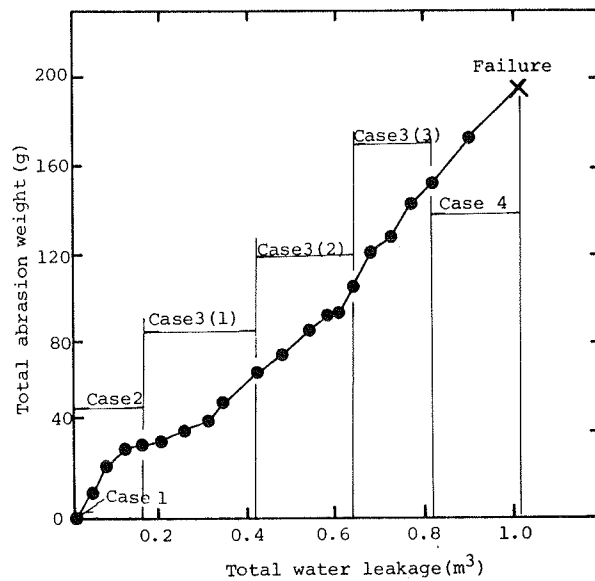
FIGURE 4 Relationship between total water leakage and total abrasion weight.

Figure 4 shows that abrasion volume increased in proportion to the increase in total leakage volume. Apparently water infiltration of cracks and abrading action occurred. Figure 5 shows this abrading action. Figure 5(d) represents relative movement parallel to the crack direction near point 12 on the bottom surface. The sliding direction of a crack reverses when the loading point is moved from point

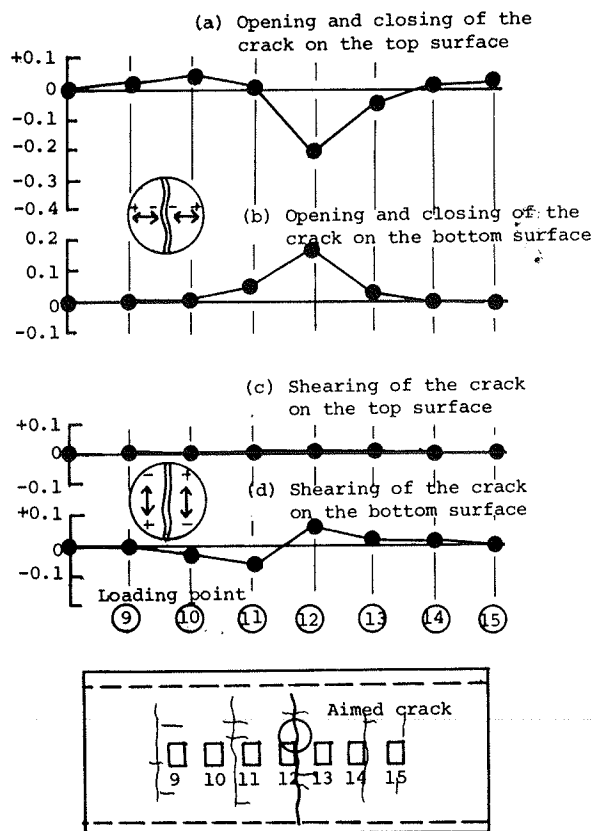
FIGURE 5 Change of representative crack caused by moving load.

11 to 12, abrading action occurs, and crack width is about 0.15 mm. After loading in case 3, the loading point was moved to point 103 in case 4. When point 103 was loaded, water leakage volume increased considerably to 4000 to 5000 cm³ per hour, and at 0.65 million repetitions of load it suddenly increased significantly.

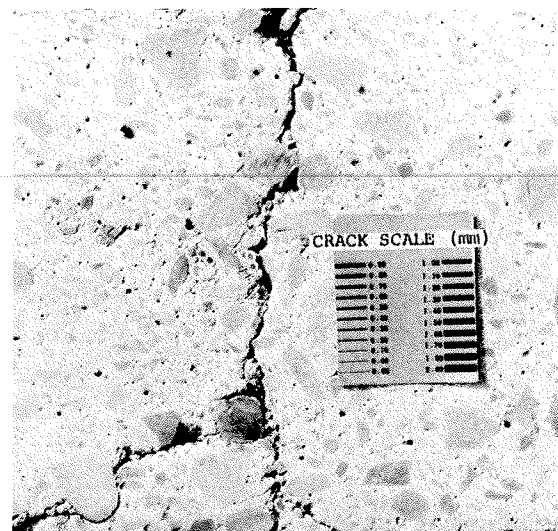
FIGURE 7 Magnified cross section under point 20 (width of crack expanded because of abrading action).

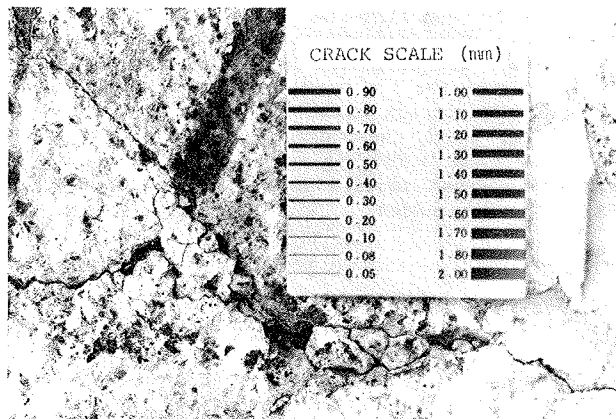
FIGURE 8 Deterioration of top surface of specimen.

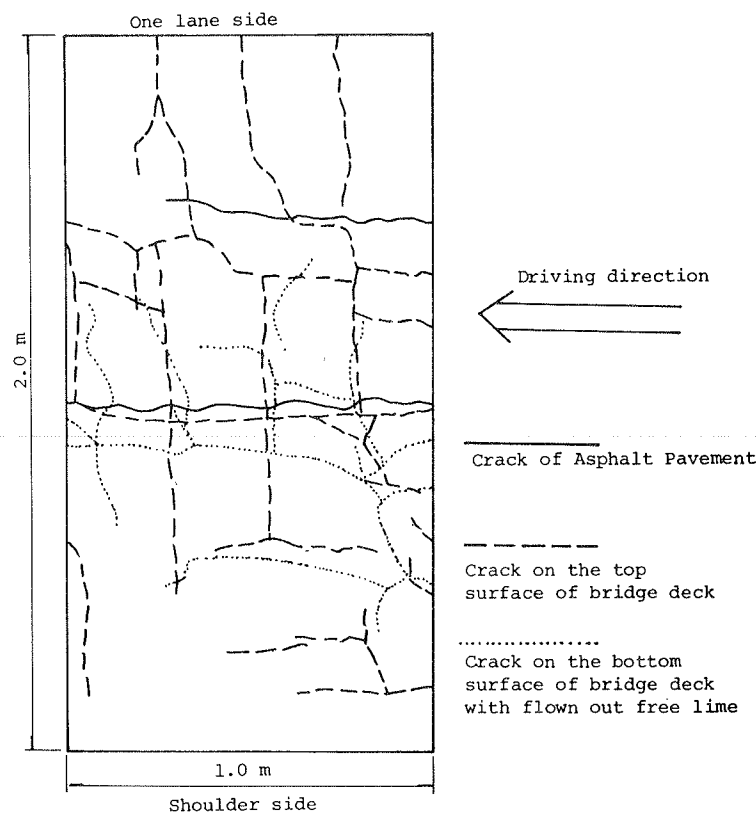
FIGURE 9 Typical crack pattern of deteriorated bridge deck in service.

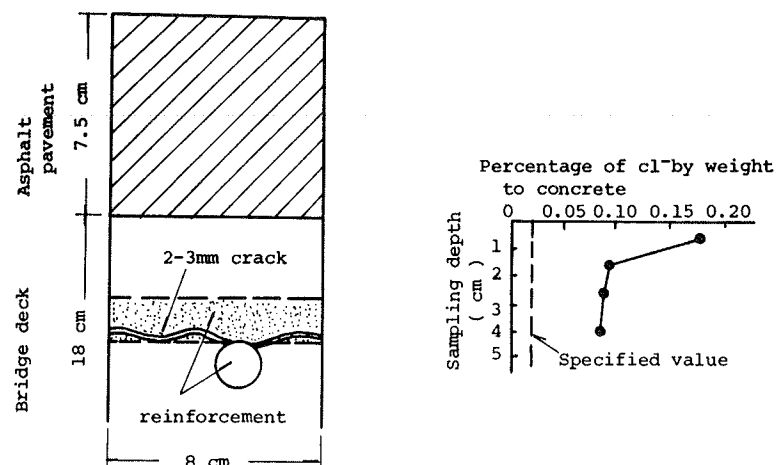
FIGURE 10 Cl^- content of concrete core of actual bridge deck and crack caused by corrosion of reinforcement.

Figure 10 shows a concrete core taken from a severely deteriorated bridge deck where deicing chemicals were scattered. There are wide crack links between main reinforcing bars due to corrosion of the bars, and the covering concrete is spalling off. In this figure chlorine quantity inside the core far exceeds the specified value (in Japan NaCl weight in concrete must be less than 0.1 percent of sand weight).

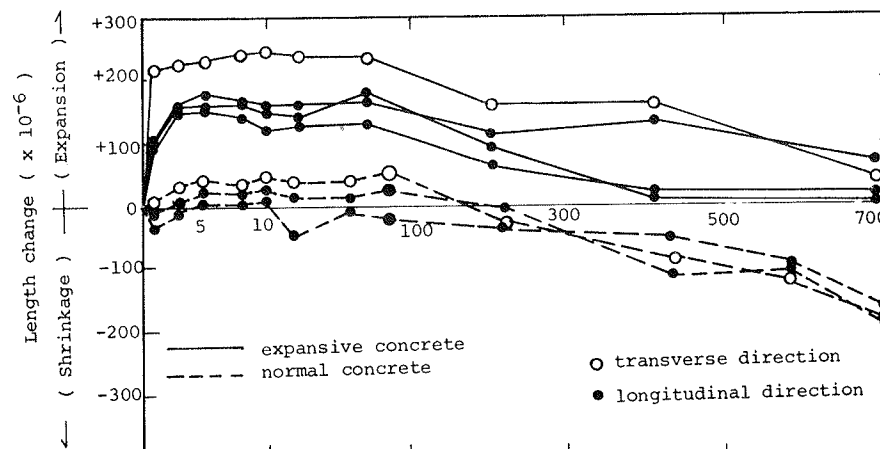
FIGURE 11 Change in length of normal and expansive concrete bridge deck.

Figure 11 shows the change in length of an expansive concrete deck in actual service compared with a like-shaped normal concrete deck constructed at the same time. Expansion of the expansive concrete deck reached its maximum value at 5 days, and expansive strain was measured as 160×10^{-6} longitudinally

and 220×10^{-6} transversely. After about 700 days this expansion became nearly zero because of drying shrinkage. From this time on, expansive concrete completely compensated for the drying shrinkage of concrete. The normal concrete deck shrank to about 200×10^{-6} due to drying and, as shown in Figure 12, many cracks developed after 30 days. Few cracks developed in the expansive concrete deck. Another experimental construction of an expansive concrete bridge deck was carried out in 1982 on an expressway plate girder bridge with a span of 36.0 m. The results of this experiment were similar to those of the first.

It has been confirmed that expansive concrete is effective in preventing crack break-out. Therefore, Nihon Doro Kodan is now investigating the use of expansive concrete decks as a standard construction method.
