Fatigue Strength of Weathered and Deteriorated Riveted Members

A study has been performed on the fatigue resistance of corroded and deteriorated riveted members. The need for this study arose from the concern with the large number of riveted structures functioning today that have various degrees of corrosion and potential fatigue damage. The validity of AASHTO and American Railway Engineering Association category D that is generally used for riveted connections is uncertain, particularly near the fatigue limit. A series of fatigue tests was carried out on 80-year-old steel bridge stringers with a riveted built-up

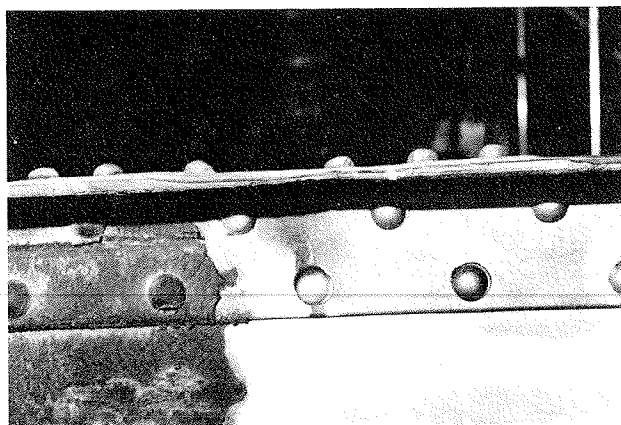
Significant deterioration was generally present along the compression flanges, as illustrated in Figure 5, which shows a thickness reduction of the flange where the cross ties had rested on the stringers. Several long cracks were found in the compression flange at the location of the lateral bracing connection plates, as illustrated in Figure 6. It appears that the bracing connection had provided restraint to the top flange adjacent to a tie-bearing point.

FIGURE 5 View of compression flange showing significant reduction in outstanding legs.

The significant loss of section of the compression flange apparent in Figure 5 was typical of every test beam. In extreme cases this loss was sufficient to result in the development of fatigue cracking in the outstanding legs of the angle. Figure 20 shows one such fatigue crack. The crack surfaces are shown in Figure 21.

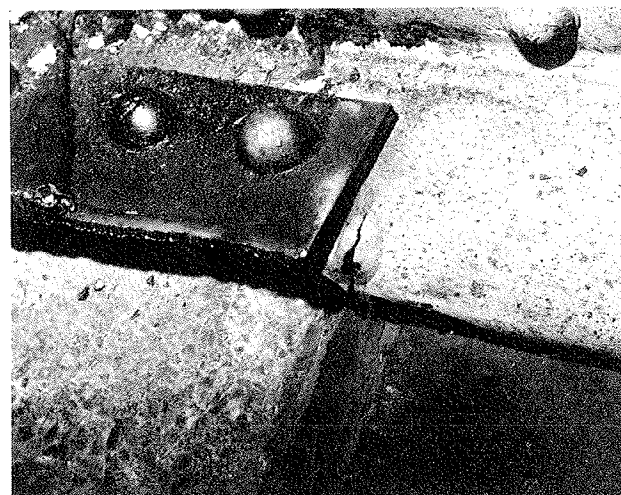
FIGURE 6 Preexisting crack in compression flange next to bracing connections.

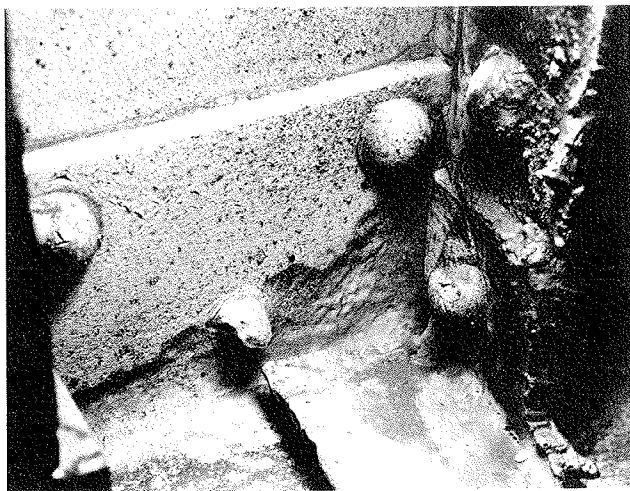
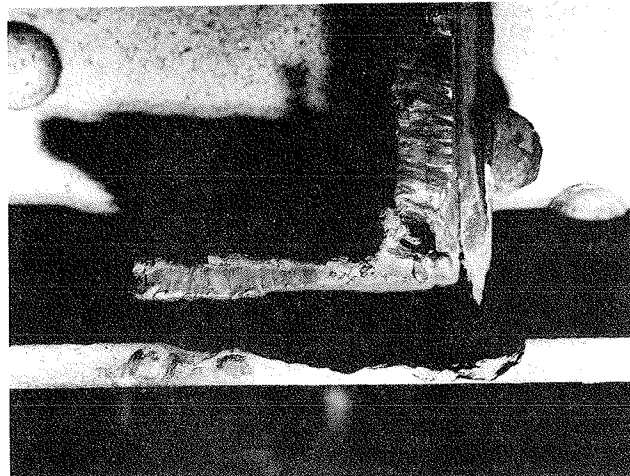
flange was relatively undamaged except at sections where the cross frame had been connected to the web (Figure 4). The bottom inside flange angle is seen to be severely corroded, so that a reduced thickness resulted as well as a partly eliminated rivet head at that section. The regions of reduced thickness contained a set of notches and associated stress concentrations, which proved to be rather severe.

FIGURE 4 Flange angle corrosion at cross-frame connections.

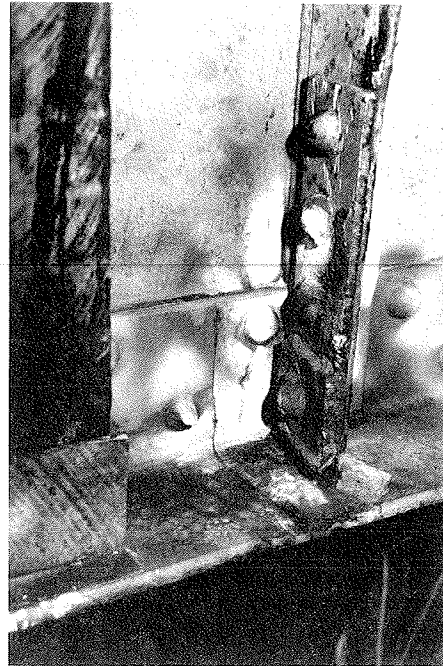
FIGURE 8 Crack at corroded area of test beam 1.

The four stringers tested all had the region of reduced thickness from corrosion. The degrees of reduction, however, were quite different and varied from 5 to 40 percent of the angle leg area. Figure 8 shows the cracked-reduced section of beam 1. The crack surface at this section is shown in Figure 10. Cracking was observed to initiate at multiple sites in the region near the edge of the angle where the thickness is minimal.

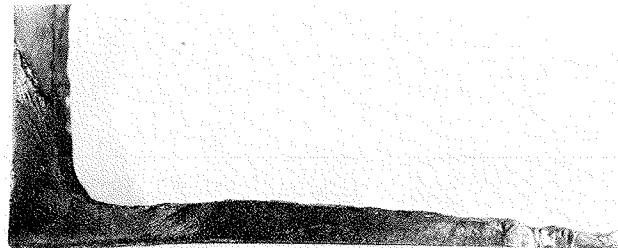
FIGURE 9 Surface of crack in corroded area of test beam 1.

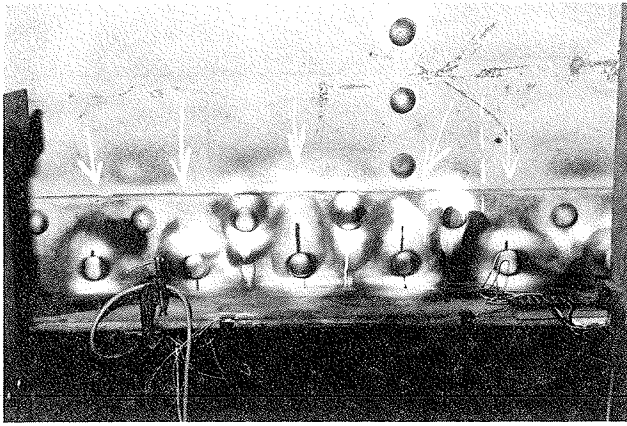
severing of the corroded angle, the opposite flange angle developed several cracks within a short period of time.

FIGURE 10 Set of cracks developed because of force redistribution in section.

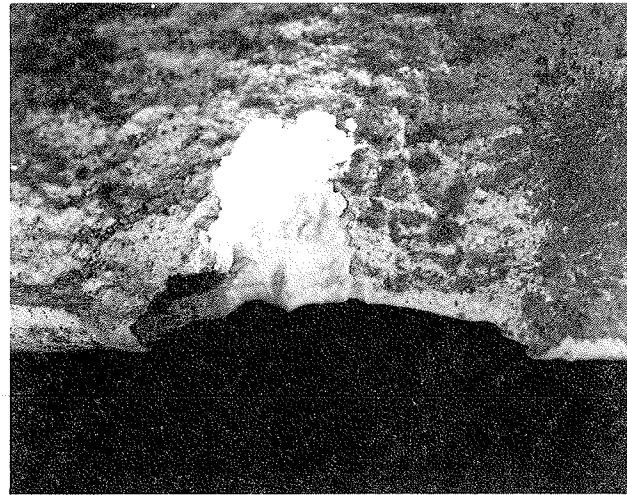
The corroded section of beam 2 after fracture is shown in Figure 11. Before the test a small existing crack had been detected in the corroded section, which was removed by grinding. This segment is shown in Figure 12.

FIGURE 12 Initial crack in corroded area of test beam 2.

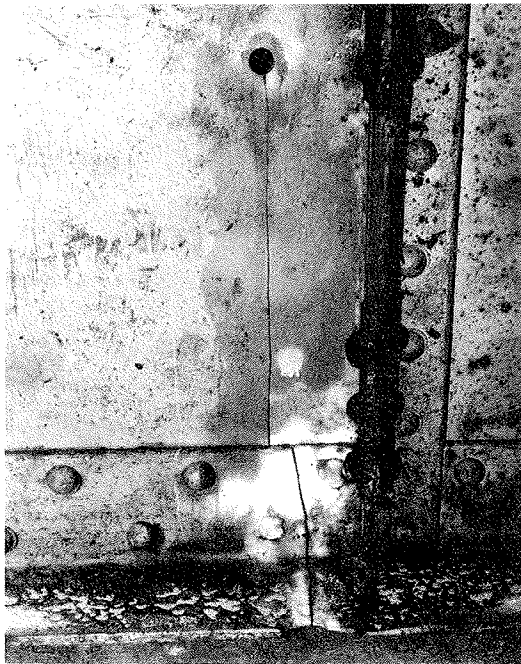
FIGURE 11 Cracked section at corroded area of test beam 2.

The corroded areas of stringers 2 and 4 (see Figures 11 and 14) had a fatigue life at the first observed cracking that was lower than that provided by category E. The corroded detail of stringer 1 (see Figure 8) had a fatigue resistance slightly lower than category C. Stringer 3 (see Figure 13) did not crack at this location.

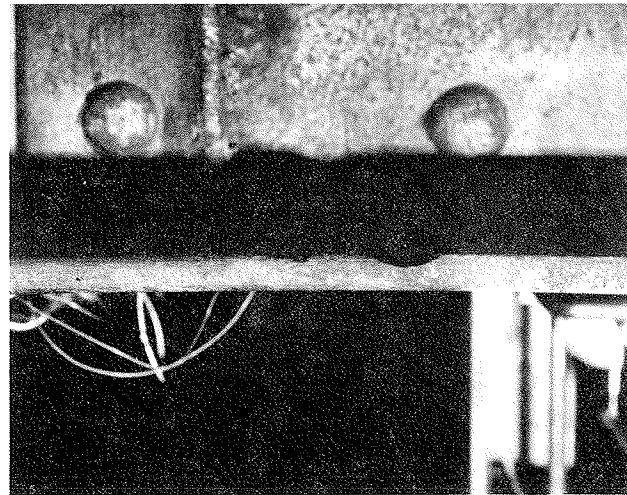
The degree of corrosion of the third stringer is shown in Figure 13. No cracking was observed at

FIGURE 13 Corroded area of test beam 3.

this section throughout the test. The thickness reduction was less than half the original thickness.

The deterioration of the flange angle of beam 3

was not severe enough to have a crack initiate. The severity of the corroded regions of stringers 1, 2, and 4 were greater than that predicted by considering the loss of cross-sectional area only, as they all plot well below category A. Apparently, the roughness of the surface and the associated stress concentrations are the major factors in making this detail more severe than anticipated.

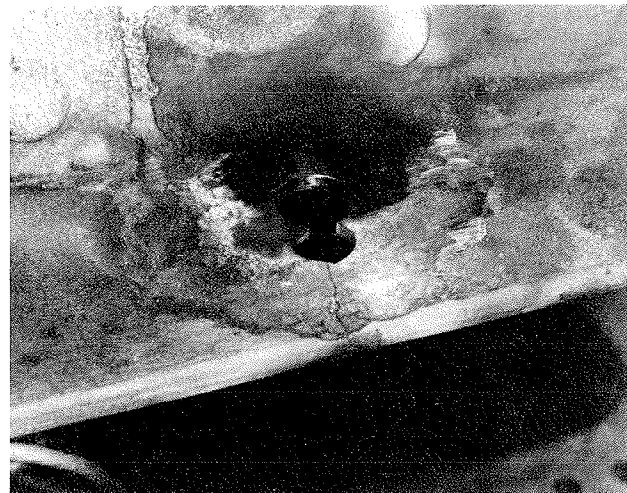
Figure 14 shows the crack in the reduced section of beam 4. This crack was arrested by drilling holes centered on the crack tip after it had grown to a length of about 64 mm. The crack subsequently reinitiated after 2.2 million additional stress cycles, and the section was finally spliced to permit continued testing of the stringer.

FIGURE 14 Corroded area of test beam 4 with crack, reinitiated after having holes drilled.

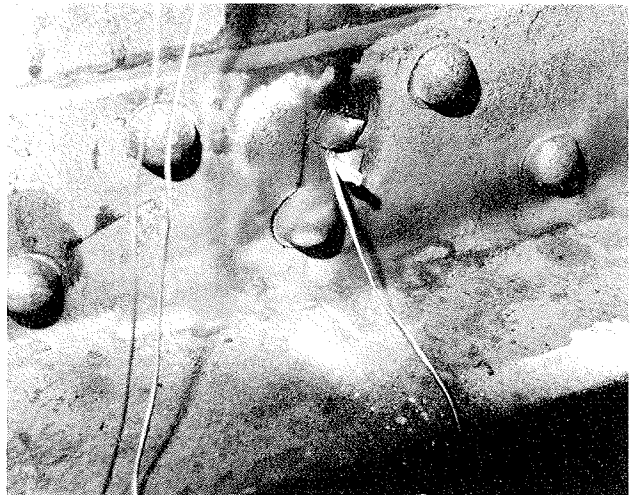
Fatigue cracks formed at rivet holes, as illustrated in Figure 16. The crack surface of one of these details is shown in Figure 17. The fatigue strengths of the rivet details that cracked independently of each other are summarized in Table 2 and plotted in Figure 18 as a function of the net section stress range. In Figure 18 cracking denotes first observed cracking. Failure of the flange angle developed for stringer 3 only. The cracked angles of the remaining stringers were retrofitted before failure could

FIGURE 16 Fatigue cracked riveted section in test beam 3, after several reduced temperature tests.

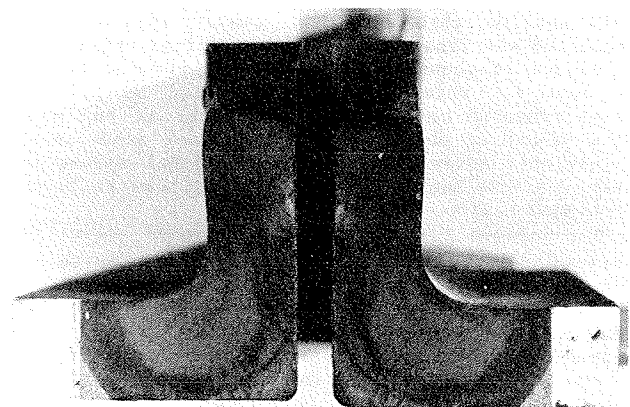
FIGURE 17 Cracked surface of crack at rivet hole running into bottom flange.

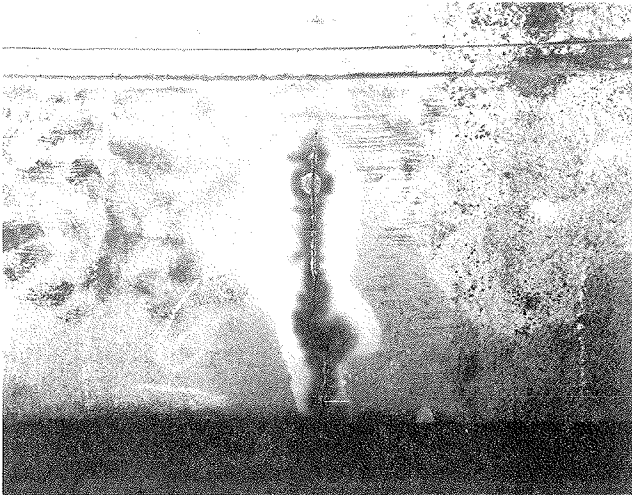
The cracks always started at the section that had the largest thickness reduction. The explanation for this phenomenon is that the compressional stress cycle resulted in yielding on the net ligaments of the reduced section as a result of stress concentration and reduced area. During the unloading part of the stress cycle a residual tension stress field formed, which permitted crack initiation. In these circumstances the crack propagated toward the heel of the angle and arrested after having grown out of the region of yielding. None of the cracks propagated past the heel. Hence the cracks in the compression flange did not adversely affect the load-carrying capacity of any of the test beams.

FIGURE 20 Fatigue crack in deteriorated compression flange of test beam 1.

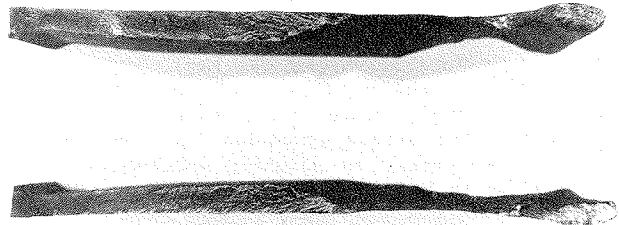
FIGURE 21 Fatigue crack surface in deteriorated compression flange of test beam 1.
