## Fatigue Behavior of Welded Wrought-Iron Bridge Hangers

PETER B. KEATING, JOHN W. FISHER, BEN T. YEN, and WILLIAM J. FRANK

The behavior of fatigue crack growth and fatigue strength of welded lap splice wrought-iron hangers in a railroad bridge was studied. The original wrought-iron hangers were lap spliced with steel plates for the purpose of tightening the members. Field inspection revealed cracks in the welded lap splices. Examination of simulated test joints and cracked hanger splices in the laboratory indicated that fatigue cracks would develop from weld deposits at the cut of the wrought-iron bar, propagate into the steel splice plate, and cause failure. Fatigue cracks could also propagate into the wrought-iron bars but would be arrested by the slag (iron silicate) stringers. Breaking of the wrought-iron bar only occurred when the applied stress was quite high in comparison with the yield point. Measured live-load stresses in the actual bridge member were relatively low. Evaluation of traffic and load records indicates that the effective live-load stresses would be well below the fatigue strengths of these spliced joints. No imminent problem of fatigue failure is expected

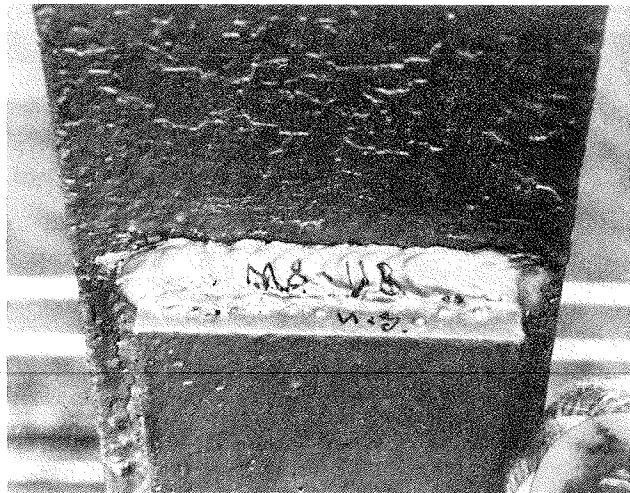
FIGURE 4 Toe crack in transverse weld.

A detailed inspection of the bridge revealed fatigue cracks in the welded lap splices. The most severe cracking was found in the transverse welds in the hangers of span F, where the cracks had coalesced across the toe of the transverse weld. Figure 4 shows the presence of the crack along the entire length of the transverse fillet weld. Also, fatigue cracks were found in the welded gap at the center of the lap splice (Figure 5). Although each hanger is comprised of a pair of eyebars, with a combined cross-sectional area of 8.0 in.<sup>2</sup>, the inspection revealed that only one eyebar was carrying the load. The other eyebar was found to be slack, even during live loading of the span. This may have occurred from pin wear, pin rotation, or improper tensioning during repair. This condition effectively doubled the stress range level in the active member, which resulted in a more serious situation. A study was undertaken to determine the severity of the cracking and to determine what corrective measures were necessary to prevent failure of the member.

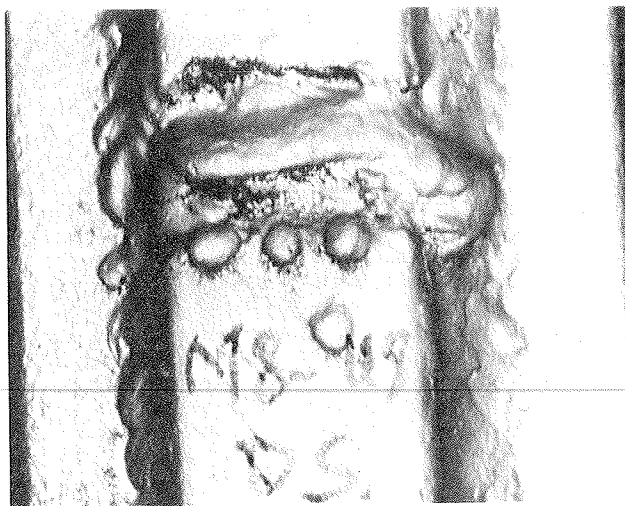
FIGURE 5 Crack in welded gap.

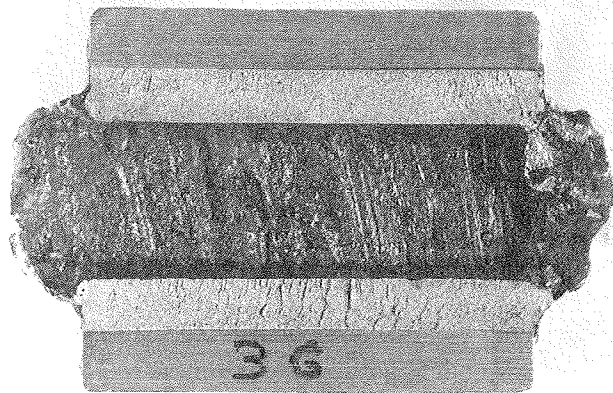
The remaining lap splice joints were cut open to expose cracks that might have occurred in the welds during service. For most joints, cracks were found on only one side of the joint. This was generally observed at the weld with the greater reinforcement angle. Also, toe cracks were found toward the center portion of the transverse weld, and root cracks were found at the outer ends of the weld. No cracking was found in the longitudinal welds, except at the center gap location. Here the crack had propagated through the entire weld, but in no case was the crack observed to enter the steel lap plates. Figure 10 shows an exposed surface at the member gap. The two lap plates were partly cut with a saw before pulling the member apart at a reduced temperature. No significant crack extension can be seen in the splice plates. Cracking was visible in the welds at each edge only.

FIGURE 10 Exposed welded gap.

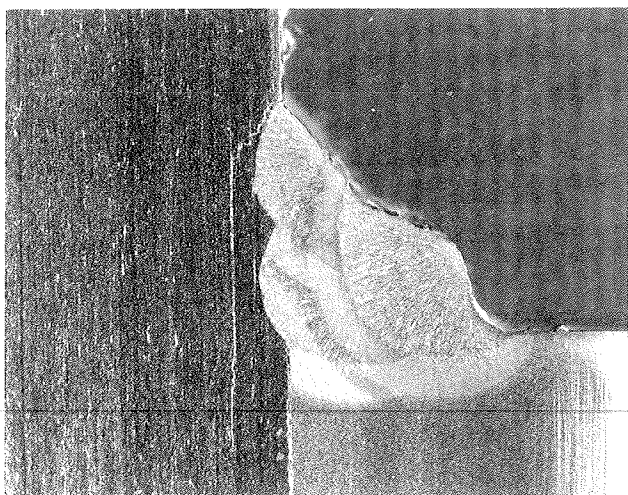
were first noticed at approximately 0.5 million cycles at a stress range of 12 ksi. Initially, the toe cracks propagated perpendicular to the thickness of the wrought-iron plate until they encountered a significant slag stringer. The crack may then re-initiate out of the stringer at a location that is further into the joint. The crack continues to encounter stringers, and this process continues to a depth of approximately 0.1875 to 0.125 in. at an approximate angle of 45 degrees. At this point the crack is arrested as the crack turns and extends vertically into the joint, parallel to the stress. The angle of growth corresponds to the plane perpendicular to the stress field through the fillet weld. The crack growth results in a staircase effect, as can be seen in Figures 11 and 12.

FIGURE 11 Crack growth in test specimen.

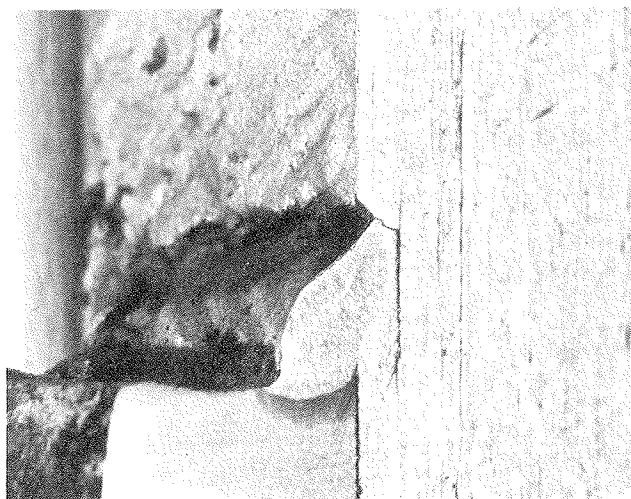
The importance of the stringers in the wrought iron appears to be their ability to arrest the transverse crack and deflect the growth of the crack into the joint. A similar joint geometry in steel would result in the toe crack propagating through the thickness of the main plate. In the welded wrought iron, the crack is arrested and turned parallel to the plate and cyclic stress. There is an obvious redistribution of the stress in the vi-

FIGURE 12 Crack growth in span F hanger.
