Evaluation and Field Testing of the Dan Ryan Rapid Transit Structure

ANDREW E. N. OSBORN and MICHAEL J. KOOB

A post-construction investigation of the Dan Ryan elevated rapid transit structure between 17th and 23rd streets in Chicago was conducted for the Chicago Transit Authority (CTA). The purpose of the investigation was to evaluate the sensitivity of welded details in the structure to fatigue.

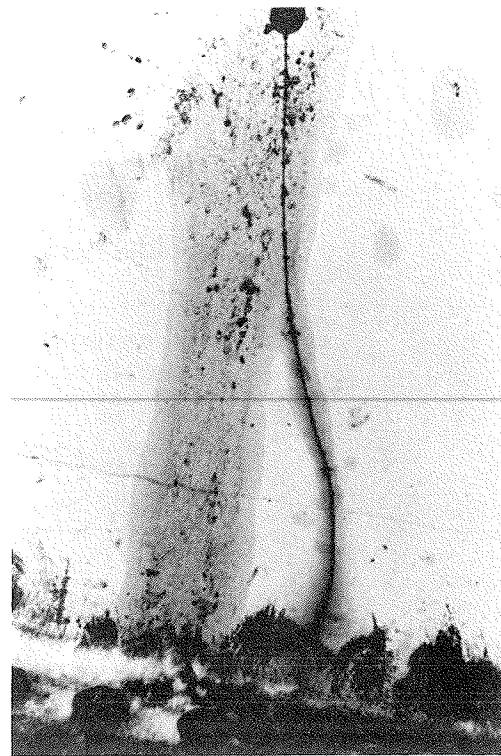
In fall 1982 a crack was found in the stringer of span 15. Again the crack originated at the gap between the vertical stiffener and the gusset-plate cutout. The crack had propagated down through the bottom flange and also up about 12 in. into the web. A hole was drilled at the top end of the crack and a cover plate was bolted to the bottom flange across the crack. An exterior view of the crack is shown in

Figure 7. Staining in Figure 7 is from the cutting oil used for drilling.

FIGURE 7 Appearance of retrofitted crack located in span 15.

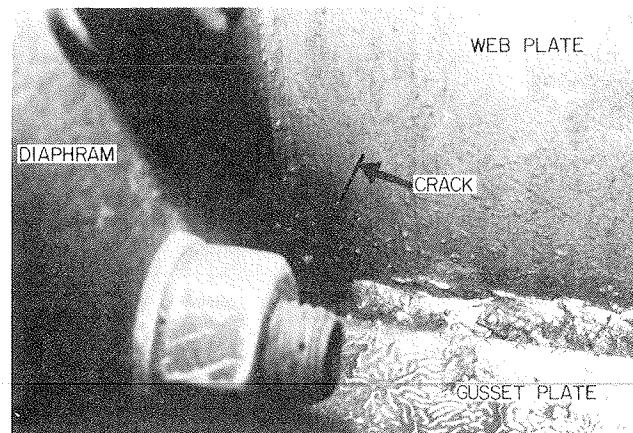
FIGURE 16 Upper segment of 4-in.-long crack found near midspan of span 16.

During the field examination one major crack and a total of 42 small cracks or cracklike indications were found. The terminology major crack is used because of its significant length (4 in.) and because it penetrated the full thickness of the stringer web. No other observed crack had these characteristics. The major crack was located adjacent to the vertical stiffener near the midspan of span 16 (see Figure 16). For comparison purposes, the crack found in span 15 is shown in Figure 7.

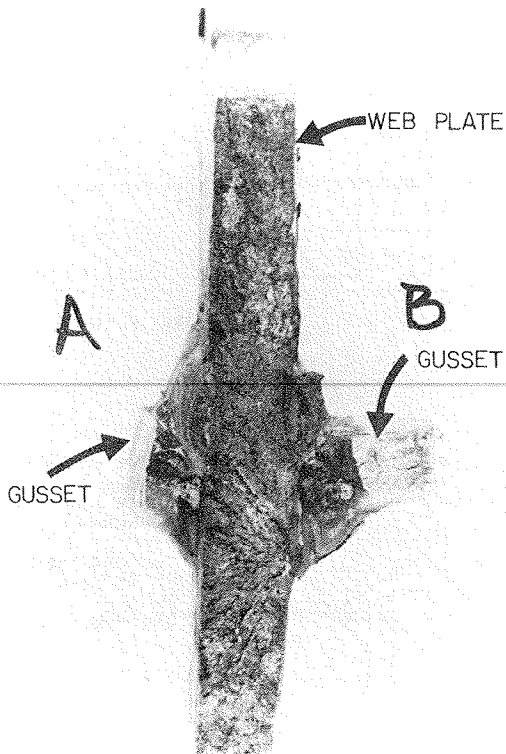
FIGURE 17 Exposed crack surface of specimen from span 16.

surface of the sample from span 16 was found to exhibit fatigue crack growth in the stringer web near the bottom surface of the gusset plate. The web plate fracture surface is shown in Figure 17. The fatigue crack was roughly elliptical in shape, its dimensions were about 0.125 in. deep by 0.375 in. long, and it exhibited fatigue crack growth striations. The striation spacing or crack growth rate was observed to vary between 1.4×10^{-6} and 5×10^{-6} in. per cycle. Figure 18 is a transmission electron microscope photograph that shows the striations. It is estimated, based on these data, that the crack after initiation can propagate to critical size after only 6 months of service.

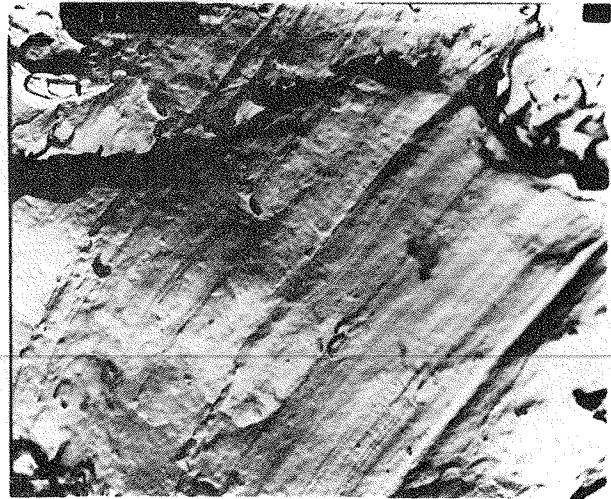
FIGURE 18 Transmission electron microscope photomicrograph: side B at 17,000X showing striation lines.

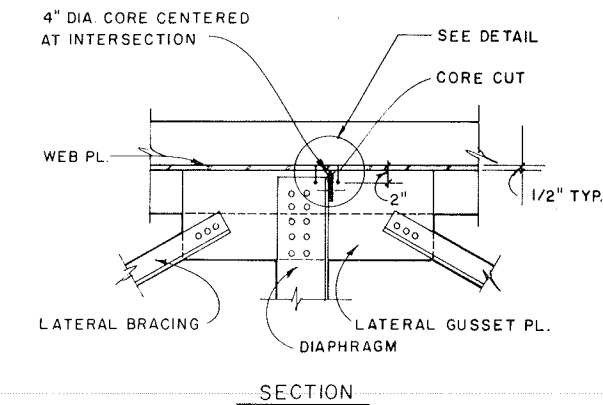
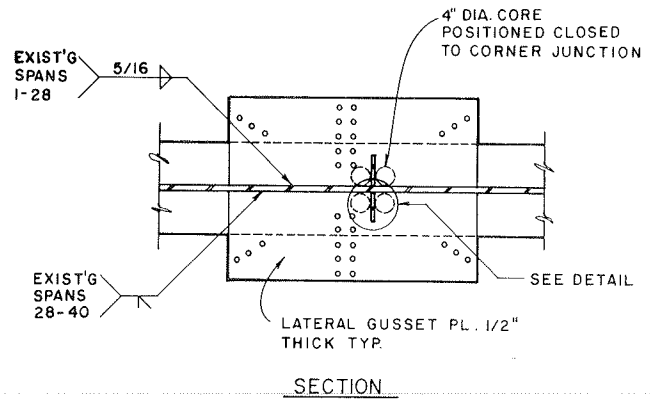
FIGURE 19 Exterior stringer retrofit by coring through web plate.

1. Exterior stringer: This retrofit requires coring a 4-in.-diameter hole into the stringer web, as shown schematically in Figure 19. The core cutter is intended to penetrate the lateral gusset and transverse stiffener by 1.5 in. The purpose of this retrofitting procedure is to shield the fatigue-sensitive detail from stress and increase the gap width. It is intended to be used on exterior or fascia stringers.

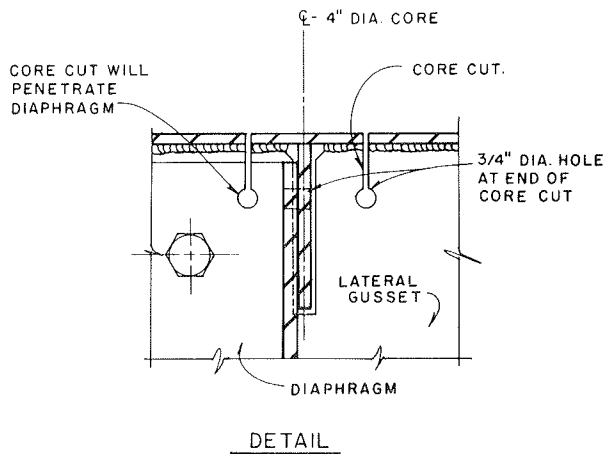
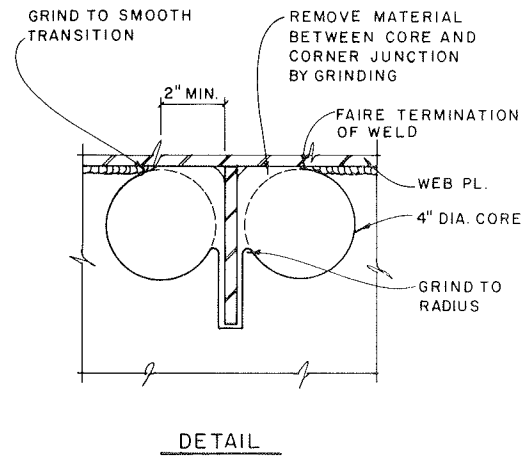
FIGURE 20 Interior stringer retrofit by coring holes through lateral gusset plate.

2. Interior stringer: This procedure requires coring 4-in.-diameter holes vertically through the lateral gusset plate on both sides of the transverse stiffener. The edge of the hole along the web plate is milled or ground to achieve the profile indicated in Figure 20. The purpose of this retrofit is to increase the gap width between the gusset plate and stiffener. This modification will reduce the stress gradient in the gap region, thereby improving the fatigue life of the detail and providing a condition that will be easier to inspect.
