Case Histories of Scour Problems at Bridges

STANLEY R. DAVIS

Ten case histories of scour problems at bridges are presented to provide a review of the various factors contributing to the problems, corrective actions taken, and the influence of the events on current design practices. Designing bridge foundations to resist scour is still a technical area that requires engineering judgment by experienced bridge and hydraulic engineers, and evidence indicates that additional attention to designing for scour is needed. Analyzing case histories is encouraged as a means of understanding the conditions and events that contribute to bridge scour and ways to avoid or alleviate scour problems.

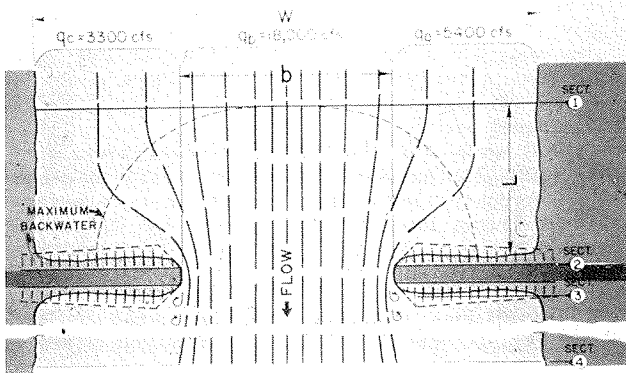
FIGURE 1 Flow lines for a typical stream crossing.

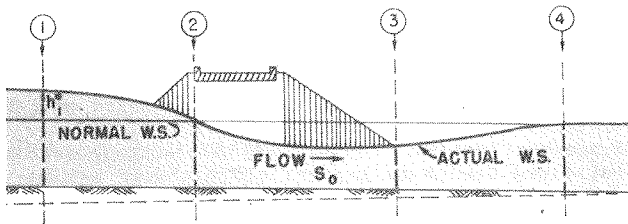
FIGURE 2 Illustration of water surface profile through a bridge constriction.

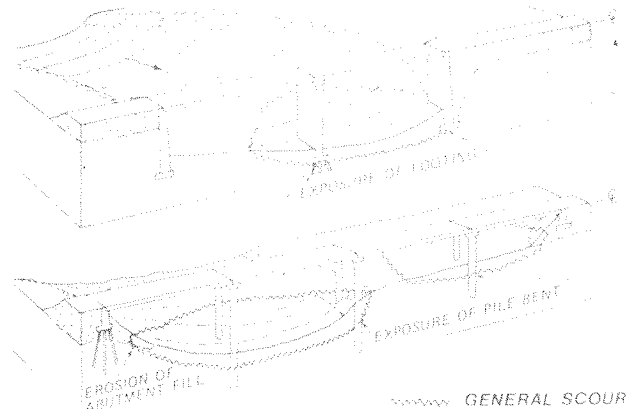
FIGURE 3 Diagram of general scour at a bridge crossing.

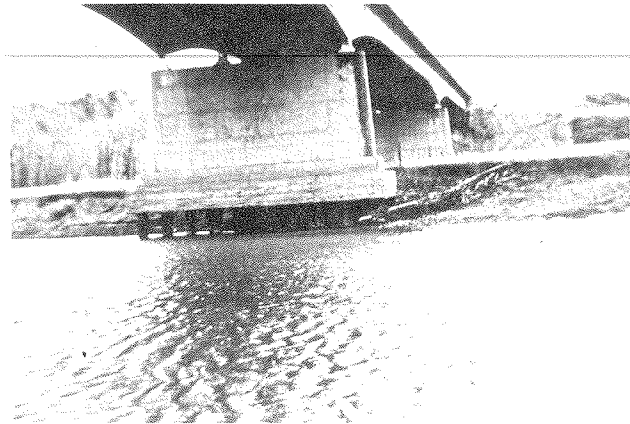
FIGURE 4 Illustration of general scour.

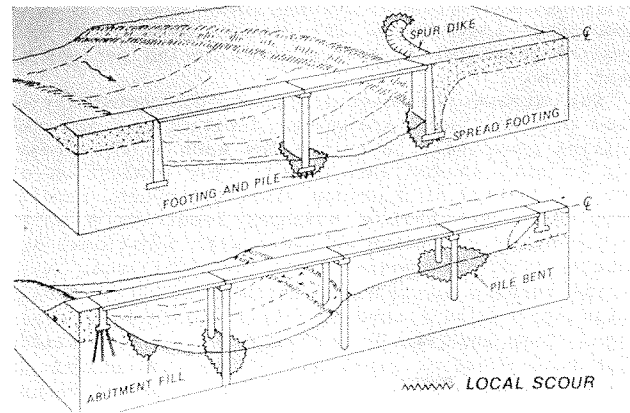
FIGURE 5 Diagram of local scour at bridge piers and abutments.

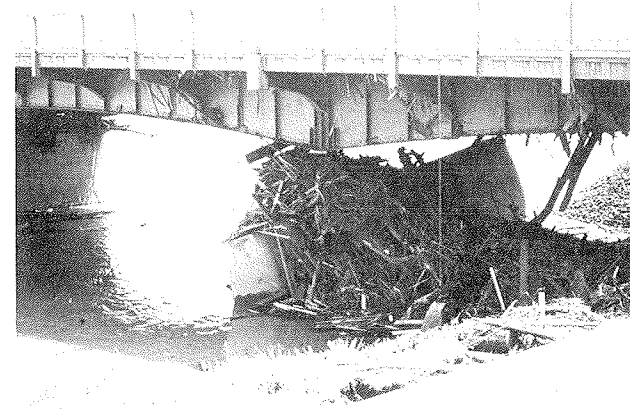
FIGURE 6 Settlement of bridge pier due to local scour.

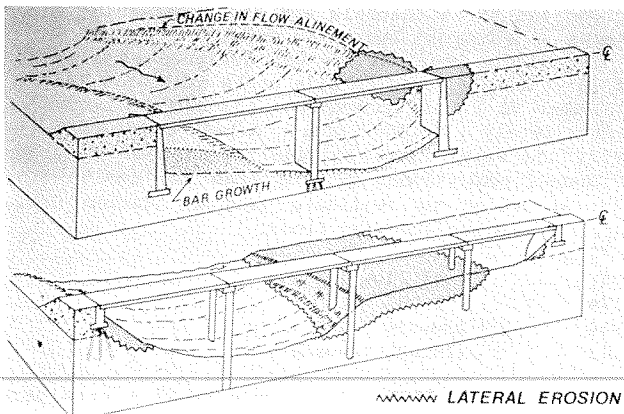
FIGURE 7 Diagram of lateral erosion resulting from realignment of a stream.

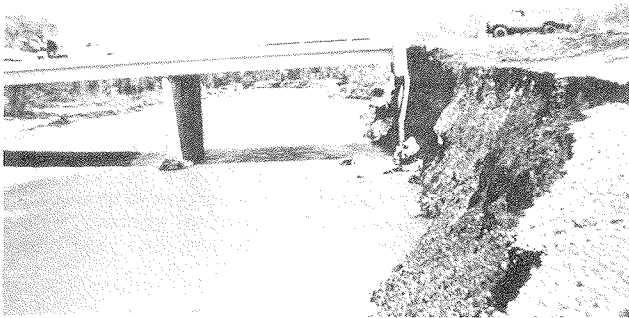
FIGURE 8 Illustration of abutment damage caused by lateral movement of stream.
