Corrosion of Galvanized Steel Floor Slab Reinforcement

SAM BHUYAN and ROBERT G. TRACY

The objective of this paper is to provide a report on the field performance of a 17-year-old parking structure with galvanized floor slab reinforcement.

The case study is for the Kennedy Square Parking Garage in Detroit. The parking facility, built in 1965, consists of a slab on grade and two supported levels of parking. The parking levels are located directly beneath a pedestrian plaza, complete with plantings and a wading pool. The structural system for the supported level consists of a conventionally reinforced flat slab with drop panels and circular columns. The slab has galvanized steel reinforcing bars in the top and bottom mat of slab reinforcement. Typical slab reinforcement is shown in Figure 1.

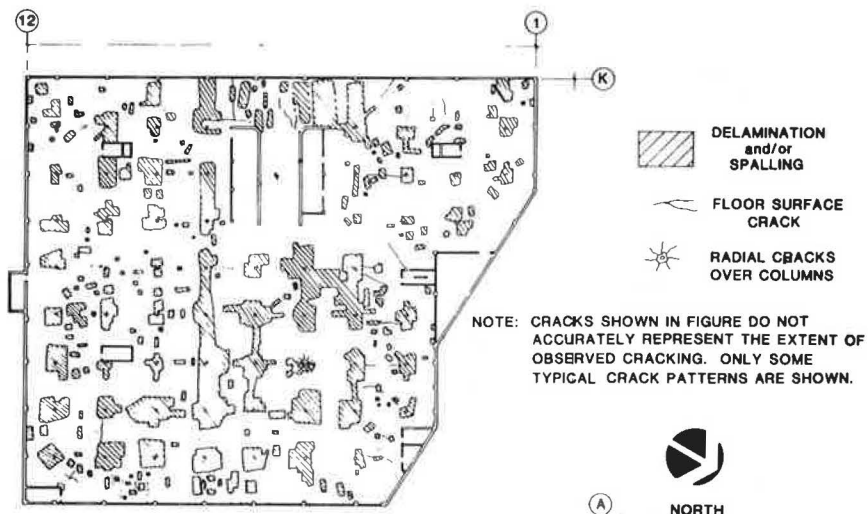
FIGURE 2 Second level plan view.

Spalls and delaminations were concentrated around columns and along column lines. The extent of surface delaminations determined were observed to range from several to hundreds of square feet and were typically 2 to 3 in. deep. Approximately 31,000 ft² (26 percent) of the supported floor surface was determined to be spalled or delaminated (see Figure 2, which is a field survey sheet).

Examination of the cores and open spalls indicated that much of the deterioration was caused by reinforcement corrosion. This corrosion had proceeded to the point of causing humps in the floor surface. Cores removed from the floor slab exhibited fracture planes 2 to 3 in. beneath the exposed surface. At isolated locations, 20 percent section loss of embedded reinforcing steel was observed. The most significant section loss was observed in the column capitol region.

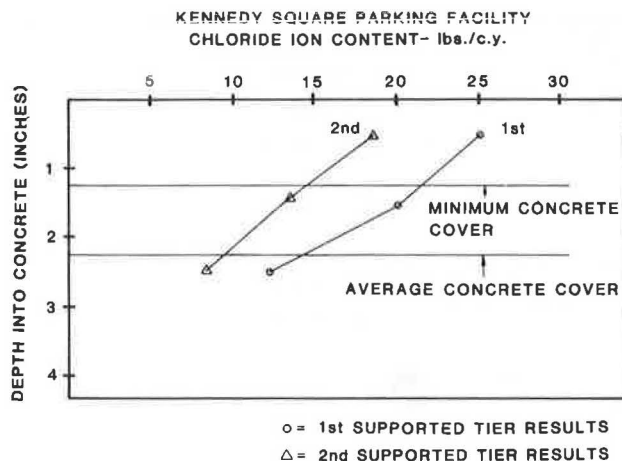
FIGURE 3 Chloride ion content versus depth into concrete.

Chloride sampling was performed at 17 locations throughout the structure. Samples were taken from random parking bays and drive lanes by using the dry (Roto hammer) sampling method. Test results indicated high concentrations of chloride within the first 3 in. of the concrete. Concentrations ranged from 25.2 lb/yd³ of concrete in the top 1 in. to 12.4 lb/yd³ of concrete at the 3-in. increment of the first supported tier.

Results from the second supported tier, or upper parking level, had somewhat lower chloride concentrations, ranging from 18.6 lb/yd³ of concrete in the top 1 in. to 8.5 lb/yd³ of concrete at the 3-in. increment. Results of chloride ion content testing are shown in Figure 3, which indicates significant chloride contamination of concrete at the level of reinforcing steel. However, the corrosion threshold level for galvanized reinforcement is not known. For plain black steel the threshold level is indicated to be 1.1 to 1.6 lb/yd³ of concrete (1).
