Landslide Activity and Groundwater Conditions: Insights from a Road in the Central Sierra Nevada, California

JEROME V. DeGRAFF, JAMES McKEAN, PAULINE E. WATANABE, and WILLIAM F. McCAFFREY

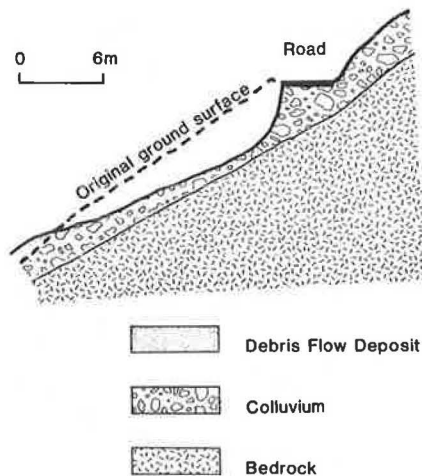
During periods of infiltration, water percolates downward through surficial soils and road fill until bedrock or some other less permeable layer is encountered. The groundwater then flows down gradient roughly parallel to the bedrock surface (8). Figure 3 shows a scaled cross section of a 1982 debris flow at Sheepthief Creek. It is reconstructed as a repre-

FIGURE 3 Cross section of subsurface conditions at a representative debris flow.

sentative landslide based on surveyed topography and seismic data. Granitic bedrock is overlain by colluvial soil and limited road fill material. The bedrock surface roughly parallels the ground surface. Seismic velocities for the surficial soils are about 300 m/sec. By contrast, the underlying bedrock has a velocity of 1700 m/sec. A density increase of nearly 5.5 times that of the overlying material suggests a substantial decrease in hydraulic conductivity.

During associated precipitation events, hydrostatic pore pressures and seepage forces increased because of the greater saturated thickness of overlying soils and groundwater flow. This reduced shear strength of the soils to the point that failure occurred (9,10). The magnitude of the total groundwater forces during the storm was estimated by back analysis of the roadway failures. A slope stability model using noncircular failure surfaces was utilized in this back analysis. The stability model assumes parallel side forces on each slice and thus satisfies all equilibrium conditions.

At the toe of the failure r_u was found to have reached a maximum of about 0.5, whereas near the head of the slide r_u was about 0.15. This suggests that the failures were initiated at the original toes of the slides and then retrogressed headward.
