Characteristics of Sinkhole Development and Implications for Potential Cavity Collapse

BYRON E. RUTH and JANET D. DEGNER

ABSTRACT

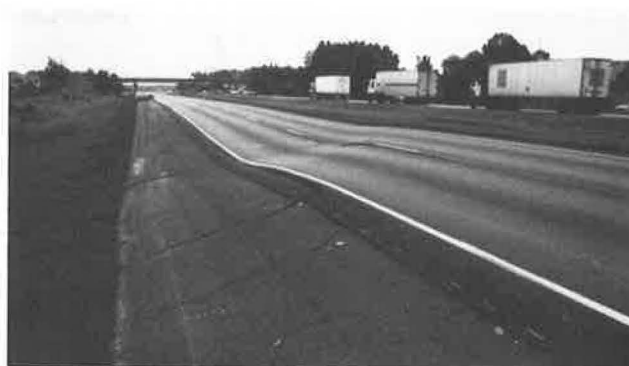
subsidence that was located in a topographic low. The southbound lanes of I-75 were closed because of concern about the possibility of a collapse after a depression and cracking occurred in the pavement (Figure 2).

The distressed area extended from the western portion of the median, west across the pavement, and about 30 ft (9 m) beyond the right-of-way to surface cracks, which were displaced vertically about 5 in. The observed cracks did not form a continuous circular shape but, when mapped (as shown in Figure 3), they revealed an elliptical pattern approximately 140 ft (43 m) wide that was estimated to be more than 180 ft (55 m) long. Borings down to 75 ft (23 m) indicated sandy soils with isolated clayey soil lenses. The water table was not encountered at this depth, even though there had been considerable rainfall for several months preceding the subsidence.

FIGURE 2 Subsidence on I-75 near Alachua, Florida.

Investigations are currently being conducted using resistivity, ground-penetrating radar, and a cone penetrometer in an attempt to identify the source of the problem. However, it is hypothesized that it is a deep-seated failure, induced by localized piping into a cavity, which resulted in the overstressing of overlying soils.

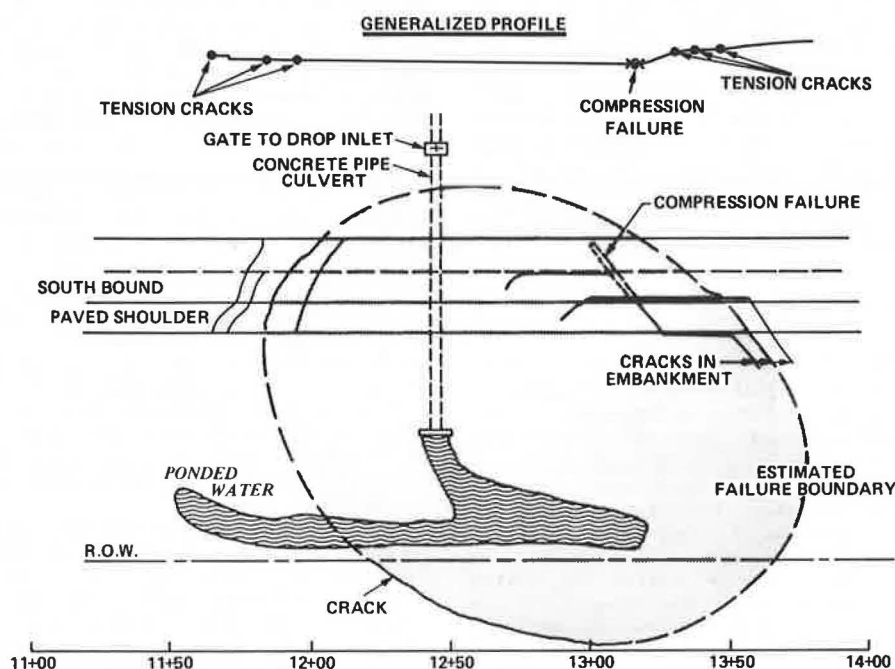
FIGURE 3 Subsidence on I-75 (MP 396.2).
