Field Performance of a Low-Modulus Silicone Highway Joint Sealant

THOMAS R. ZIMMER, SAMUEL H. CARPENTER, and MICHAEL I. DARTER

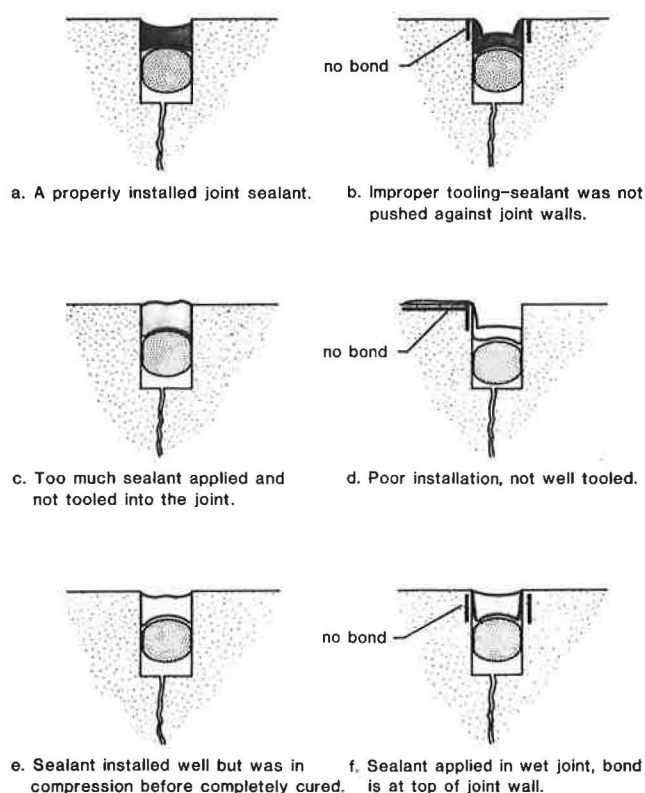
FIGURE 4 Joint cross section illustrating installation problems.

An adhesive failure with no sealant residue on the joint wall indicates a firm bond was never established because of improper cleaning before sealant installation. Insufficient tooling or contamination of joint walls with dirt, sawing residue, old sealant, or moisture can prevent a good bond. Figure 4 shows the results of common installation problems.

Poorly formed joints appear to have caused problems during application and tooling. In many joints the surface of the sealant is wavy, as shown in Figure 4c, rather than concave, as in a properly tooled joint.
