# Examination of Pavement Deterioration in the Presence of Automobile Traffic

W. RONALD HUDSON and STEPHEN B. SEEDS

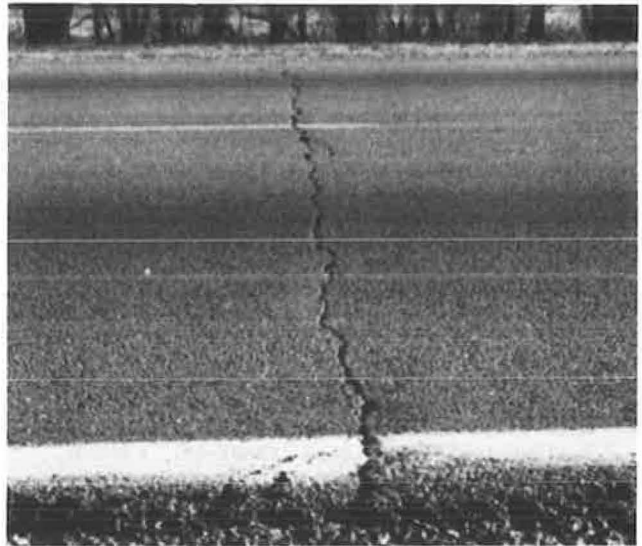
1. Above every joint in the original pavement is a moderate to severe width (0.25- to 0.50-in.) reflection crack in the HMAC overlay. This is shown in Figure 1. In many cases excessive horizontal movements of the underlying slab have resulted in a

FIGURE 1 Reflection crack in HMAC overlay, B/W Parkway.

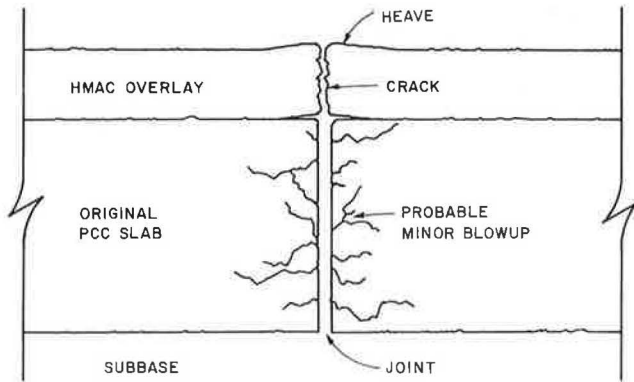
"hump" above the joint, as shown in Figure 2. The hump is probably the result of some type of joint distress in the underlying slab. It is difficult to detect this visually, but it can be easily felt when riding across it in an automobile. If not for the roughness generated by these humps, the riding quality of the pavement would be high [AASHTO present serviceability index (PSI) estimated at 4.0].

FIGURE 2 Illustration of probable joint condition beneath humps in overlay.

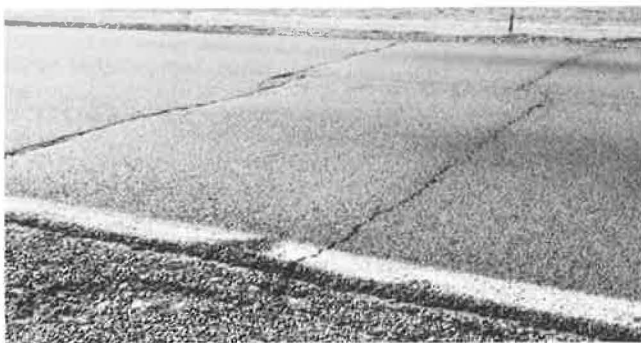
2. In cases where there are likely underlying full-depth hot-mix patches in the original joint area, there are two cracks at the surface (Figure 3). Between these two cracks a heave of material will generally be found that is most likely the result of the shoving of the hot-mix patch, which occurs as the long PCC slabs expand during warm

FIGURE 3 Heave of material above underlying hot-mix patch.

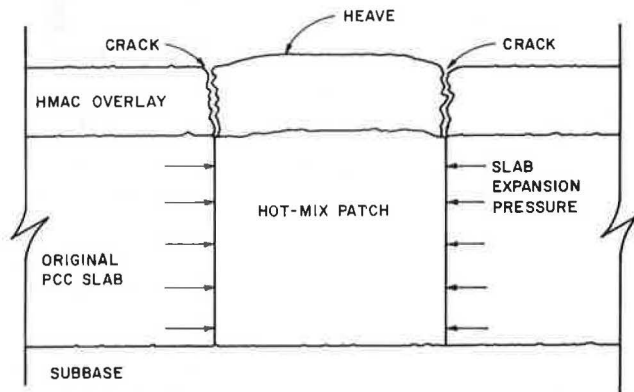
FIGURE 4 Illustration of heave mechanism.

weather (see Figure 4). Because of its width, this heave has an even greater detrimental effect on riding quality.

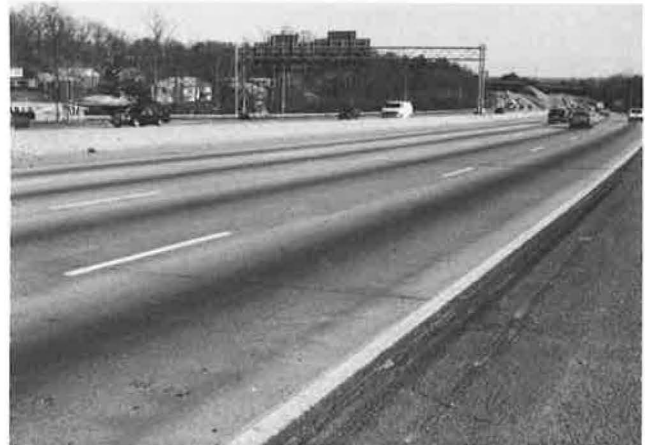
FIGURE 5 Capitol Beltway (I-495), middle section constructed with Prince George's coarse aggregate.

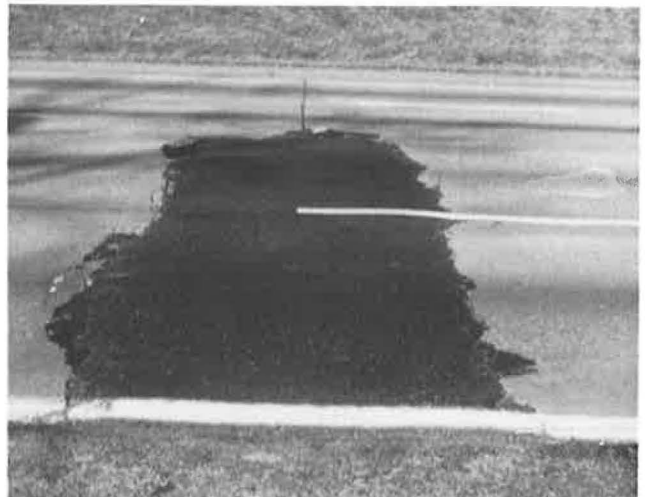
FIGURE 6 Capitol Beltway (I-495), western section constructed with Prince George's coarse aggregate.

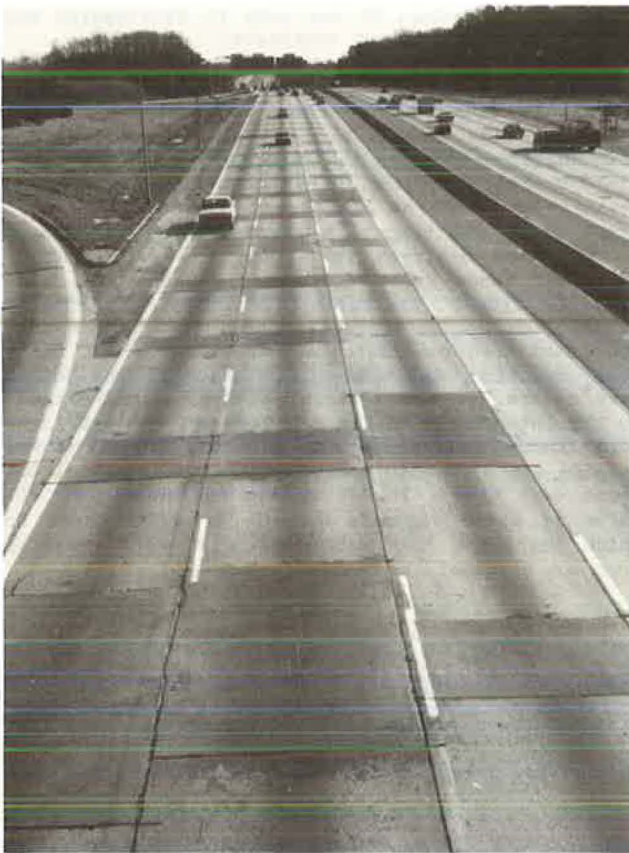
FIGURE 7 Capitol Beltway (I-495), eastern section constructed with Prince George's coarse aggregate.

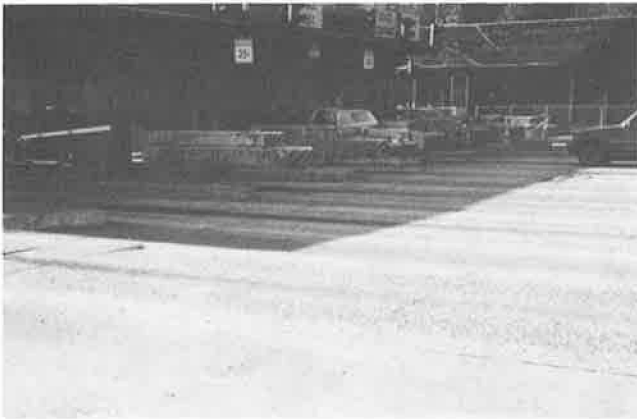
FIGURE 8 Wheel track wear and surface deterioration on Merritt Parkway, Greenwich toll station.

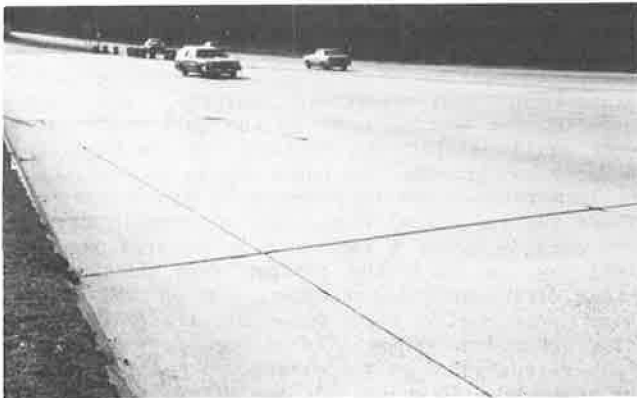
FIGURE 9 Structural condition of PCC pavement on Merritt Parkway at Greenwich toll station.

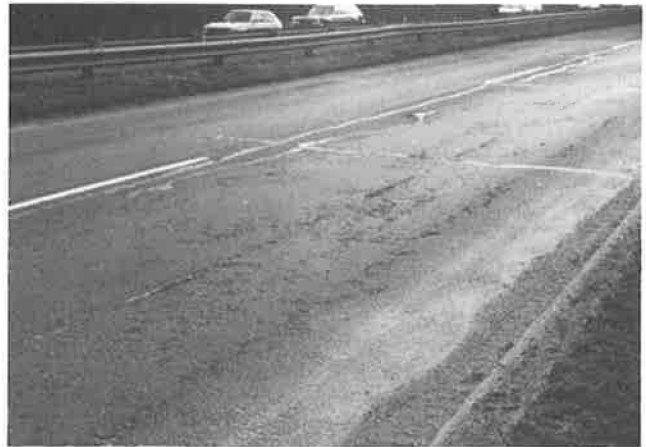
related to surface deterioration from studded tire use. The distress takes the form of slight to moderate rutting, raveling, pop-outs, and both large and small areas where skin patching had been accomplished to repair surface distress (see Figures 10 and 11). It was also evident that many of the overlaid bridge decks required considerable maintenance in the form of small skin patches.

FIGURE 10 Surface deterioration and raveling on HMAC overlay, Merritt Parkway.

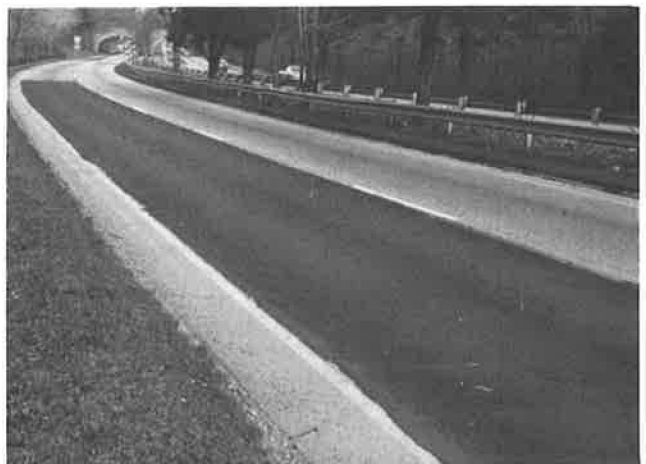
FIGURE 11 Full lane width skin patching to repair surface deterioration along Merritt Parkway.

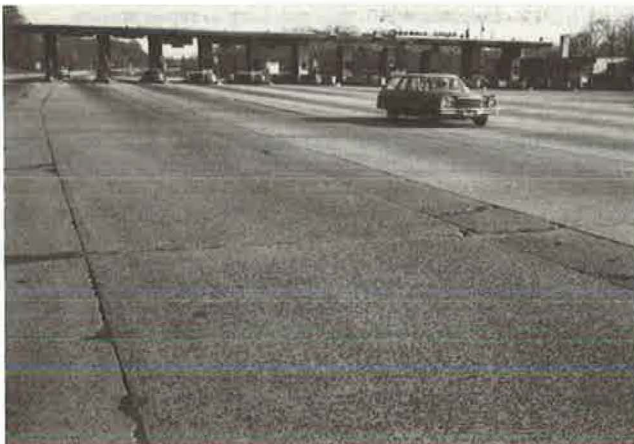
FIGURE 12 Structural condition of PCC pavement along I-95, Norwalk toll station.

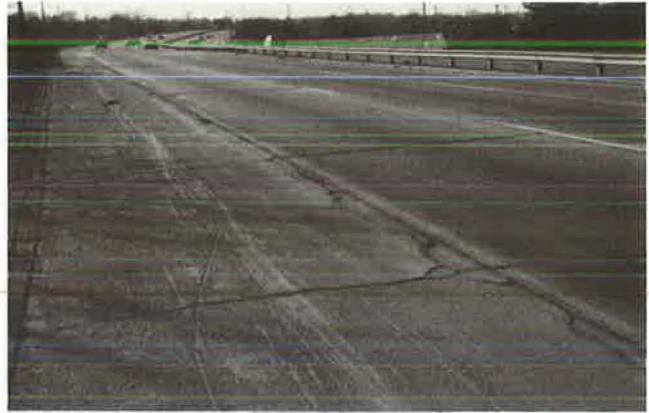
FIGURE 13 Severe faulting in outside lanes of PCC pavement along I-95, Housatonic River Bridge.
