Minicar Crash Test Evaluation of Longitudinal Traffic Barriers

MAURICE E. BRONSTAD, JARVIS D. MICHIE, and JOSEPH B. MAYER, Jr.

The number of small cars in use in the United States is growing rapidly, and the changing characteristics of the vehicle fleet should be considered in highway safety design. Before the series of crash tests described in this paper was performed, few of the current operational barrier systems had been evaluated for the 1,800-lb car test in NCHRP Report 230. Eleven barrier systems were selected for evaluation and findings indicate that all systems met impact test requirements for the 1,800-lb car at 60 mph and a 15-degree angle. The 11 barrier systems included 5 guardrail, 2 median-barrier, and 4 bridge-railing systems.

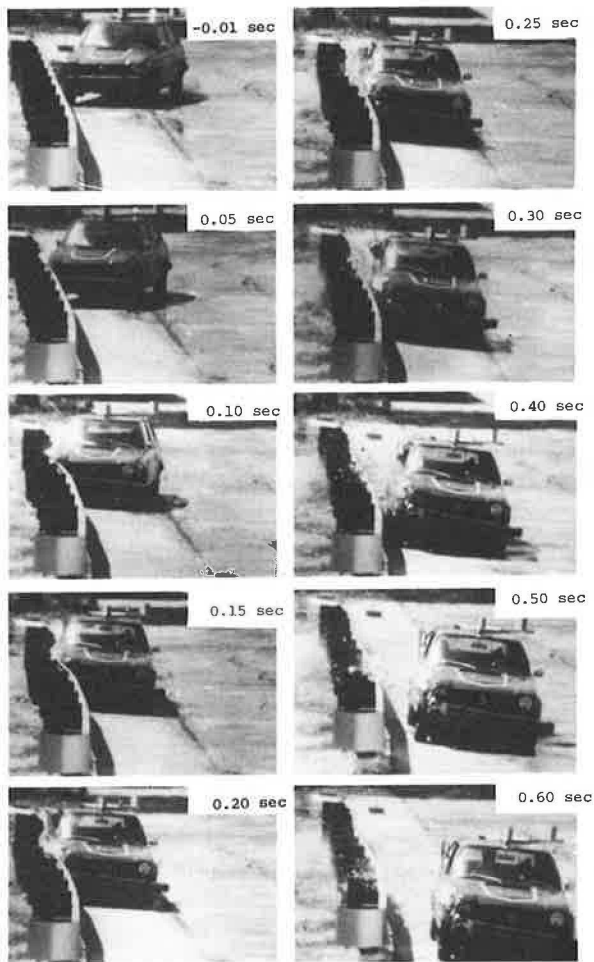
FIGURE 4 Sequential photographs, Test GR-1.

smoothly redirected with a maximum dynamic barrier deflection of 7.7 in. as shown in Figure 4. Damage to the barrier and vehicle was moderate, as shown in Figure 5. The vehicle was operable after coming off the rail, and the barrier was fully serviceable with small permanent deformations. Measured data indicated compliance with the recommended values of NCHRP Report 230.

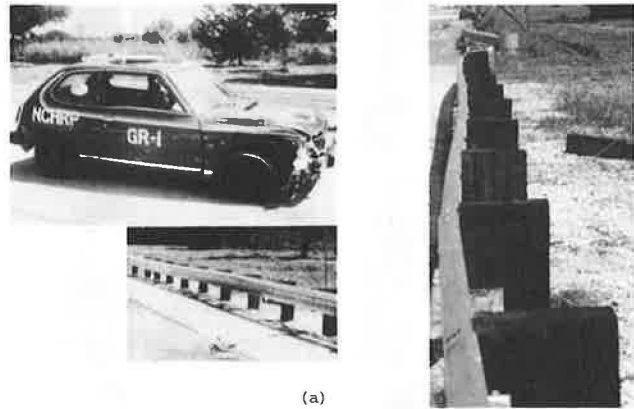
FIGURE 5 Barrier and vehicle damage after guardrail tests: (a) Test GR-1, System G4 (2W); (b) Test GR-2, System G9; (c) Test GR-3, System G2; (d) Test GR-4, System G3; (e) Test GR-5, System G1.

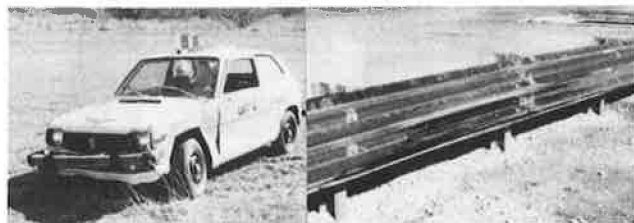
(b)

Test GR-2 evaluated System G9, a blocked-out thrie beam on steel posts. The test vehicle was smoothly redirected with a maximum dynamic barrier deflection of 6.0 in. as shown in Figure 6. Damage to the barrier and the vehicle was moderate, as shown in Figure 5. The vehicle was operable after the test with mostly sheet metal damage, and the barrier was fully serviceable with negligible permanent deformation. Test values indicated marginal compliance with the recommended occupant risk lateral impact velocity change (ΔV) values of NCHRP Report 230. The test was judged to be successful.

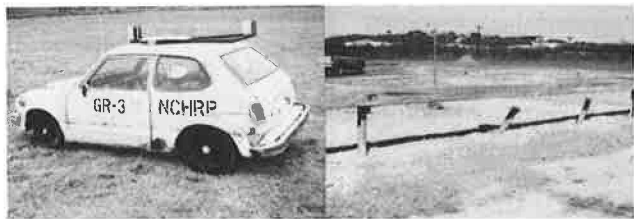
(c)

Test GR-3 evaluated System G2, a W-beam on weak steel posts. The vehicle was smoothly redirected with a maximum dynamic barrier deflection of 16.0 in. as shown in Figure 7. Contact with the posts caused the rear of the vehicle to yaw away from the barrier as it left the rail. There was sheet metal and left front wheel and tire damage to the vehicle resulting from contact with the posts. Damage to the barrier was sufficient to reduce the serviceability. One post was completely out of service. Measured test values indicated compliance with NCHRP Report 230.

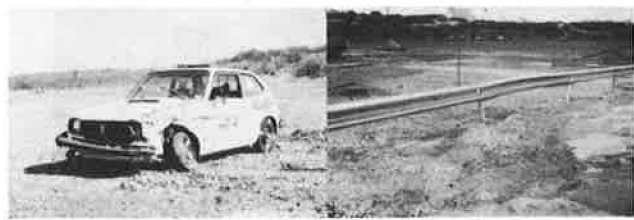
(d)

barrier downstream. There was considerable front wheel damage because of contact with the posts; sheet metal damage was extensive in the front quadrant. There was no permanent set in the rail although two posts were completely out of service and another was detached from the rail. Test values measured indicated compliance with NCHRP Report 230. Vehicle and barrier damage are shown in Figure 5.

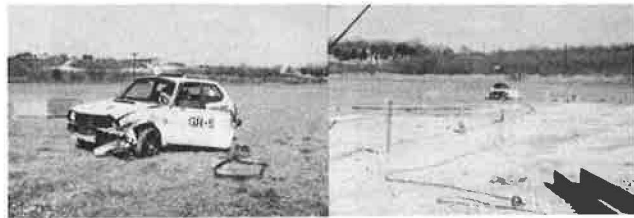
(e)

Test GR-5 evaluated System G1, a cable on weak steel posts. The vehicle was smoothly redirected with a maximum dynamic barrier deflection of 43.4 in. as shown in Figure 9. The rear of the vehicle yawed away from the barrier as the vehicle left the barrier; the vehicle then recontacted the barrier terminal, snagged, and rolled over. The breakaway feature of the terminal failed to release the cables from the anchorage. Vehicle damage before rollover was confined to sheet metal and the front wheel (because of post contact). Barrier damage was extensive with three posts out of service and cables lying on the ground as shown in Figure 5. Before the rollover the test would have been judged successful except for the 15-mph velocity change criterion of NCHRP Report 230 (1, Table 6, I). This value was slightly exceeded and a marginal pass was indicated.

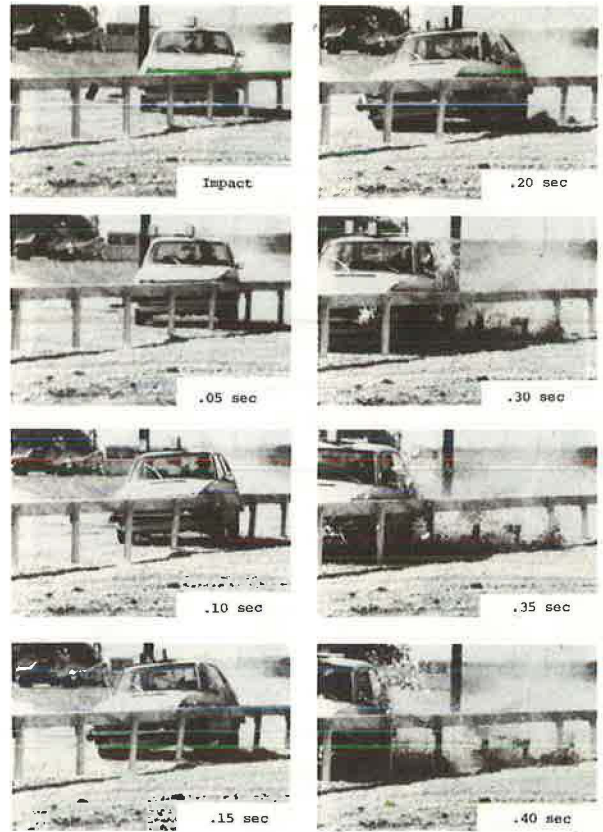
FIGURE 8 Sequential photographs, Test GR-4.

Test GR-4 evaluated System G3, a box beam on weak steel posts. The vehicle was smoothly redirected with a maximum dynamic barrier deflection of 6.4 in. as shown in Figure 8. Contact with the posts caused the rear of the vehicle to yaw away from the barrier as it left the rail; the vehicle recontacted the

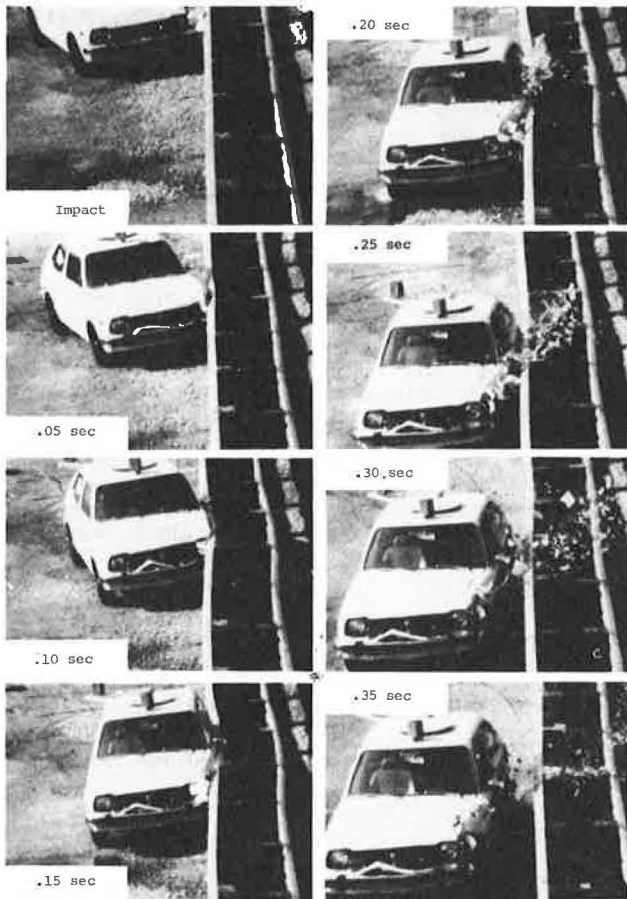
FIGURE 10. Sequential photographs, Test MB-1.

Test MB-1 evaluated System MB4W, a blocked-out W-beam on 8 x 8-in. timber posts with channel rub rail. The test vehicle was redirected with a maximum dynamic barrier deflection of 2.5 in. as shown in Figure 10. There was no evidence of vehicle contact with the rub rail. The vehicle sustained side sheet metal and

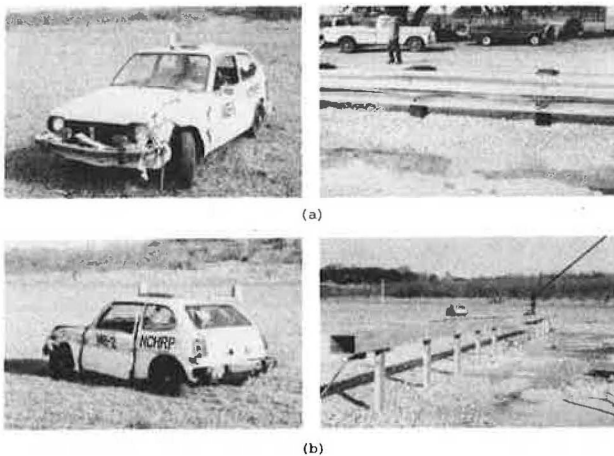
FIGURE 11 Barrier and vehicle damage after median-barrier tests: (a) Test MB-1, System MB4W; (b) Test MB-2, System MB3.

bumper damage; it was operable after the test. Damage to the barrier consisted of local beam deformation at two block-outs as shown in Figure 11. The barrier was fully serviceable with no measurable permanent deformation. On the basis of measured values, the test was judged to be successful although the occupant risk lateral ΔV slightly exceeded the NCHRP Report 230 value.

Test MB-2 evaluated the performance of System MB3, a box beam on weak steel posts. The test vehicle was redirected with a maximum dynamic barrier deflection of 7.0 in. as shown in Figure 12. Because of contact with the posts, the rear of the vehicle yawed away from the barrier as contact with the barrier was lost. Vehicle damage was limited to sheet metal and bumper; all tires remained inflated and the vehicle was operable after the test. Damage to the barrier consisted of three failed posts as shown in Figure 11; there was no permanent set in the rail. Measured values indicated full compliance with the recommendations of NCHRP Report 230.

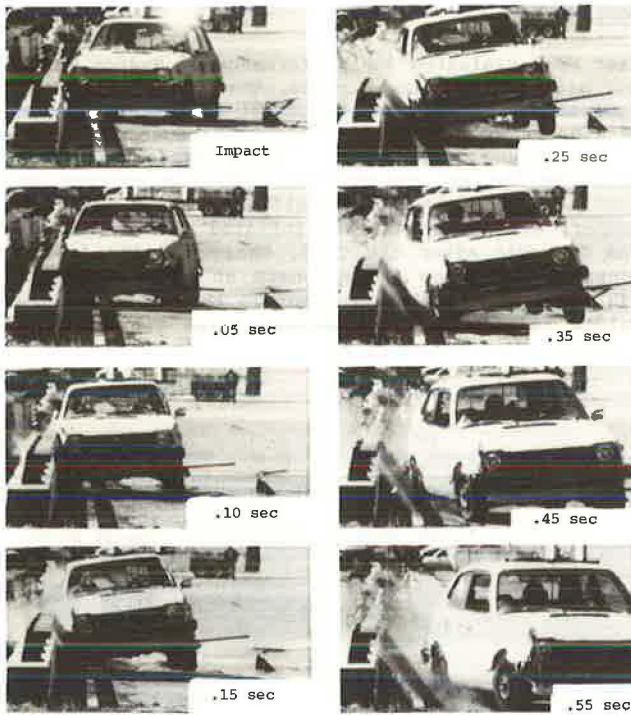
FIGURE 13 Sequential photographs, Test BR-1.

Test BR-1 evaluated System BR2, a California Type 9, featuring a steel rail mounted on a 15-in.-high parapet [this is 3 in. below the requirement of the AASHTO specifications (4)]. The vehicle was smoothly redirected with no barrier deflection, as shown in Figure 13. No snagging or wedging of the vehicle under the rail was noted. There was sheet metal deformation of the right front and side of the vehicle; the vehicle was operable after the test. No damage to the barrier was noted, as shown in Figure 14. Measured values indicated compliance with NCHRP Report 230.

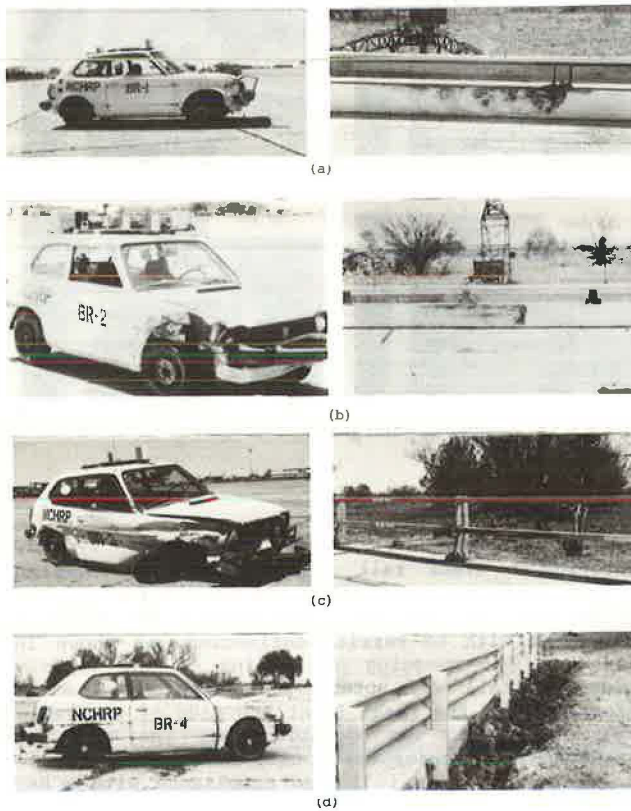
FIGURE 14 Barrier and vehicle damage after bridge-rail tests: (a) Test BR-1, System BR2; (b) Test BR-2, Texas Type T4; (c) Test BR-3, System BR3; (d) Test BR-4, Service Level 1 bridge rail.

vehicle was smoothly redirected with no barrier deflection and no evidence of snagging, as shown in Figure 15. The vehicle sustained front and side sheet metal damage. All tires remained inflated and the vehicle was considered operable after the test. No damage to the barrier was evident, as shown in Figure 14. Measured values indicated compliance with NCHRP Report 230.

Test BR-3 evaluated System BR3, a New York box beam bridge rail mounted on a flush deck. The test vehicle was redirected after significant wheel snagging had occurred on the first downstream post as shown in Figure 16. The redirected vehicle remained essentially parallel to the rail for a considerable distance. No barrier deflection was evident, as shown in Figure 14. There was extensive sheet metal damage to the vehicle. A-pillar, windshield, and the right A-frame were significantly damaged. No significant damage to the barrier system was evident. Measured values indicated compliance with NCHRP Report 230.

wheels of the vehicle dropped off and below the deck upper surface, they returned to the deck as the redirection continued. The vehicle damage was slight and confined to sheet metal. The vehicle was operable after the test. The barrier damage included one slightly deformed three-beam section and two posts that were detached from the base plate, as shown in Figure 14. Measured values indicated compliance with NCHRP Report 230.

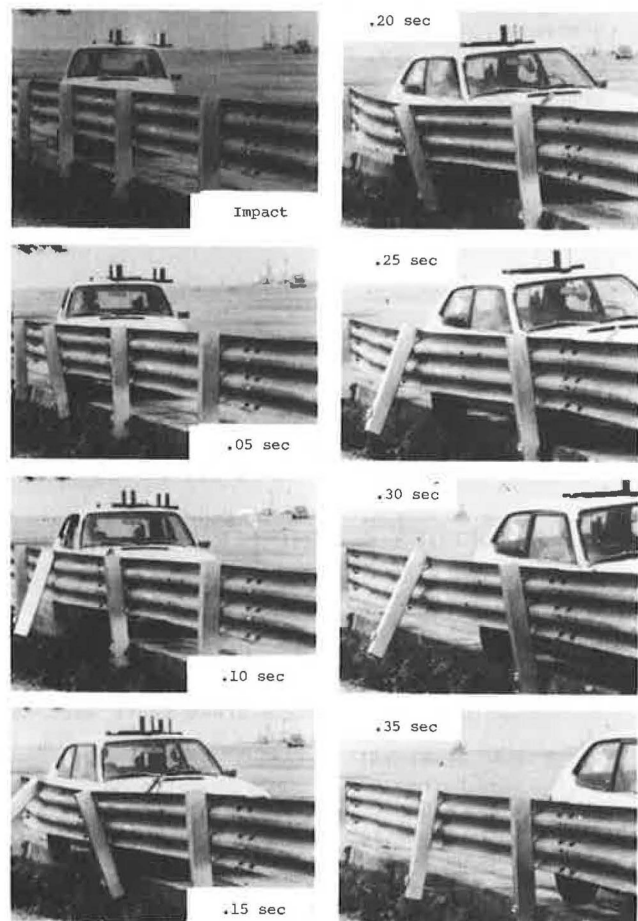
FIGURE 17 Sequential photographs, Test BR-4.

Test BR-4 evaluated the NCHRP Service Level 1 bridge-rail system, which uses a three beam mounted on breakaway steel posts. The test vehicle was smoothly redirected after a 17.2-in. maximum dynamic barrier deflection as shown in Figure 17. Although the right
