## Performance of a Thrie-Beam Steel-Post Bridge-Rail System

JAMES E. BRYDEN and RICHARD G. PHILLIPS

Twelve full-scale crash tests were performed to evaluate the performance of a thrie-beam bridge-rail system. The railing consisted of 10-gauge thrie-beam steel rail attached to W6x9 steel posts spaced at 8 ft 4 in. Posts were attached to the deck by using base plates and anchor bolts. The system was tested both with and without a 6-in. curb with the rail at a height of 33 in. (measured from the deck) for both designs. Also tested were transitions from W-beam guiderail on S3x5.7 posts to thrie-beam guiderail on W6x9 posts and from the thrie-beam guiderail to the bridge rail. Tests with both 4,500- and 1,800-lb vehicles showed that the railing system generally meets the recommended performance standards in NCHRP Report 230.

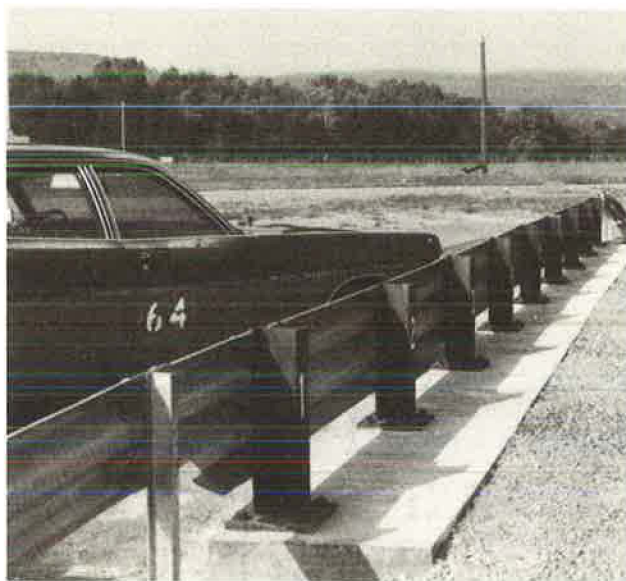
For the first test of the railing with curb, W6x25 steel posts were spaced at 6 ft 3 in. with the face of the thrie beam flush with the curb face (Figure 1). In Test 64, the 4,500-lb Dodge station wagon impacted 1.9 ft downstream from Post 3 at 60.1 mph and 26 degrees. It remained in contact with the barrier for 15.5 ft and was smoothly redirected at an 8-degree exit angle. After departure, the vehicle turned gradually toward the left, achieving an angle of 15 degrees with the barrier. Dynamic barrier deflection was limited to 1.1 ft. The vehicle remained stable throughout the impact, with maximum roll of 15 degrees (clockwise), maximum pitch of 5 degrees (front down), and maximum yaw of 21 degrees (counterclockwise). Peak 50-msec average decelera-

FIGURE 1 Thrie beam mounted on W6x25 post for Test 64.

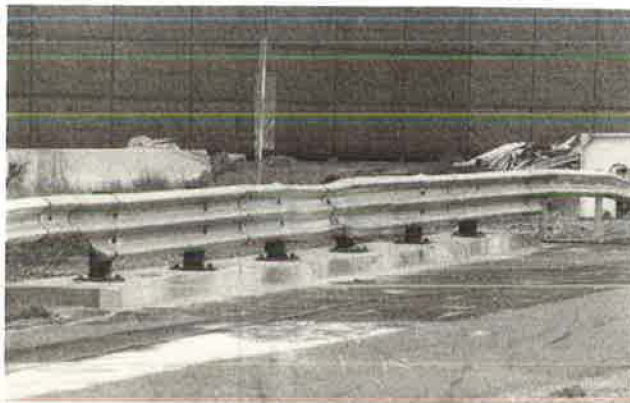
In Test 65, the 4,500-lb Plymouth station wagon impacted 0.8 ft downstream from Post 2 at 58.8 mph and 27 degrees. Contact distance was 17.4 ft, with maximum dynamic deflection of 1.4 ft. The vehicle was again smoothly redirected at a 16-degree exit angle, 4-degree maximum roll, 5-degree pitch, and no measurable yaw. Impact severity was similar to that of the previous test, with peak 50-msec average decelerations of 4.8 g longitudinal and 9.3 g lateral. Occupant impact velocities were 18.2 ft/sec longitudinal and 21.5 ft/sec lateral. Vehicle damage was again moderate and similar to that in Test 64. Barrier damage, however, was significantly less (Figure 2). Two rail sections were again damaged, as well as two posts. However, the posts were bent above the base plates, with no damage to the anchor bolts or curb. Repair thus required simply unbolting and replacing the two damaged posts and no curb repair or anchor-bolt replacement was needed.

FIGURE 2 Bridge-rail damage from Test 65.

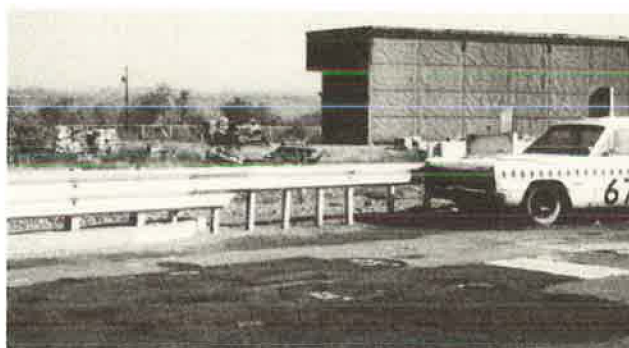
In Test 67, the 4,500-lb Plymouth station wagon impacted 8.75 ft upstream from the tapered section at 58.8 mph and 25 degrees. Initially, the vehicle had started to redirect until it encountered the tapered transition. At that point, the right front wheel and suspension snagged against the end of the lower thrie-beam corrugation. Dynamic deflection up

FIGURE 3 W-beam-to-thrie-beam transition evaluated in Test 67.

to that point was about 4 ft, but after the snag the longitudinal load was so great that the W-beam broke in tension at the connection to the tapered section. The W-beam section, tapered transition, and thrie-beam approach section all disconnected from the posts as they were knocked down by the vehicle and rotated back about the first bridge post. The vehicle came to rest against the first bridge post (Figure 4). Peak 50-msec average decelerations were 9.9 g longitudinal and 4.4 g lateral, with occupant impact velocities of 30.8 ft/sec longitudinal and 14.8 ft/sec lateral. The vehicle was heavily damaged, and the entire transition railing was totally destroyed. In addition, the curb was broken and displaced by the impact in the transition area, and the first two bridge posts were bent. Tensile tests were performed on two W-beam samples after the failure. Yield strengths were 59,000 and 62,500 psi with elongations of 23 and 20 percent, both exceeding the specified minimums of 50,000 psi and 12 percent.

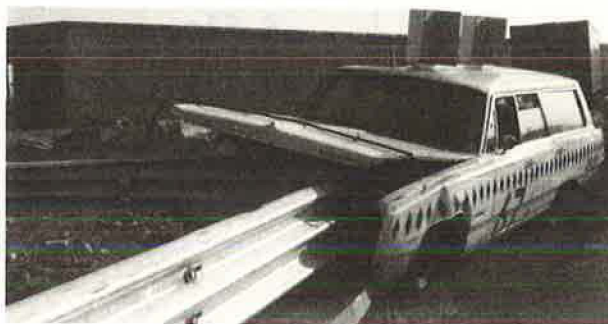
FIGURE 4 Results of Test 67.

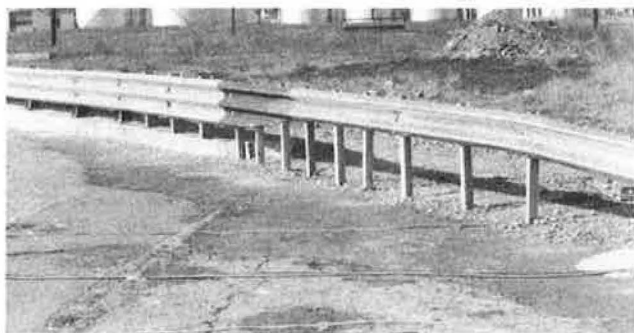
For Test 68, the length of the tapered transition was increased to 6 ft 3 in. between mounting bolt holes, with the lower corrugation taper increased to 3 ft (Figure 5). Light posts were again used behind the transition piece spaced at 2 ft 1 in. The increased taper length was intended to reduce the severe snag encountered in Test 67, but it was not successful. The 4,500-lb Ford station wagon impacted at 59.5 mph and 24 degrees 4.6 ft upstream from the tapered section. The vehicle again snagged on the end of the lower corrugation after beginning to redirect. The front wheel and suspension were again trapped between the bottom of the thrie beam and the top of the curb, and the vehicle came to rest against the first bridge post. The rail did not break, but all the posts in the transition area were bent over, and the rail was deflected 2.5 ft. The vehicle traveled 23.4 ft from impact to rest. Peak 50-msec average decelerations were 9.2 g longitudinal and 4.2 g lateral. Occupant impact velocities were 25.6

FIGURE 5 W-beam-to-thrie-beam transition evaluated in Test 68.

ft/sec longitudinal and 14.6 ft/sec lateral. The front and right side of the vehicle were heavily damaged.

After Test 68, it became clear that the termination of the lower corrugation presented an insurmountable snag point, and the entire transition was redesigned to include the symmetrical tapered section shown in Figure 6. In this section the middle corrugation drops out and the upper and lower ones continue. This has been adopted as a standard by the American Road and Transportation Builders Association (ARTBA) (8). Because the 8-in. decrease in section depth was split equally between top and bottom, a total height adjustment of 4 in. was required in the top-of-barrier elevation. Sufficient tolerance in the splice bolt holes permitted the tapered section to be tipped up about 1 in., and the remaining 3 in. was gained by lowering the top of the W-beam over one section length. Standard height to the top of the W-beam has since been decreased to 30 in., thus simplifying this connection. As in previous tests, S3x5.7 posts were used with the W-beam and at the beginning of the 6-ft 3-in. tapered section. Mid-length and at the downstream end of the taper, W6x9 posts were substituted to stiffen the transition, and 6-in.-deep blockouts were added to reduce contact with the posts and help maintain rail height during deflection. Finally, the vertical curb radius was replaced with a ramped curb end that terminated the curb 6 ft upstream from the bridge.

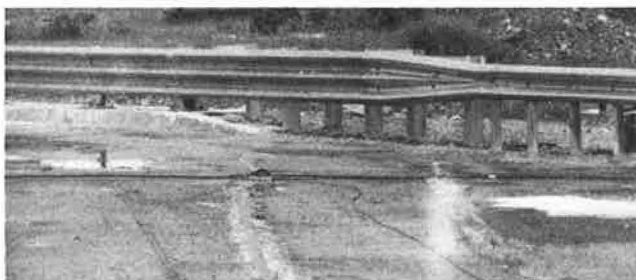
FIGURE 6 Symmetrical transition evaluated in Test 69.

In Test 69, the 4,600-lb Cadillac sedan impacted at 54.4 mph and 26 degrees 6.8 ft upstream from the tapered section. This time, the vehicle was smoothly redirected at a 17-degree angle. However, some contact with the heavy posts did occur in spite of the 6-in. blockouts, and exit speed was only 33.4 mph on the basis of accelerometer data. Maximum dynamic deflection was 2.5 ft over the 24.3-ft contact distance. The vehicle turned back toward the rail after exiting and came to rest against the downstream terminal. Maximum roll was 6 degrees, pitch was 4

degrees, and no yaw was observed. Peak 50-msec average decelerations were 4.5 g longitudinal and 6.0 g lateral. Occupant impact velocities were 20.8 ft/sec longitudinal and 13.9 ft/sec lateral. Damage to the vehicle was limited to the right front corner of the grill and bumper, right front fender, and right front wheel. Moderate barrier damage included three light posts and four heavy posts partially bent over, as well as one W-beam, one thrie beam, and the tapered section.

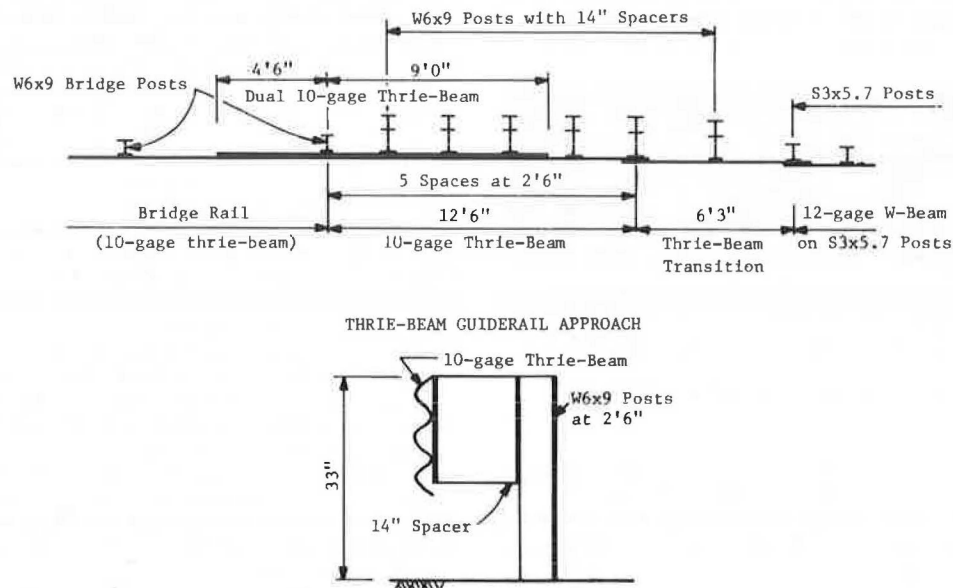
Even if the blockout collapse had not contributed to the snag on the unblocked post, it appeared that with a 1.5-ft deflection, the vehicle would have pocketed at the first bridge post. Thus, it was necessary gradually to increase barrier stiffness in the bridge-approach transition. To accomplish this, a backup section of 10-gauge thrie beam was added behind the thrie-beam approach rail, extending 4.5 ft onto the bridge from the first bridge post and 9 ft upstream into the approach section. Full 12-bolt splices were used at each end to attach it to the front thrie-beam section. The notches in the post blockout were eliminated, and post spacing behind the approach thrie beam was decreased to 2.5 ft. Finally, the last guiderail post at the upper end of the curb ramp was eliminated, because fill conditions at the bridge end would not normally permit it to be installed behind the curb with a blockout. As seen in the previous test, installation on the curb without a blockout presented a potential snag point. Details are shown in Figure 7.

FIGURE 7 Details of final transition design evaluated in Test 73.

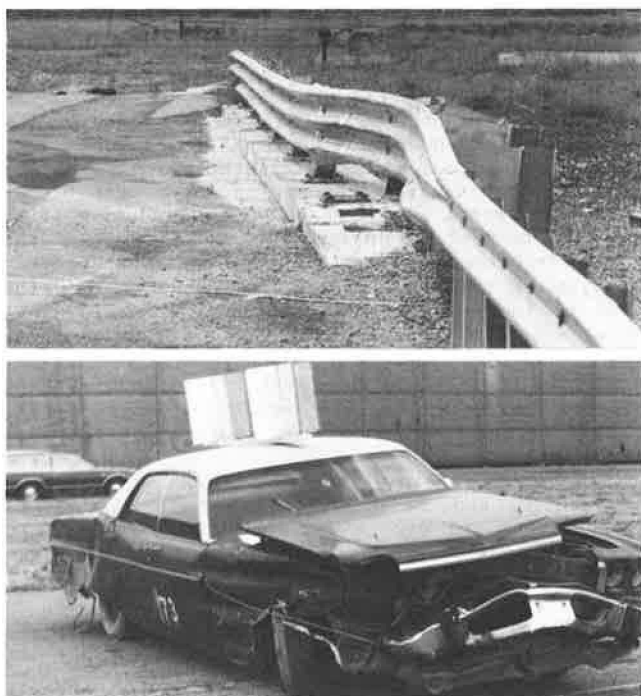
In Test 73, the 4,500-lb Plymouth sedan impacted at 56.5 mph and 29 degrees 3 ft downstream from the tapered section, 9.5 ft from the first bridge post. This time, vehicle redirection was achieved at a 16-degree exit angle after 16 ft of barrier contact and 15-in. dynamic deflection. After exiting, the vehicle turned back toward the rail. Maximum roll was 9 degrees, pitch was 4 degrees, and no yaw was observed. Peak 50-msec average decelerations were 5.2 g longitudinal and 8.9 g lateral, with corresponding occupant impact velocities of 22.0 and 20.5 ft/sec. The right front corner of the vehicle was extensively damaged, but there was no damage to the passenger compartment. The rail was also extensively damaged, with the posts behind the approach thrie beam pushed back. In addition, the last two guiderail posts twisted 90 degrees, permitting the rail to collapse against the side of the post. Vehicle and barrier damage are shown in Figure 8. Use of heavier bolts to attach the rail to the blockout may have prevented this twisting. In addition, the welds

FIGURE 8 Vehicle and barrier after impact on guiderail-bridge-rail transition, Test 73.

attaching the first bridge rail to the anchor plate sheared off, permitting that post to deflect back about 1 ft. The welds at the second post cracked but did not separate. There was some concern that this failure at the first post may have helped to reduce the pocketing experienced in the previous test. However, it appears that pocketing would have simply occurred at the second bridge post if deflection of the approach rail had been excessive. It thus appears that the backup rail section and closer post spacing increased transition stiffness enough to prevent pocketing. Performance of the entire bridge-approach rail was now considered satisfactory with both small and large cars.

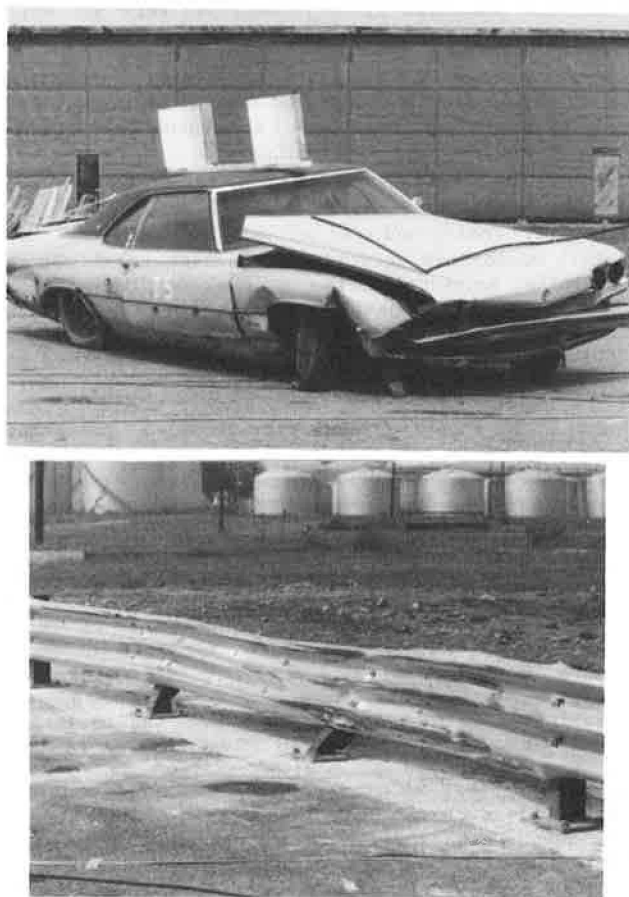
In Test 75, the final test in this series, the 4,500-lb Buick sedan impacted at 59.3 mph and 29 degrees at the second bridge post. After 24.7 ft of contact and 21-in. dynamic deflection, the vehicle exited at 14 degrees with a maximum roll of -36 degrees (away from the barrier) and -8-degree pitch, but no measurable yaw. Peak 50-msec average decelerations were 6.1 g longitudinal and 7.8 g lateral, with corresponding occupant impact velocities of 22.5 and 18.0 ft/sec. Although the vehicle was redirected, it is apparent that this test, which somewhat exceeded the standard 25-degree impact angle, was at the upper limit of performance for this barrier. Post 3 (the first post past impact) was bent back at the base plate, with a permanent deflection of 20 in. at the top of the post. The square plate washers prevented the rail attachment bolts from pulling through, and the rail also bent back and formed a partial ramp. The vehicle was thus pitched up on redirection, with all four wheels in the air as it left the rail. Two rail sections and two posts were damaged, and extensive damage was sustained by the right front corner of the vehicle (Figure 9).

FIGURE 9 Vehicle and barrier after impact on bridge rail, Test 75.
