Emergency Opening System for Authorized Vehicle Lanes

JAMES R. MORGAN, JOHN W. STRYBOS, HAYES E. ROSS, Jr., and JAMES G. DARDEN III

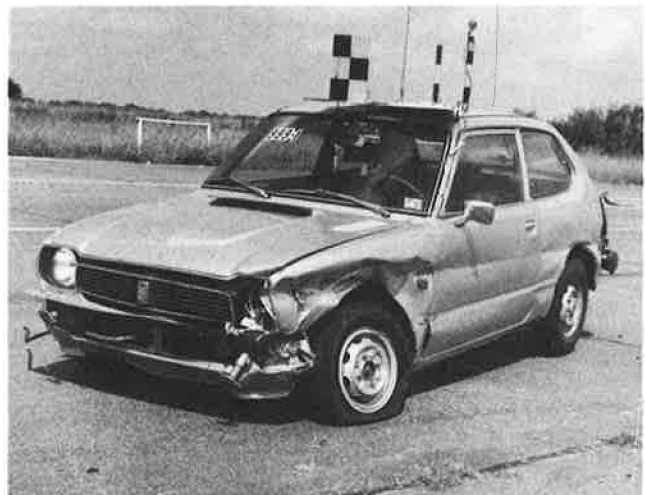
FIGURE 6 Test vehicle after Test 1.

The test vehicle and installation after the test are shown in Figures 6 and 7. Damage to the vehicle occurred when the W-beam corrugation dragged the front bumper down and the left front tire snagged on one corner of the downstream CMB section. The vehicle damage consisted of sheet metal damage to the left front fender, a flattened left front tire, and a left front tire rim that was bent from the impact with the CMB. The EOS was damaged by having the paint scraped off the W-beam at the impact point and some surface cracking in the downstream end of the CMB. The only repair to the gate was repainting the W-beam at the impact point. The EOS was still operational after this test, which was considered a success based on the barrier safety performance and the relatively light damage incurred by the system.

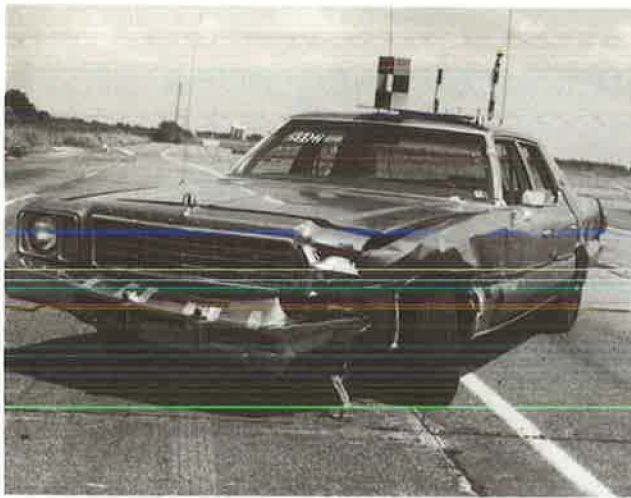
FIGURE 9 Test vehicle after Test 2.

The damage incurred by the test vehicle and installation is shown in Figures 9 and 10. The vehicle sustained sheet metal damage to the left front fender. The EOS damage included the W-beam on the vehicle impact side of the gate, which had to be replaced, and noticeable flexural cracking in the CMB sections. The permanent beam deflection was 1.63 in. (4.1 cm). The gate could still be opened after this test, which was considered very successful based on the safety performance of the system.

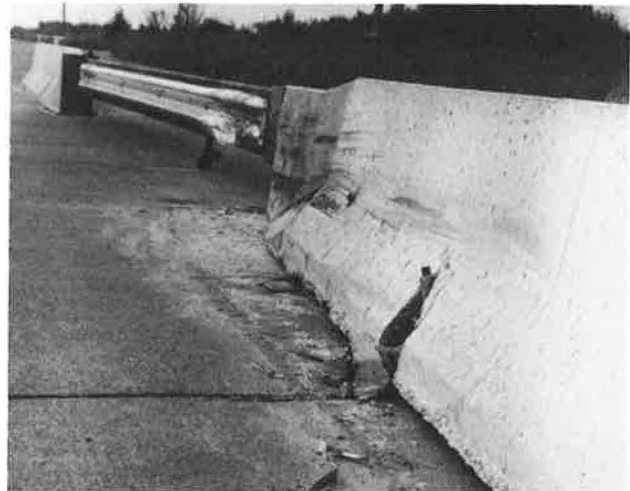
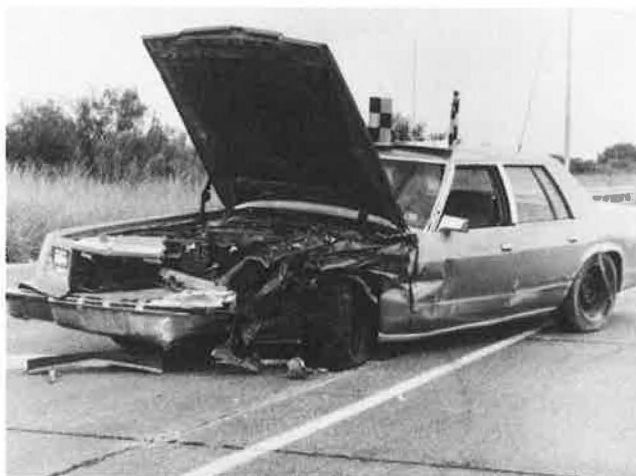
FIGURE 13 Test installation after Test 3.

Damage incurred by the vehicle and test installation for Test 3 is shown in Figures 12 and 13. The test vehicle was severely damaged in this test when it snagged on the downstream CMB section. The permanent deflection of the gate was 23.88 in. (60.66 cm). The gate section of the EOS sustained damage to the W-beam on the impact side of the tubes, which had to be replaced. The downstream CMB section was severely damaged because of flexural cracking and failure of one of the anchor rods in the concrete. The upstream CMB section was also severely damaged because of flexural cracking. In addition, the gate could not be opened because the metal tubes were binding about the pin connections. However, this test was still considered a success because of the barrier's safety performance and because the vehicle did not penetrate the barrier. The damage to the barrier would be minimized if proper anchorage were achieved, and although the

forces on the vehicle would increase, they should not exceed those of a CMB.

2. To improve postimpact operation of the system, an improved anchorage system is being implemented for the CMB (which will eliminate binding of the gate after a crash and also reduce damage to the CMB);
