In-Track Performance of Geotextiles at Caldwell, Texas

S. M. CHRISMER and G. RICHARDSON

ABSTRACT

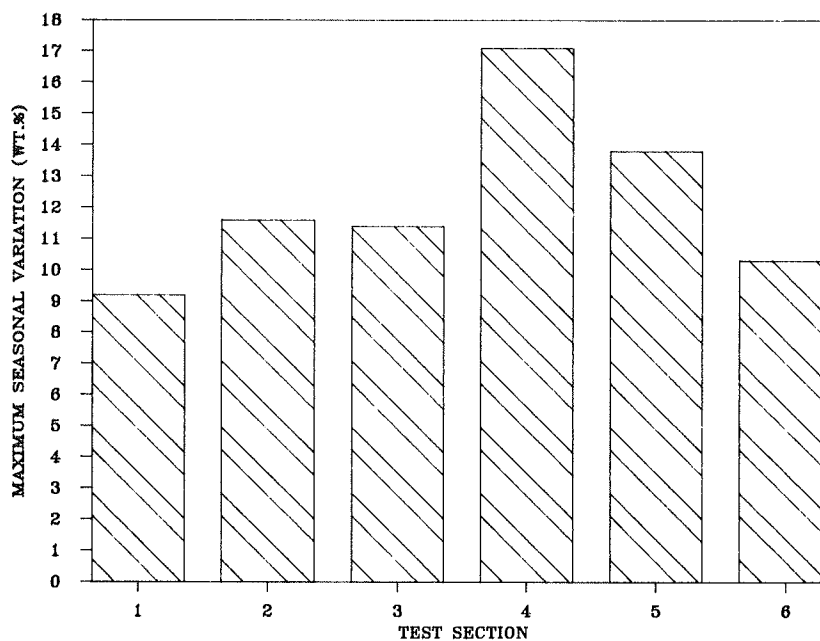
tance transducers, and (c) electrical capacitance transducers. The last two methods (those using instrumentation) gave values of moisture content that were close to those of the field corings. However, the instrumentation responses were flatter and did not show the increase resulting from the rainy months of March through June as did the samples recovered from the field. Because the water content measurements from the manual corings are believed to be the most reliable, only the data from the field corings will be given. Soil samples were obtained every 6 in. to a depth of 24 in. at the middle of each test section. Figure 3 shows the variation of subgrade water content in the test sections over approximately 1.5 yr. Figure 4 shows the test section differences between the seasonal maximum and minimum soil moistures that occurred during the 17 months.

FIGURE 3 Maximum seasonal variations in soil moisture content from July 1978 to March 1980 for Sections 1-6.

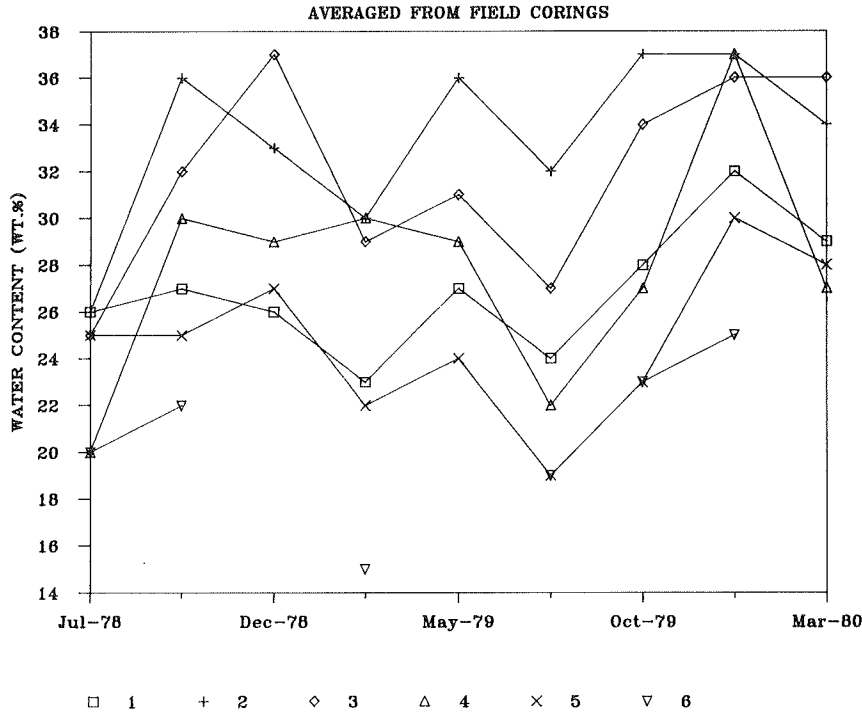
FIGURE 4 Variations in average soil water content with time in Sections 1-6.

tion of subgrade moisture content in Section 5 was not significantly greater than that of the average of all of the fabric sections (see Figure 4).

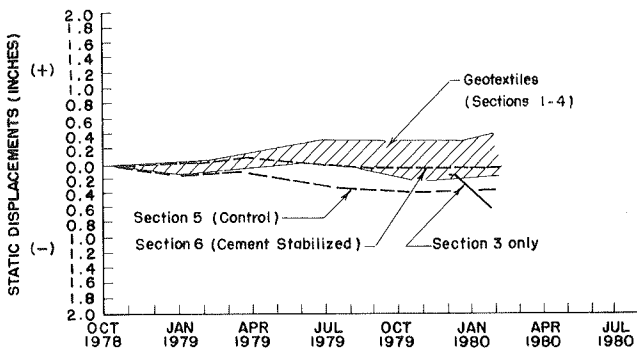
FIGURE 5 Extensometer data showing static soil displacement variations with time in Sections 1-6.

rise and fall of the interface. Section 5, the control section, clearly experienced greater vertical settlements than the remaining sections. Note also that the vertical movement of Section 3 began to accelerate rapidly during December 1979. The failure of Section 3 occurred in January 1980, as shown in Figure 5.

The control section did experience somewhat more ballast/soil interface settlement than the other sections (Figure 5). However, this most likely is due to ballast penetration into the subgrade in Section 5. Therefore, rather than a reinforcement function, the decreased settlement in the fabric sections is probably attributable to the separation function of geotextiles.

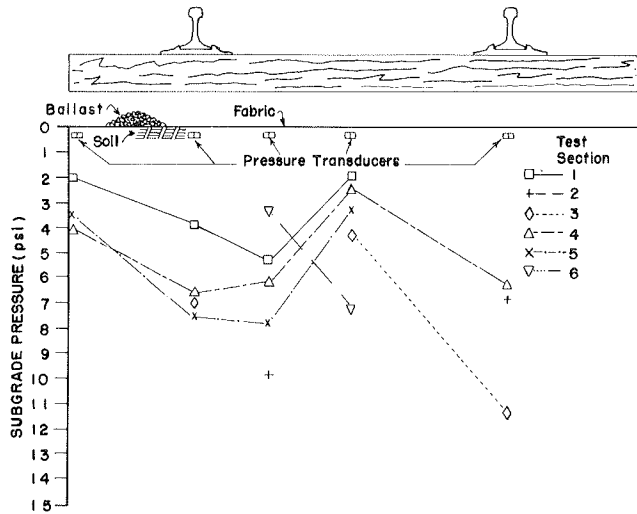
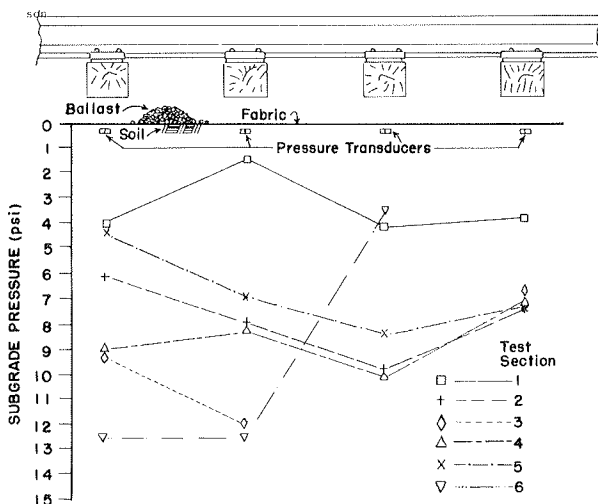
FIGURE 6 Subgrade pressures under one tie in each of Sections 1-6.

FIGURE 7 Subgrade pressures under four ties in each of Sections 1-6.

The transverse and longitudinal earth pressure measurements showed approximately the same pressure profiles for each site. No significant differences could be observed between the pressure profiles in the fabric sections and those in the control section.

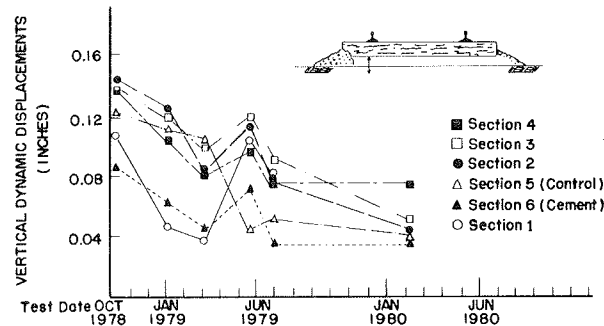
section, which were installed under the rail-tie seats. The mean values obtained under loading are plotted in Figure 8 for the respective test dates. The elastic deformations measured in Sections 2-4, and 6 showed the same climatic variations, with Section 6 having consistently smaller amplitudes. General weather data obtained from Caldwell, Texas, showed that March through June were months that had significant amounts of rainfall, which would explain the increase in dynamic displacements in all but Section 5.

FIGURE 8 Variations in mean values of elastic deformation under load at the ballast/subgrade interface with time, for Sections 1-6.

The anomalous behavior of Section 5 during the wet season was shown by decreasing elastic deformation, while the other sections were experiencing increasing deformations. Section 1 also had anomalous behavior, as evidenced by the wide range in deformation with the seasons. The soil moisture content data did not indicate that the soil in Section 1 experienced greater variation of moisture content; the moisture content in Section 1 was the most uniform during this period.

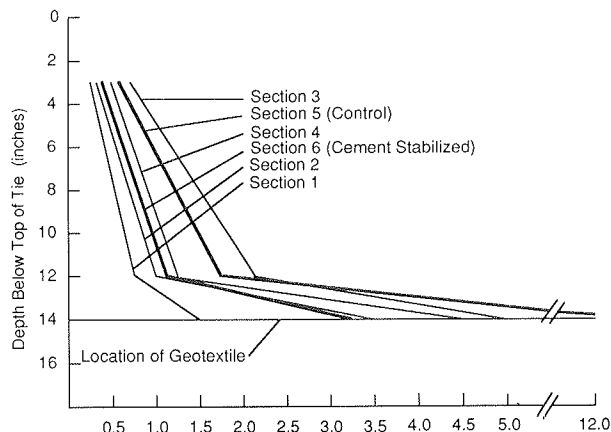
Mean values were established for the percentage of contamination versus depth data from each test section, and are presented in Figure 9. In the ballast above the level of 12 in. from the top of the tie, only Sections 3 and 5 had contamination in excess of that measured in Section 6 (the "control" section in this case). (Note the contamination of the ballast just above the fabric. Section 5, with no fabric, had significantly more contamination at this level than the remaining sections, and only Sections 3 and 4 of the fabric sections had contamination greater than Section 6.)

FIGURE 9 Percentage of fines passing a No. 200 sieve versus sampling depth in Sections 1-6.

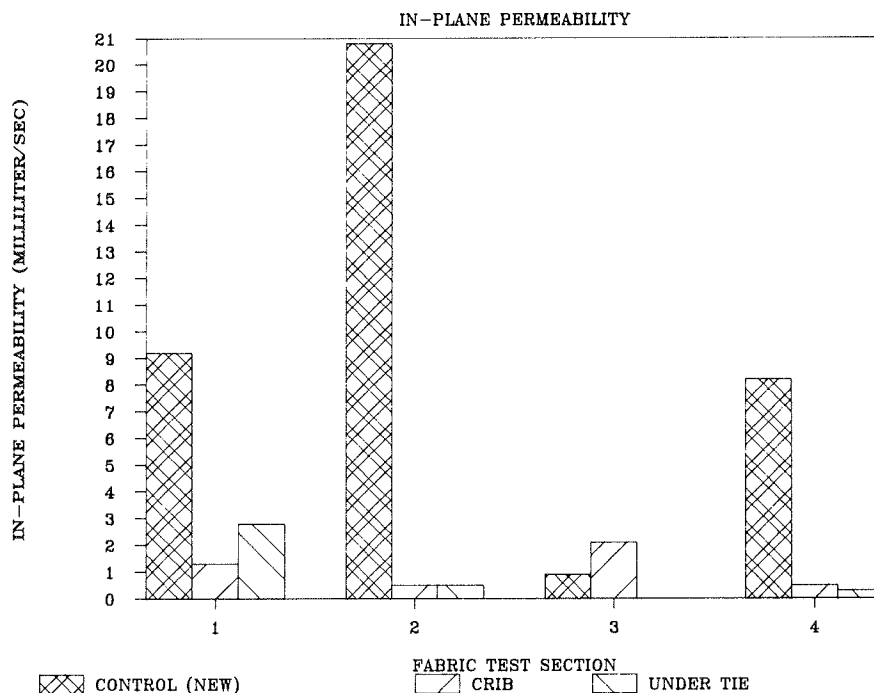
FIGURE 10 In-plane permeability of geotextiles recovered from the field and tested at a pressure of 3.4 psi, applied normal to the surface.

after removal from the field. As shown, the in-plane permeability of the fabric samples after 17 months in track have decreased by as much as a factor of 100. The fabric in Section 1 retained the greatest percentage of its initial in-plane permeability. The test performed on the fabric from Section 3 appeared to show a gain in permeability in the field; however, this test was reported by the technician to be in error. The fabric in Section 3 is known to have clogged more severely in the field than any of the other fabrics based on the observed performance in the field.

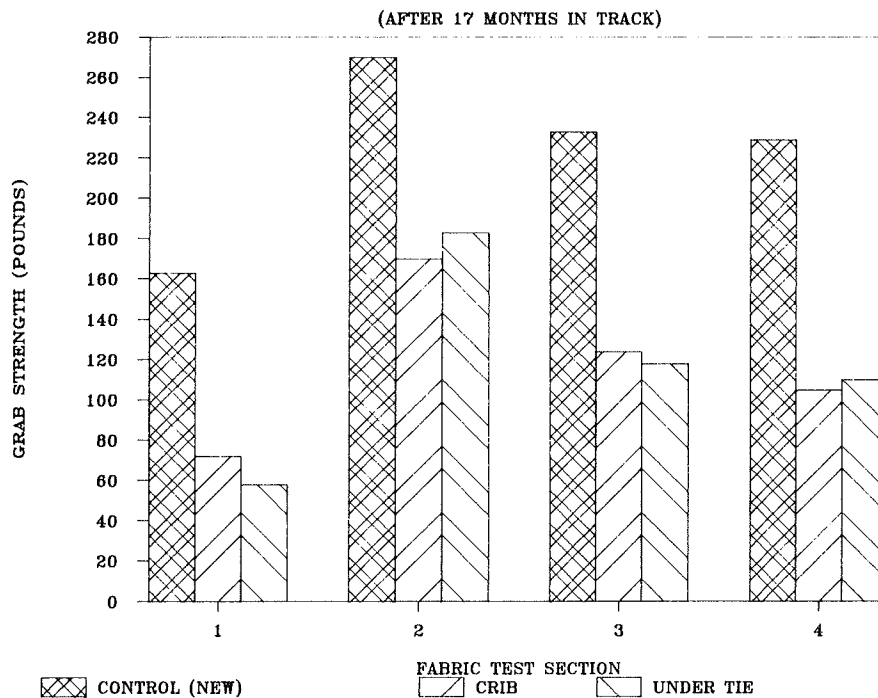
The grab strength test was used to determine the tensile resistance to tearing, when subjected to a slowly increasing load applied to either end of a standard sized strip. Fabric in a soiled and wet condition was tested in this manner; the results are shown in Figure 11 for samples recovered from under the tie and in the crib area. The fabric with the largest loss of strength, as compared to a new control sample, was Fabric 1, which exhibited a 56 percent decrease. Fabric 2 had the least amount of strength loss, with only a 35 percent decrease.

FIGURE 11 Grab strength of geotextiles recovered from the field and tested under wet and soiled conditions (after 17 months in track).
