# Fish Passage Through Poplar Grove Creek Culvert, Alaska

MICHAEL D. TRAVIS and TIMOTHY TILSWORTH

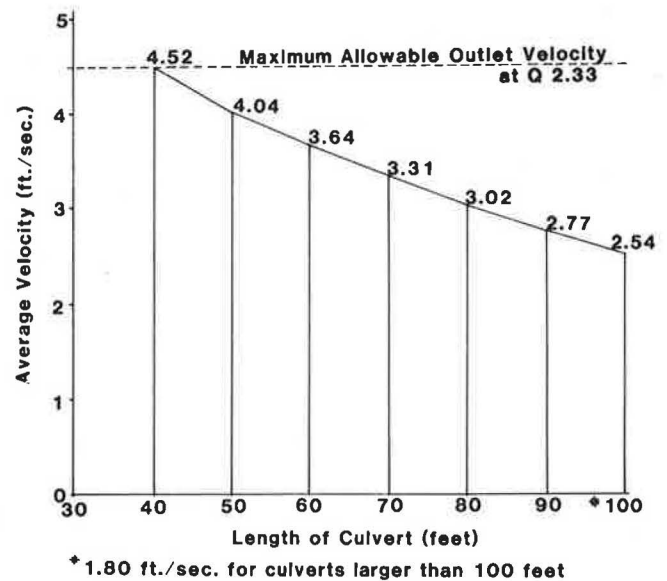
FIGURE 1 Alaska Department of Fish and Game fish passage criteria.

In order to facilitate fish passage, the ADF&G has set maximum water velocities for varying culvert lengths that can be attained during a mean annual flood discharge ( $Q_{2.33}$ ) (Figure 1). These criteria were derived from a study performed by MacPhee and Watts in 1976 (1). They analyzed the swimming performance of Arctic grayling through various outlet

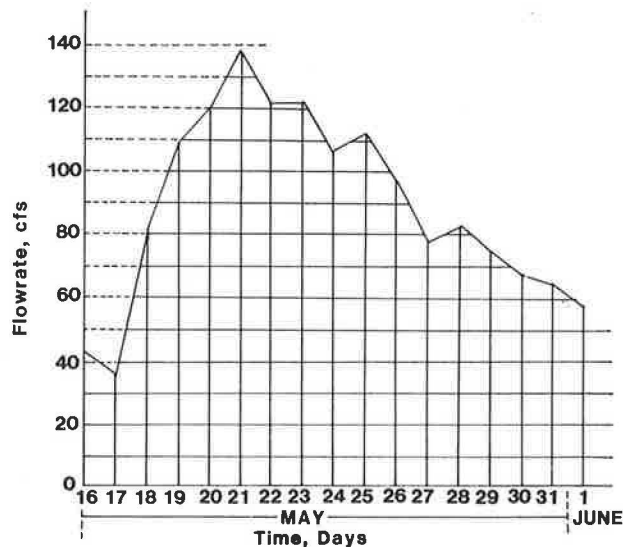
FIGURE 3 Daily discharge rates for 1985 (cfs).

Figure 3 shows the daily discharge rates through the culvert. The flow peaked at 139.1 ft<sup>3</sup>/sec (cfs) on May 21. Grayling first were observed at the highway culvert on May 23 but were held in the scour pool for 8 days because of excessive culvert outlet velocities. Fish arrival at the culvert corresponded to the decreasing side of the hydrograph.

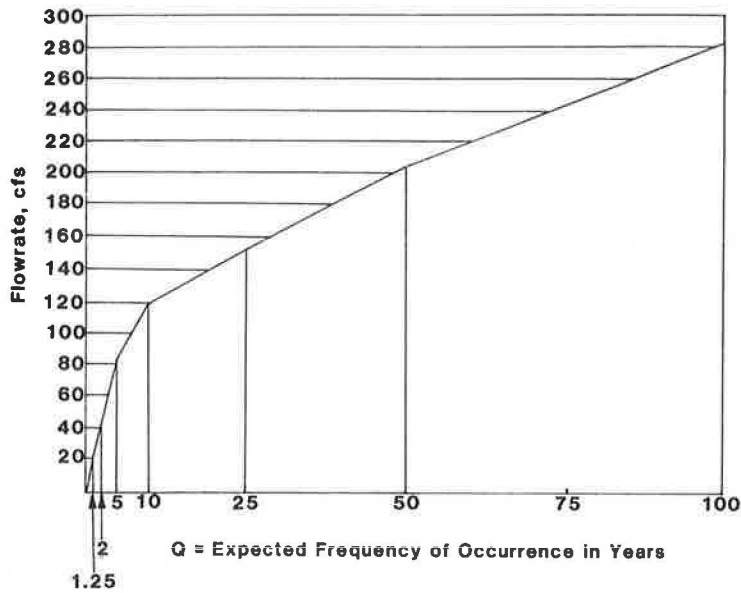
FIGURE 4 Calculated magnitude and frequency of peak discharge.

quency of peak discharges for Poplar Grove Creek. By comparing the peak discharge that occurred during the study period with the graph, 139.1 cfs should occur about every 20 years (Q<sub>20</sub>). Therefore, the study took place during an unusually high peak discharge.

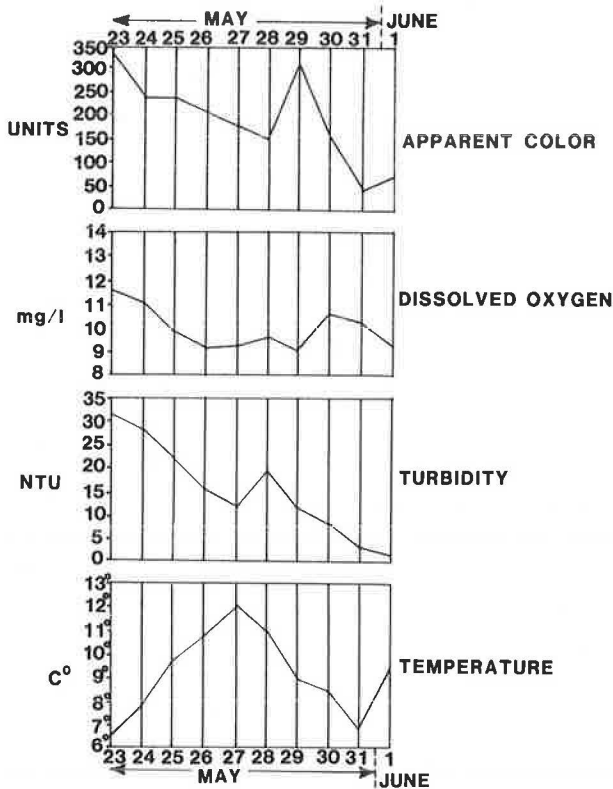
FIGURE 5 Daily water quality parameters.

Figure 5 shows the water quality in the scour pool during the study. The maximum daily water temperatures ranged from 6.6°C to 12.0°C, and apparent color fluctuated from 40 to 320 units. Turbidity ranged from 3.1 Nephelometric Turbidity Units (NTU) to 32 NTU. Dissolved oxygen varied from 9.0 mg/l to 11.2 mg/l.

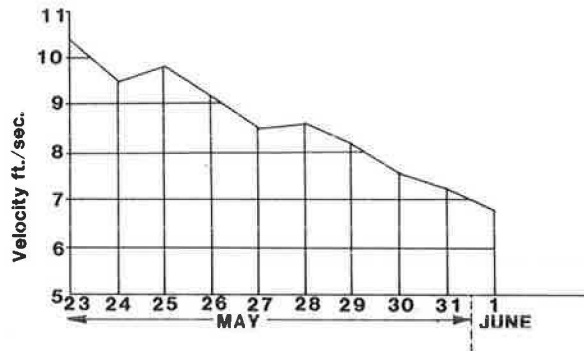
FIGURE 6 Daily outlet velocities.

Daily average culvert outlet velocities ranged from 6.9 to 10.3 fps (Figure 6). At 1:35 p.m. on May 26, one ± 9-in. grayling was observed exiting the upstream end of the culvert. The water temperature was approximately 10.3°C, and the outlet velocity was 9.2 fps. Because of abnormally high flows, the investigating crew was unable to determine how many fish negotiated the culvert during these high-flow and high-velocity conditions.
