Field Performance of Corrugated Polyethylene Pipe Culverts in Ohio

JOHN O. HURD

A total of 172 corrugated polyethylene pipe culverts 12 through 24 in. in diameter and ranging in age from 0 to 4 years were inspected in Ohio in the summer of 1985. Data pertinent to structural performance and durability of the culverts were collected at each site. These data were pipe diameter, cover over the pipe, type of backfill, culvert age, average daily traffic, pipe deflection, flow depth and velocity, bed load depth and size, water pH, and pipe slope. No culvert showed any signs of wear even at sites with abrasive flow. One 4-year-old site had constant low pH dry weather flow with a bed load of large cobbles. The incidence of large maximum deflections or wall flattening and buckling, or both, was significantly greater for 12- and 15-in. pipes than for 18- and 24-in. pipes. The only instances of wall flattening or buckling were limited to the 12- and 15-in. culverts. Large deflections, flattening, and buckling were generally due to bending of the pipe wall in both the circumferential and longitudinal directions. The greater flexibility and thinner walls of the 12- and 15-in. culverts were the

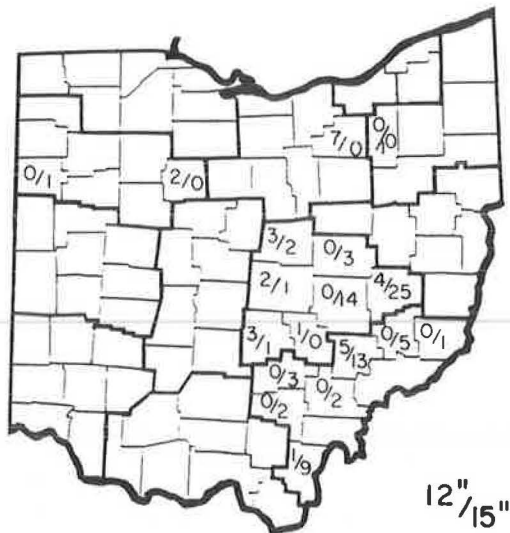
A total of 172 culverts were inspected in 21 counties in Ohio. Twenty-eight 12-in., ninety-two 15-in., thirty-one 18-in., and twenty-one 24-in. culverts were inspected. The number of culverts of each specific size in each county is shown in Figures 1 and 2.

FIGURE 1 12- and 15-in. corrugated polyethylene pipe culverts in Ohio.

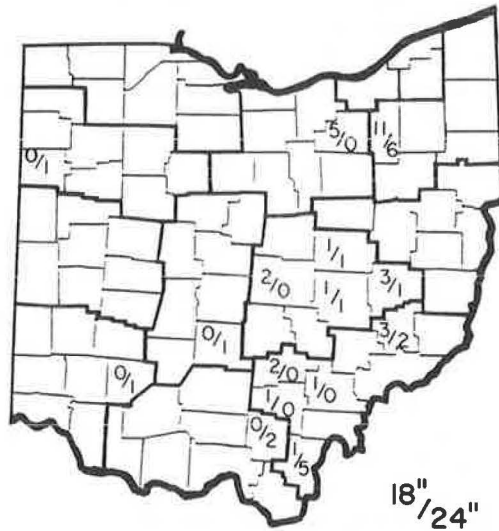
FIGURE 2 18- and 24-in. corrugated polyethylene pipe culverts in Ohio.

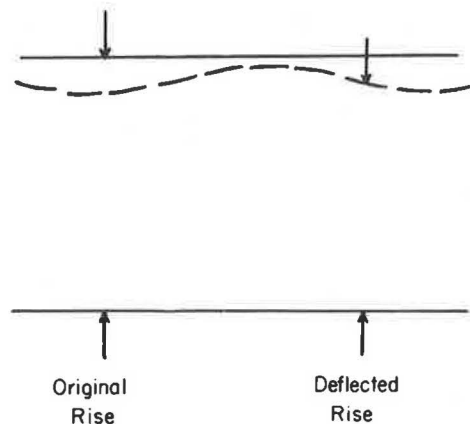
Significant deflection to the point of wall flattening or buckling through a significant portion of the culvert length was observed in four culverts. Flattening occurred at deflections exceeding approximately 15 percent. Buckling occurred at deflections exceeding 25 percent. Where significant deflection occurred throughout the pipe length, it was not constant but occurred in waves as shown in Figure 6. Large deflections, flattening, and buckling appeared in general to be caused by bending of the pipe wall inward in both the circumferential and longitudinal directions. In three cases flattening of the wall was more prevalent in the invert than on the crown

FIGURE 6 Varying deflection observed in corrugated polyethylene pipe culverts.

of the culvert, which suggests poor foundation. Two of the culverts had buckled to the point of being cracked and needing repair. Apparently the internal corrugation crests had been stressed by bending moment to the point of tearing apart.

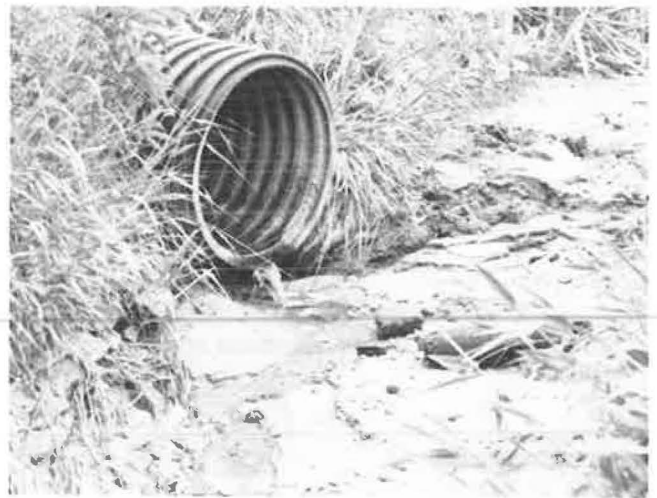
Although no estimate of service life could be made because of the small age range of the culverts studied, an indication of the durability of corrugated polyethylene pipe can be obtained by looking at the worst-case installation. A 24-in. corrugated polyethylene pipe culvert was installed at NOB-145-3.58 in 1981. This culvert is shown in Figure 7. There is constant acidic dry weather flow at the site, and storm flows carry a bed load of abrasive cobbles. The pile of sediment on the bank of the outlet channel shown in Figure 8 is indicative of the force generated by the storm water flowing through the culvert. After 4 years this culvert is in good condition. The invert of the polymeric-coated galvanized corrugated steel pipe previously at this location completely deteriorated in less than 1 year.

FIGURE 7 24-in. corrugated polyethylene pipe culvert at NOB-145-3.58: low pH and severely abrasive flow.

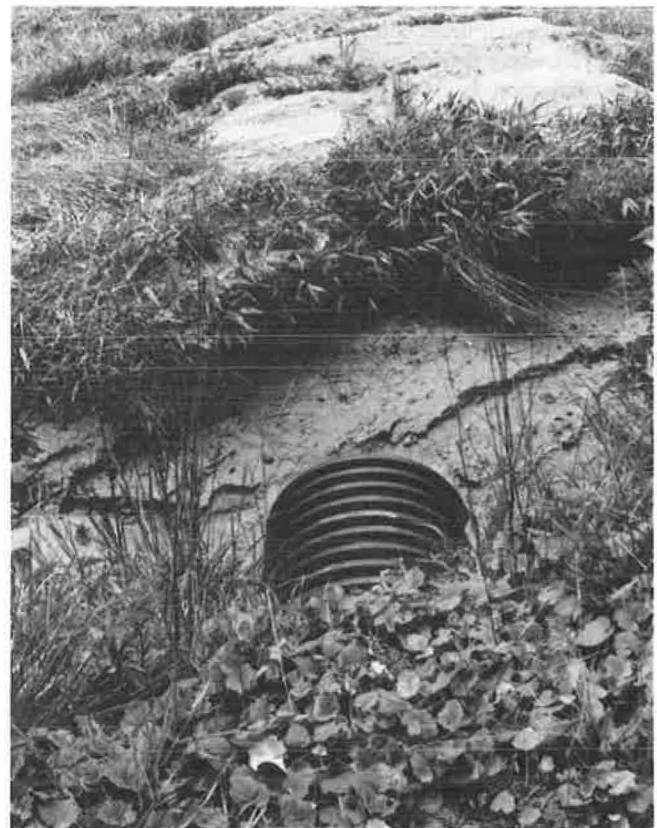
FIGURE 8 Outlet channel debris at NOB-145-3.58 indicative of force of storm flow.

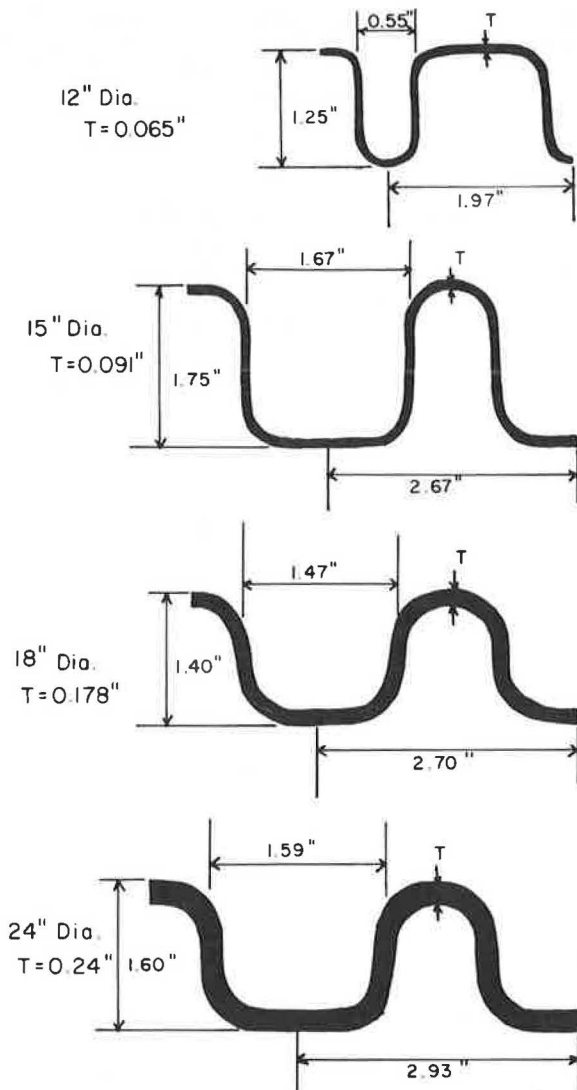
FIGURE 9 Corrugated polyethylene pipe corrugation profiles.

However, it can be seen in Figure 9 that the wall thicknesses of the 12- and 15-in. pipes are considerably thinner than those of the 18- and 24-in. pipes. Although theoretical flexibility factors (D^2/EI) for 12- and 15-in. pipe are slightly less than those for 18- and 24-in. pipe, actual measured flexibility factors for the smaller pipes were larger (10-14). It was previously noted that the 12- and 15-in. pipe was much more difficult to handle than the 18- and 24-in. pipe. It is possible that with variable loadings and large local deflections as shown in Figure 6 the thinner walls of the "more flexible" 12- and 15-in. pipe allow a flattening (reduction in the rise) of the corrugation profile during bending in the longitudinal direction. This in turn would significantly reduce the ring stiffness of the pipe and allow bending in the circumferential direction. Observation of culverts with severe deflection and buckling showed a definite flattening of corrugation profile at points of maximum deflection.

1. The wall thickness of 12- and 15-in. corrugated polyethylene pipe should be increased, or pipes of these sizes should be securely anchored in the trench during backfill operations to provide a larger factor of safety against less than optimal installation methods.
2. Revision of ASTM structural requirements for corrugated polyethylene pipe to include consideration of flexibility and resistance to bending moment should be considered.
3. Culverts with moderate to large initial deflections (10 percent or greater) under the roadway should be observed periodically to determine if any increase in deflection occurs with time for this range of initial deflections.
4. Corrugated polyethylene pipe culvert ends should be delineated and protected with headwalls under minimal cover conditions.
