Evaluation of Metal Drainage Pipe Durability After Ten Years

WILLIAM H. TEMPLE AND STEVEN L. CUMBAA

This study represents an investigation of the comparative performance of coated and uncoated, corrugated, galvanized steel and aluminum drainage pipe in Louisiana. The highly corrosive environments in some areas of the state make durability requirements of metal pipe as critical as strength requirements. Department personnel installed 10 types of metal drainage pipes at each of 10 locations in 1973. The test sites were selected on the basis of the pH and the electrical resistivity of the soil and the effluent. One pair of each type of culvert was installed at each site. Every 2 years one designated culvert of each of the pairs was removed and subjectively rated by a panel. The final (10-year) panel ratings reflect the condition of the undisturbed culverts in each pair. It was found that, in general, the 16-gauge asphalt-coated aluminum; the 14-gauge asbestos-bonded, asphalt-coated galvanized steel; and the 16-gauge galvanized steel with a 12-mil interior and a 5-mil exterior polyethylene coating were the test pipes with the most resistance to corrosion at the majority of the test s

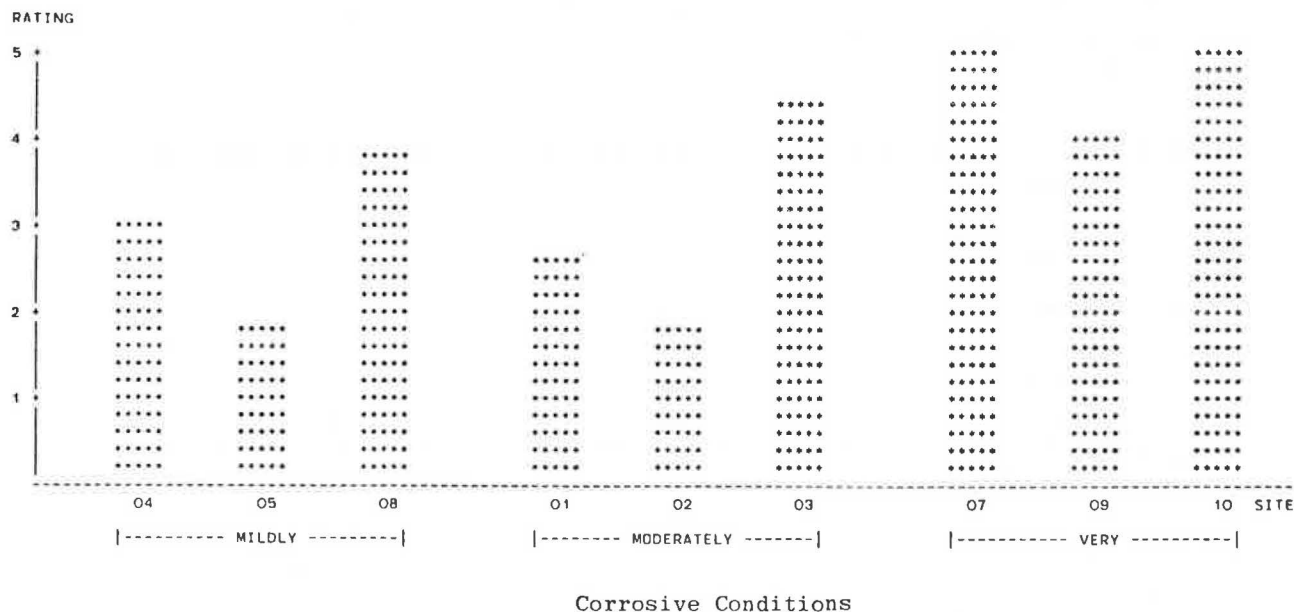
FIGURE 2 Ratings for 16-gauge galvanized steel pipe, original grouping (based on resistivity only).

Figure 2 indicates that the ratings assigned to the uncoated galvanized steel pipe (Pipe 1) are not consistent with the expected performance when based on minimum resistivities only [i.e., some galvanized steel pipes located at an assumed moderately corrosive site have a rating lower (better) than the same pipe at what was thought to be a mildly corrosive site]. Because of these inconsistencies, a different criterion for categorization or grouping of the 11 separate sites was established. This different grouping is based on the combined effect of all environmental influences on corrosion of uncoated galvanized steel as indicated by the assigned rating. In other words, the relative condition of 10-year-old uncoated galvanized steel pipe was used to place the sites in categories of increasing corrosion potential. Figure 3 shows the ratings of the uncoated galvanized steel when the sites are placed in the new categories. The limits of each category were established as follows:

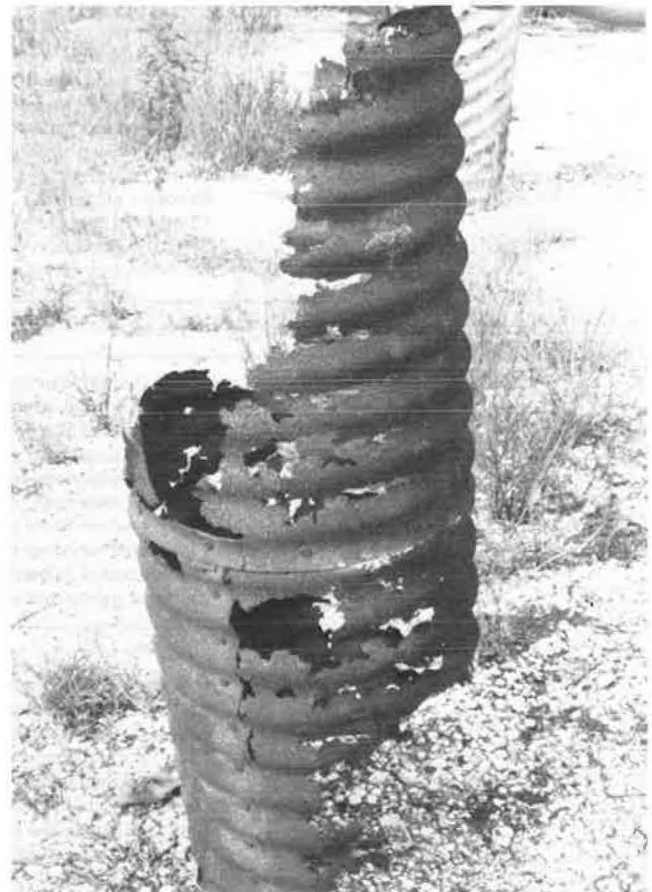
FIGURE 4 16-gauge galvanized steel after 10 years of exposure at Site 7.

the California Chart overestimates the anticipated life of 16-gauge uncoated galvanized steel at those sites where perforation or failure has occurred during this study. The chart does, however, appear to provide predicted life relative to the available range of pH and resistivities when sites are grouped by performance of galvanized steel as indicated by the data in Table 5. It is impossible to accurately estimate or predict pipe life in all of the various environments on the basis of the ratings obtained during this study because of the nonlinearity of the 1 to 5 rating scale. For example, a rating of 3.0 (midpoint of the rating scale) does not necessarily indicate that one-half of the life or usefulness of the pipe is gone. All pipes tested would require field exposure times of such length that the pipes reach a rating of 5.0 before any accurate determination of pipe life or additional life due to the various pipe coatings could be made.

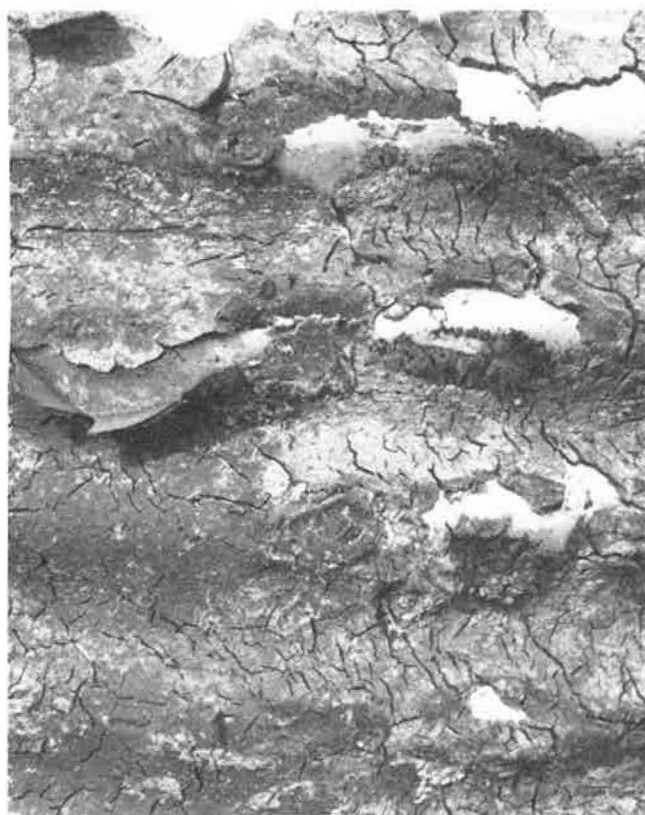
The asphalt coatings tended to be removed during handling and tended to be removed or cracked from exposure to the environment (Figure 5). In harsh environments, rust stains, which indicate corrosion of the base metal, appeared in the asbestos (Figure 6). The polymers tended to blister in harsh environments and tended to peel (separate from the base) in moderate and harsh environments (Figure 7). The thicker polymeric coatings appeared to protect the base metal better than the thin coatings.

FIGURE 5 Asphalt coating cracked and removed.

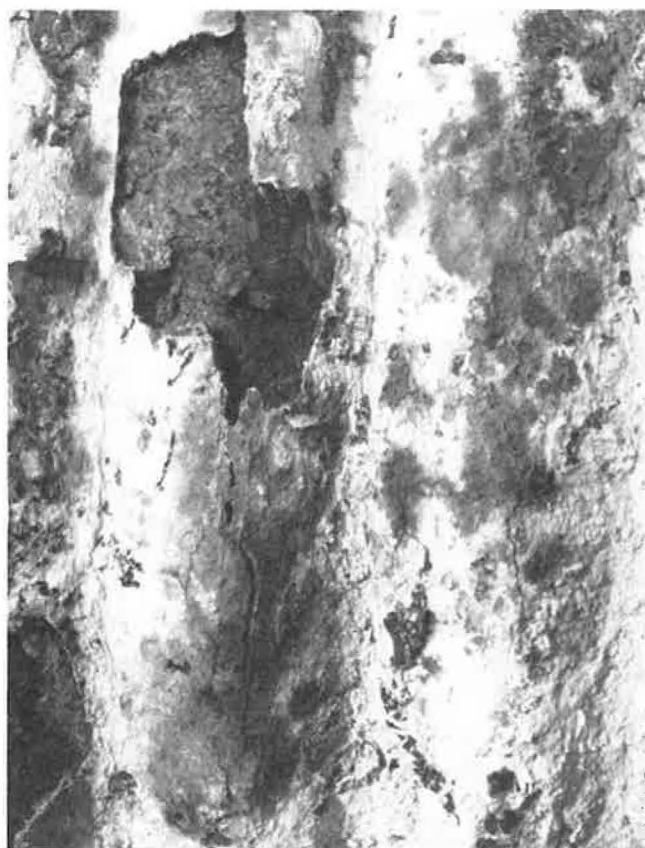
FIGURE 6 Corrosion between asbestos and base metal—Site 10.

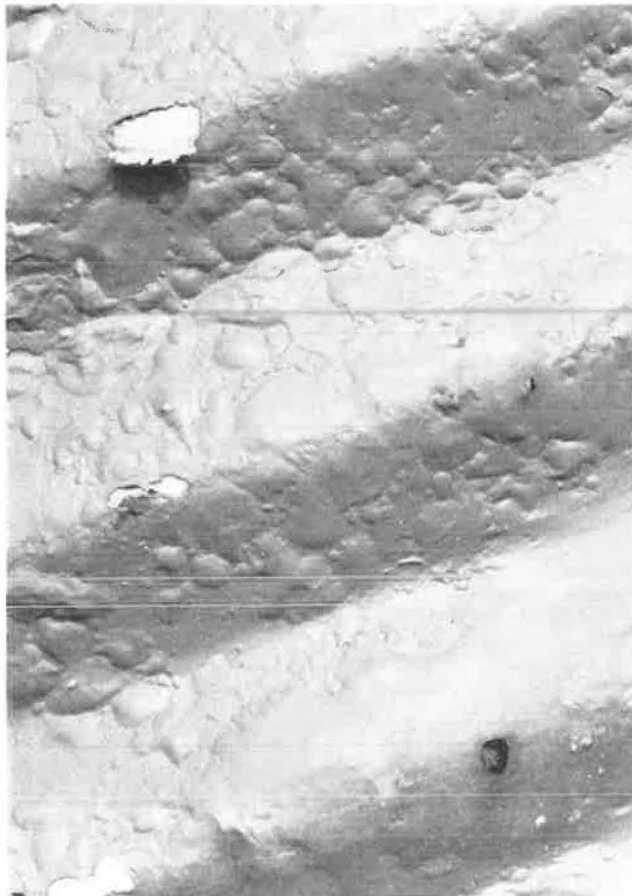
FIGURE 7 Polymeric coatings—blisters and peeling in harsh environments.
