The Sherman Landslide: A Case History

BERKE L. THOMPSON AND BARNEY C. STINNETT

The lower part of a massive colluvium landslide located along the Ohio River near Ravenswood, West Virginia, has affected railroad traffic for an undetermined time. The railroad had unsuccessfully attempted to stabilize it by using timber piles and railroad rails. The roadway above the railroad had not required significant maintenance before 1970. After the pool level of the Ohio was increased by the U. S. Army Corps of Engineers from elevation 551.4 ft to 560.0 ft between 1969 and 1971, the landslide movement became more active. The subsequent repair for the roadway had progressed beyond routine maintenance by 1975 with subsidence of the roadway and a near-vertical 2-ft scarp at the edge of the pavement. In a geotechnical study in 1976 to develop a correction, it was found that the movement at the roadway and railroad was but a small part of the total instability, which included the entire mountainside. The 1,000 ft of movement extended from the top of the mountain to below the pool level of the river. The methods of correction considered were a piling wall, a counter berm, and a relocation. The metho

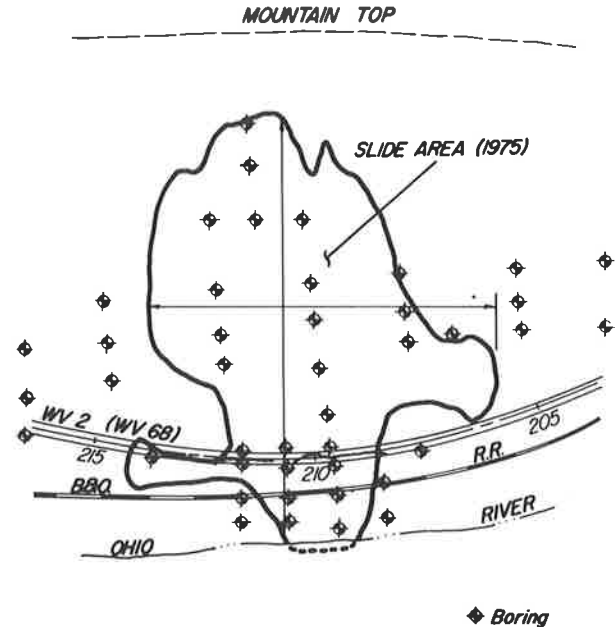
FIGURE 1 Plan view of Sherman landslide.

The Sherman landslide, so named because of a small community nearby, is located approximately 4 mi north of Ravenswood in Jackson County, West Virginia. It became a problem for the West Virginia Department of Highways in the early 1970s. A serious safety hazard resulted when a 2-ft vertical scarp occurred at the edge of the pavement. This scarp became larger as time progressed. A sag of 8 in. was apparent in the roadway, with several longitudinal tension cracks in the pavement (Figure 1).

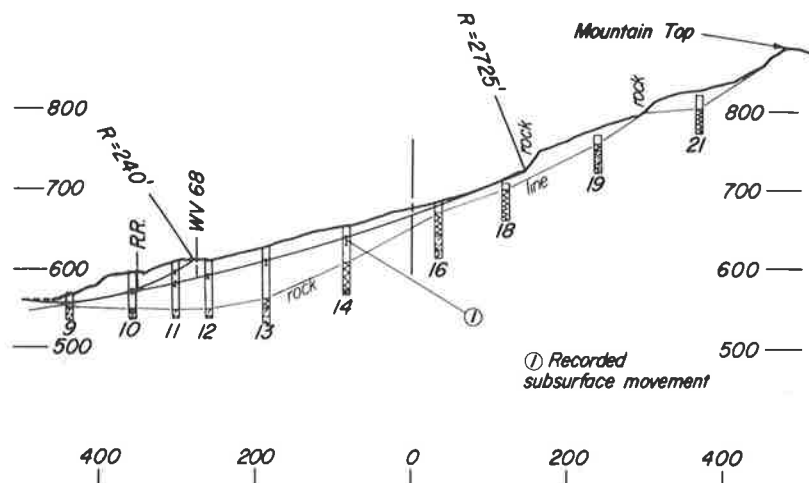
FIGURE 2 Boring locations and failure planes.

1. On the basis of the subsurface data, two failure planes are located beneath the highway (Figure 2, Station 210+00). This conclusion was based on indicated movement zones in Borings C-12 and C-11. Boring C-12 above the roadway had a surface elevation of 610.6 ft and Boring C-11 below the roadway had a surface elevation of 608.6 ft. There was only one zone of movement in Boring C-12 at a depth of 19 to 22 ft. There were two zones of movement in Boring C-11, an upper zone at a depth of 9 to 13 ft and a lower zone at 25 to 30 ft. The rate of movement also varied for the two zones of movement. The upper zone, which was in Boring C-11 but not in C-12, had a

measured movement of 1.5 in. in 81 days. The lower zone in C-11 and the zone in C-12 moved 0.25 in. in 81 days. Using the movement data from Borings C-10, C-11, C-12, C-13, and C-14, it was found that the lower deep-seated movement had a scarp 400 ft to the right (east) of the roadway. The toe for this movement was below normal river pool elevation instead of above the roadway as the consultant had previously thought.

that the deep-seated (lower) failure plane was located at or near the base of the colluvium just above the alluvium-colluvium interface and was probably the cause of this expression. The shallow (upper) failure from the roadway to the river was also in the colluvium (Figure 4). The safety factor (SF) for the upper failure plane was analyzed by the consultant using the ICES LEASE I Simplified Bishop Method. (See Figure 2 for the location of the upper failure plane.)

3. The only feasible correction is a major relocation of the roadway into the hillside and on the bedrock. This would also improve the alignment.

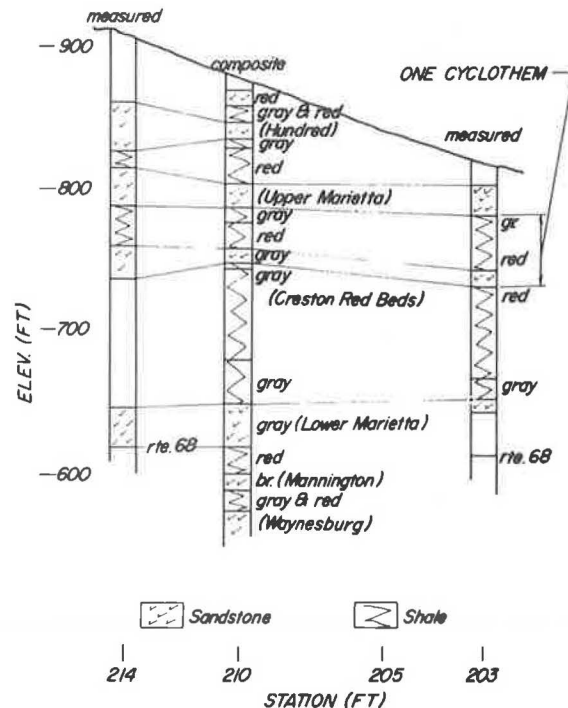
FIGURE 3 Stratigraphic columns.

A cyclothem is a repetitive cycle of rock types, arranged in a particular sequence (Figure 3). Normally the coal units would

be used as the boundaries for each cycle. Because no coal units were present, the bases of the sandstone units were arbitrarily used for the boundaries. As with cyclothem in general, and also at this site, all the rock units in a particular cyclic sequence may not be present because of erosion or environmental conditions. This is believed to be due to the variable depositional and erosional conditions at specific sites. The theory of a cyclothem is that the bedrock members that are present will be in the same relative position in all cycles to the other members in a cycle. At this site there are at least six cycles.

The bedrock units along the face of the slope have a significant variance in thickness. Measured sections and a composite boring log for several borings were used to evaluate the bedrock for slope design of the relocated roadway. Three sections are compared in Figure 3. In the center of the 1,100-ft horizontal distance along the centerline of the project, the thickness of the sandstone units decreases by as much as 50 percent. The corresponding shale units are thickened by the amount lost from the sandstone units.

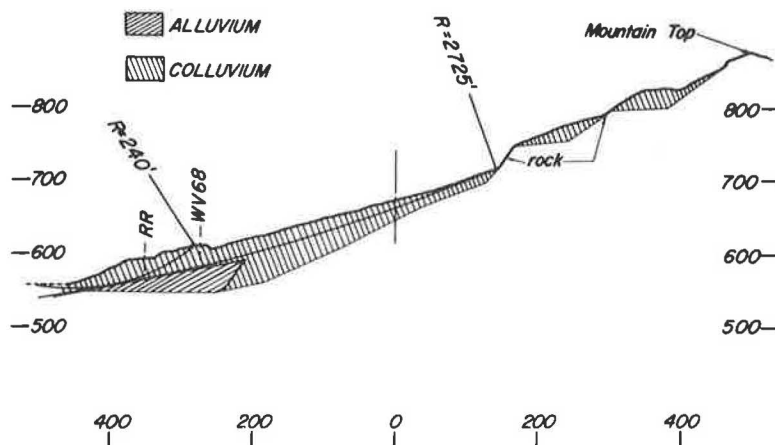
FIGURE 4 Soil types and failure planes.

There are two types of soil below the roadway (Figure 4). From the surface to a depth of approximately 30 ft is colluvium, composed of brown clayey silt and silty clay with shale and sandstone fragments.

The soil below the colluvium is alluvial, 25 to 30 ft thick, and extends to bedrock. The alluvial soil, a silty clay with no shale or sandstone fragments, is a terrace deposited by the Ohio River. The elevation of the alluvial soil indicates that it is probably the remnant of the first terrace and was deposited during or shortly after the glacial period (2).

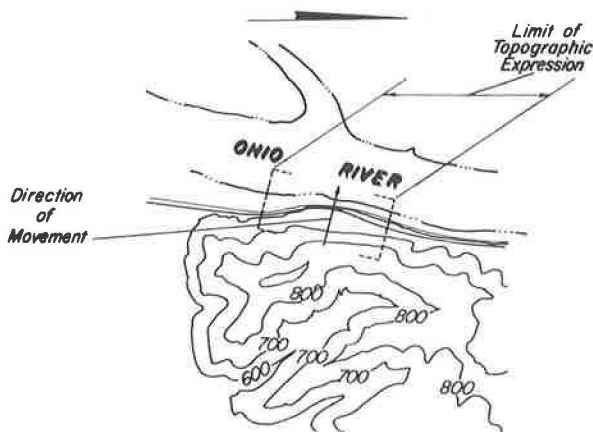
FIGURE 5 Topography of Sherman landslide.

A review of the U. S. Geological Survey topographic maps found a significant topographic expression on the river floodplain at the site of the landslide (Figure 5), which had been in evidence in all of the topographic surveys reviewed. It was apparent that this expression was made up of the continuous colluvium slope. The subsurface movement data indicated

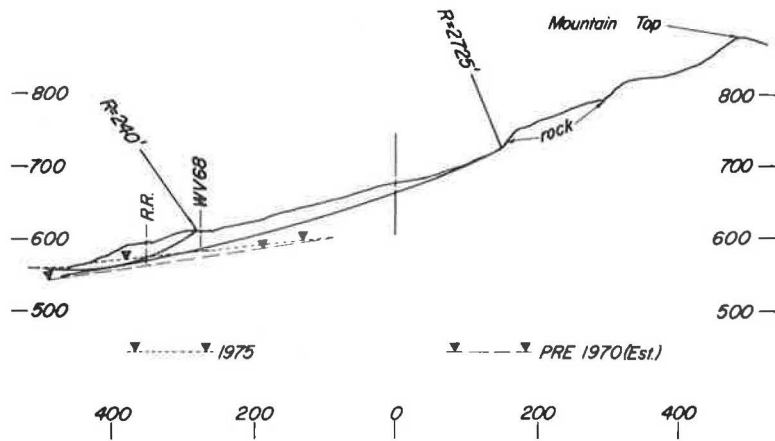
FIGURE 6 Piezometric levels and failure planes.

The analysis was conducted by using Borings C-10, C-11, C-12, C-13, and C-14 (see Figure 2), which is a cross section through the center of the landslide. A radius of 2,725 ft was used for the lower deep-seated failure plane and a radius of 240 ft was used for the upper shallow failure plane. The strength values from Boring C-12 at the depth of the failure in the colluvium were used in the analysis. The same strength values were used in the upper shallow failure (Figure 6).

The piezometric surface before 1969 to 1971 was 8.6 ft lower at the river's edge than the 1975 piezometric surface. The two surfaces were assumed to converge at the bedrock at a distance 200 ft right of the centerline of the existing roadway. This analysis indicated a reduction in SF of 10 percent for the upper shallow failure and a 5 percent for the lower, deep-seated failure plane after the pool level was raised 8.6 ft. The weight of the water in the river was considered in each analysis.

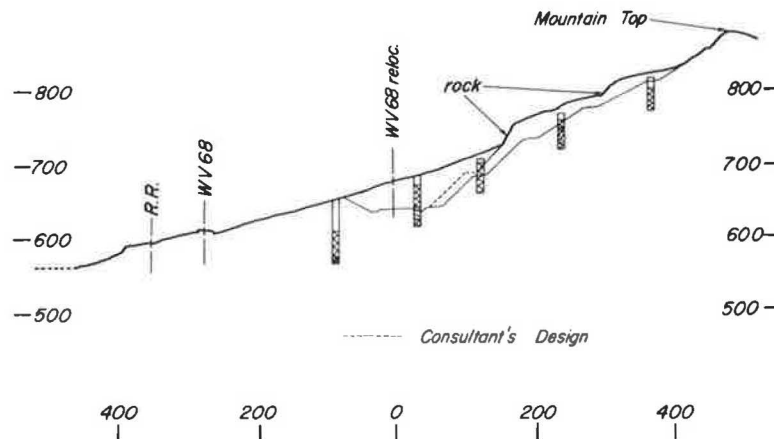
FIGURE 7 Construction cross section (1984).

Several slope failures occurred in the shale units and in one sandstone unit during construction. These failures were the result of the weak and highly weathered shale and the jointed sandstone supported by this shale. Failures of the 1.5:1 and 2:1 (H:V) slopes in the shale required a change of bench widths and a change in several instances to 2.5:1 (H:V) slopes in the shale. These changes increased the excavation by 26,000 yd³.

The redesign increased the excavation quantity from 441,290 yd³, which was the amount estimated by the consultant, to 616,438 yd³ for the department's redesign, which removed all unstable soil and bedrock, including the lateral and upslope extension of the landslide (see Figure 7).
