Analysis of Slope Failure in Overconsolidated Fissured Residual Soils: A Case Study

STEVEN F. PUTRICH, ROY H. BORDEN, AND PHILIP C. LAMBE

In this paper an analysis is presented of a slope failure that occurred in 1978 at the intersection of the Norfolk-Southern Railroad Underpass and US-64 located in the Durham Triassic Basin, the northern portion of the Deep River Triassic Basin deposit of North Carolina. Figure 1 shows the Deep River Basin deposit in relation to the series of Triassic deposits located along the Atlantic Seaboard and the general location of the site investigated in this study.

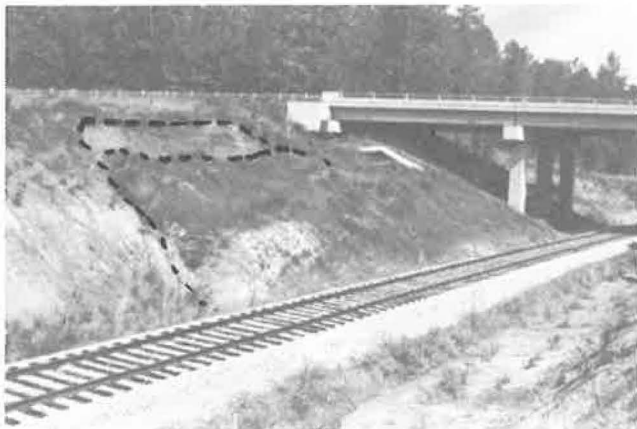
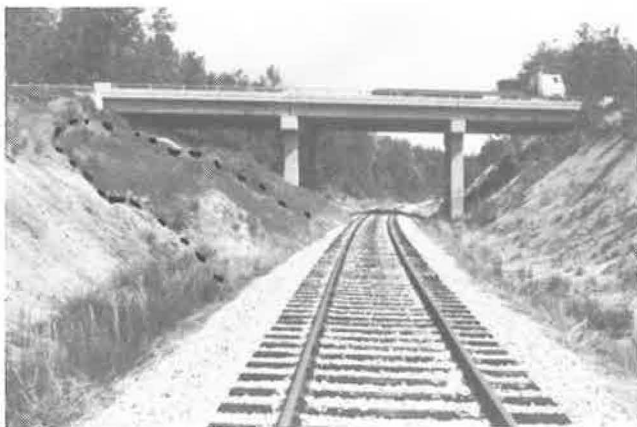
FIGURE 2 Railroad Underpass/US-64 slope failure.

In May 1978 approximately 5 years after the original slide, a second slope failure occurred in the same general location. Figure 2 shows two views of the failed slope. In a subsequent inspection conducted in 1978 by the Geotechnical Unit of NCDOT, the following observations were made about the geometry and subsurface conditions after the failure:

1. The failed soil mass was approximately 110 ft long,

2. The slope before failure was approximately 25 ft high with a 1.5 horizontal to 1 vertical slope. The location of the

1978 slide appeared to be the same as that observed in the 1973 slide at the site. Therefore this was considered a second-time slide (i.e., soil mass sliding along a previous failure surface).

3. Scarps and cracks were observed both on the surface of and within the failed soil mass.

As a result of this second failure in 1978, a tie-back pile and timber retaining wall was constructed to hold the sliding mass in place and ensure the integrity of the bridge structure on the site. Figure 5 shows two views of the slope rehabilitation project with the retaining wall in its final stages of construction. Approximately 1 year after the installation of the retaining wall, water was observed seeping through the timber retaining wall at ground elevation. The face of the slope at that time was reported to be saturated and the toe ditch filled with water. These were signs that there was still a problem with on-site groundwater seepage and surface water drainage. To correct the drainage problem, a small wall was constructed back of the toe ditch so that the ditch would be free draining. In addition, 6-in. perforated pipes were installed in the slope to drain the wet slope through the new wall.

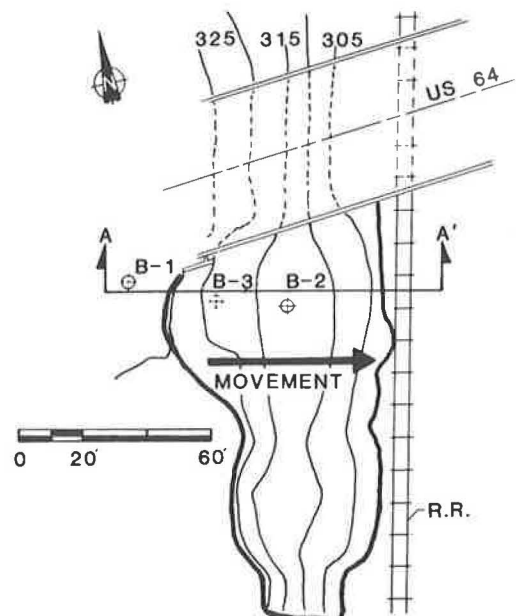
FIGURE 3 Extent of slope failure.

extending southward from the bent at the western end of the bridge structure. Figure 3 shows the extent of the failure and the direction of movement of the failed soil mass into the excavation. The opposite side of the excavation, in which the bedding planes dipped away from the excavation, remained stable.

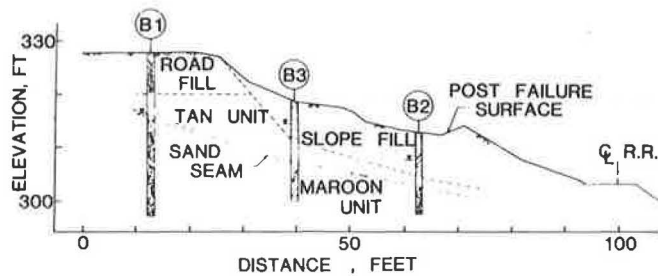
FIGURE 4 Generalized subsurface profile: Section A-A'.

Figure 4 shows the generalized subsurface profile (Section A-A') at the Railroad Underpass/US-64 site as defined by Borings B-1, B-2, and B-3 completed by NCDOT during their postfailure investigation. The soil profile can be divided into the following soil units:

1. The top unit is fill material used to construct the existing roadway embankment in 1972. This occurs only in Boring B-1.
2. The second unit is a red clay soil brought to the site to reshape the slope after the initial failure in 1973. This red clay is the surface unit in Borings B-2 and B-3.
3. The third unit is the tan unit, previously described.
4. In between the third and basal unit is a thin layer of slightly clayey coarse sand found in Borings B-1 and B-3.
5. The basal unit is the maroon unit previously described.

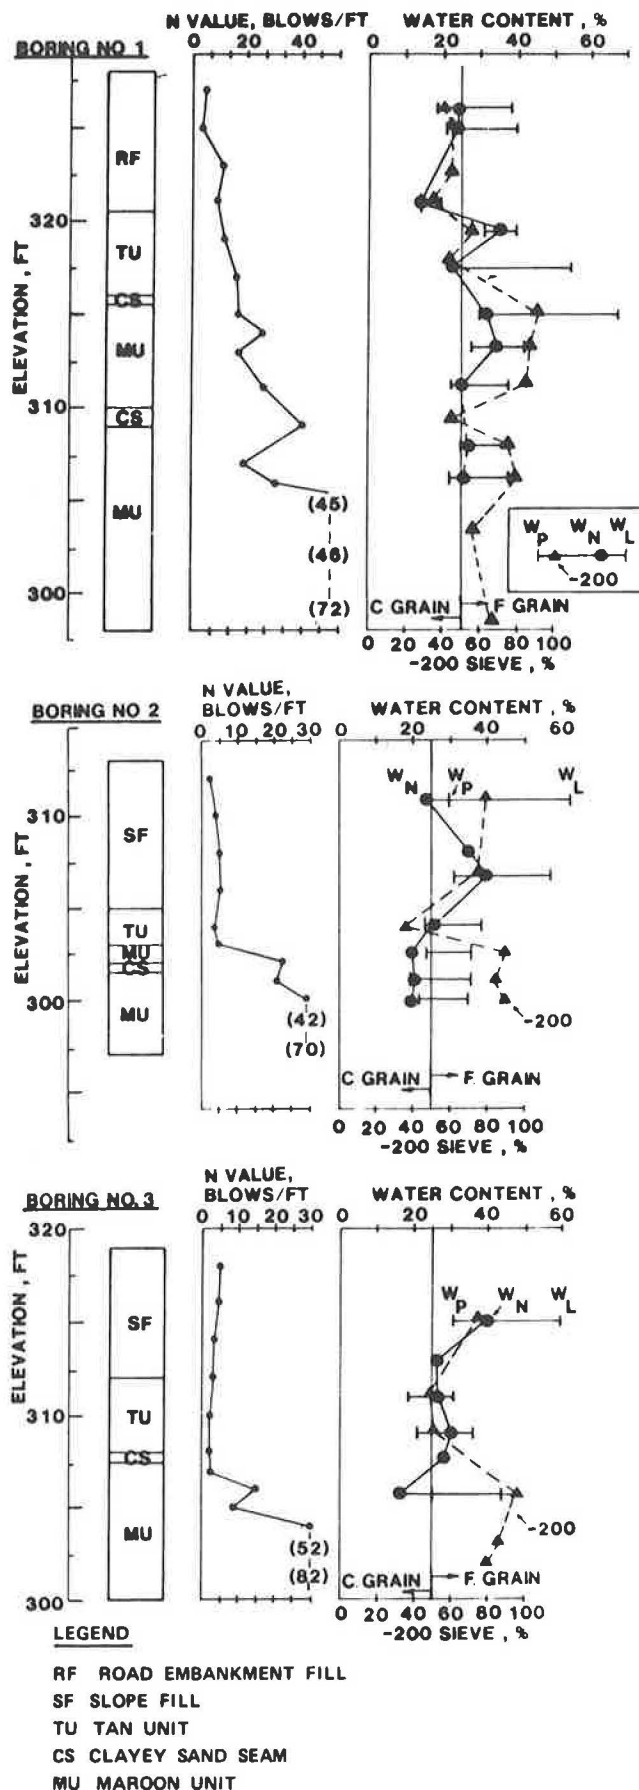
FIGURE 6 Boring logs B-1, B-3, and B-2 at Section A-A'.

Boring logs for the test borings drilled are given in Figure 6. Included in the logs are data on plasticity and percent passing the No. 200 sieve and the standard penetration values as a function of depth. As shown in the test boring logs, the standard penetration data indicate a significant increase in resistance to penetration as a function of depth into the maroon unit. These data, in conjunction with results from numerous rod soundings, suggest that the sliding surface under the failed soil mass wedge was restricted by the maroon unit. The slope geometry before and following the failure and the estimated failure surface are shown in Figure 7 and correspond to Section A-A' within the failed soil mass (see Figure 3 for location of Section A-A').

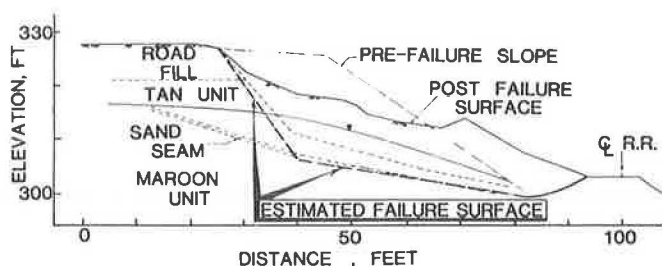
FIGURE 7 Slope geometry and estimated failure surface.

As shown in Figure 7, the estimated failure surface for this 1978 slide is located in the vicinity of the interface of the tan and maroon soil units. On the basis of field observations, this is thought to be the sliding surface for the previous slope failure

that occurred at the site 5 years earlier. Therefore, the shear strength of soil in the vicinity of this interface is of particular interest for the slide analysis.

The available data from the Railroad Underpass/US-64 postfailure investigation were used to estimate the pore pressures in the cut slope at the time of failure. The pore-pressure data from this site were obtained from well measurements (slope indicator pipe with well points attached to the bottom of the pipe) within and immediately outside the failed soil mass. These wells are not piezometers and therefore did not furnish pore-pressure data directly but gave an estimate of the groundwater level within the slope (i.e., phreatic surface). The well measurements taken immediately after the slope failure were used to evaluate the location of this phreatic surface. The pore pressures were determined directly from the location of the phreatic surface with respect to the sliding surface by assuming horizontal flow. The location of the outbreak of groundwater on the face of the failed slope observed during the NCDOT investigation was also used to estimate the position of the groundwater level. The estimated location of the phreatic surface at the time of failure is shown in Figure 7.

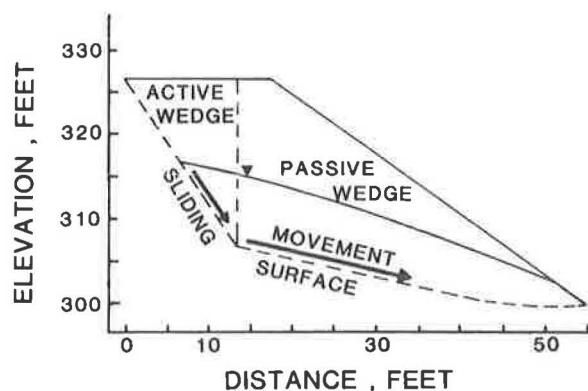
FIGURE 12 Slope failure geometry.

Based on the postfailure field investigation by the Geotechnical Unit of NCDOT, the landslide would be described as a partly rotational block failure according to the movement terminology used by Varnes (13). Movements of the soil mass involved the sliding and partial rotation of soil blocks (wedges) as shown in Figure 12. Because the layering of the soil within the slope was inclined into the cut, the soil mass had an inherent tendency to slide into the cut. The sliding surface was planar (noncircular), oriented parallel to the inclination of the

soil layering, and occurred in the vicinity of the interface between the tan and maroon units.

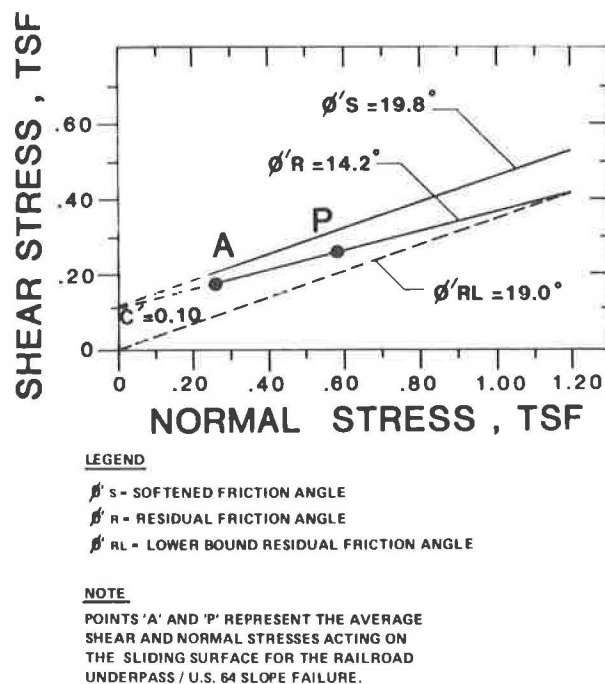
FIGURE 15 Average stress at failure for the Railroad Underpass/US-64 site.

In order to verify the results of the analyses performed, the slope was evaluated for the average shear and normal stresses acting on the failure surface at failure (i.e., $F_s = 1.0$) by using the wedge analysis with a vector approach. These average stresses were then plotted on the diagram of shear versus normal stress shown in Figure 15. Included in this figure are the strength envelopes generated from the direct shear tests conducted on the fissured clay from the Railroad Underpass/US-64 site. The average stresses from both the active and passive sliding surfaces are indicated by points A and P, respectively.

Figure 15 indicates that average stresses approximately equal to or slightly greater than the residual shear strength governed in the long-term stability of the slope. This finding is consistent with the results of the wedge analysis using the equilibrium factor-of-safety approach, which indicated that the residual

strength closely matched the in situ shear strength acting at failure for the previously failed slope.
