# Performance Evaluation of Jointed Concrete Pavement Rehabilitation Without Resurfacing

DAVID L. LIPPERT

The results of a research project that was conducted to evaluate the effectiveness of concrete pavement restoration (CPR) on jointed portland cement concrete pavement are described. The CPR methods evaluated were pavement grinding, grout undersealing, installing underdrains, retrofitting double-vee load transfer devices, and pavement patching. Five construction sections, located on Interstates in Illinois, were selected for evaluation. The original pavement sections were constructed between 1960 and 1963, then rehabilitated in 1983 and 1984. All pavements were of the same design: a 10-in. slab over a 6-in. granular base and a joint spacing of 100 ft. The evaluation began just before rehabilitation of each section and continued until May 1986. Evaluation was done using crack surveys, destructive testing, and nondestructive testing. Performance factors monitored were faulting, pavement cracking, pavement roughness, skid resistance, deflection, load transfer, void development, and drainage. A great deal of emphasis was placed on grout undersealing and doweled patching in laborat

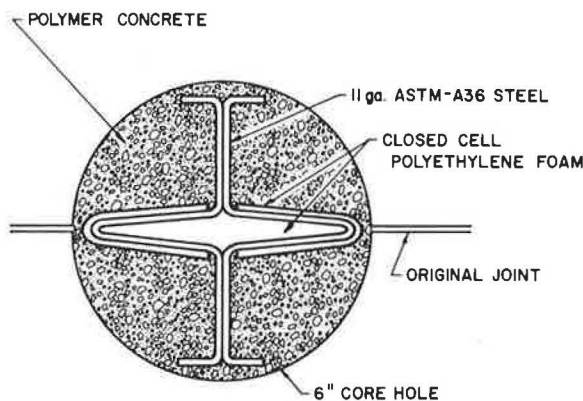
FIGURE 2 Double Vee load transfer device.

Project 4 was the only project to use the retrofit load transfer devices shown in Figure 2. Several problems were encountered in the installation of these devices. First, the contract did not call for grooving or roughing the inside of the core hole before

Within a few months of installation, more than 50 percent of the devices debonded at the pavement-polymer concrete interface. There appeared to be no pattern to the debonding in that it occurred on either or both sides of the joint or crack. The grooving of the core hole had no influence on debonding. By 1985 all 671 devices installed have failed by debonding.

- Spalled, rocking, and pumping patches should be replaced rather than undersealed.
- Future use of Double Vee or similar load transfer devices should be on a limited experimental basis to determine performance.

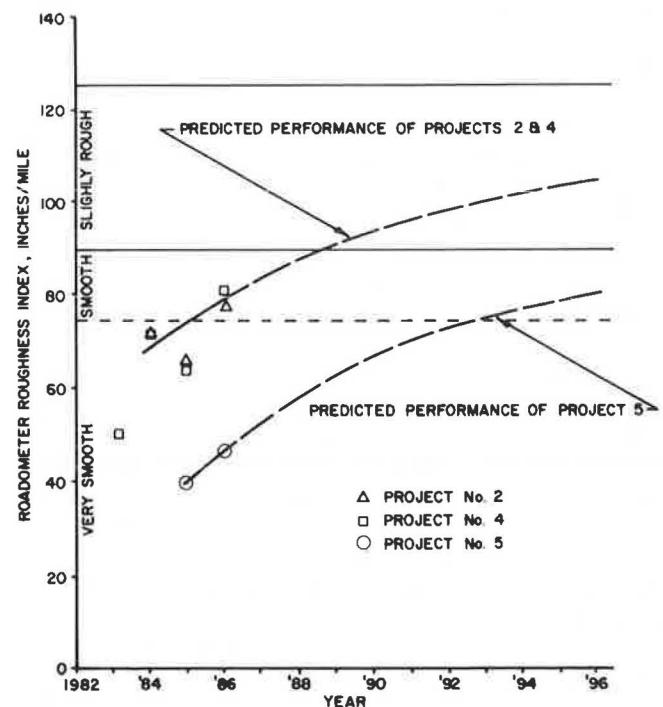
FIGURE 4 Predicted roadmeter roughness index.

The friction and faulting data are given in Tables 3 and 4, respectively. Roadmeter readings were taken before rehabilitation and annually thereafter. The roadmeter data are given in Table 5. From the roadmeter data, predictions of the roughness index (RI) were made by plotting the data on log-log paper and extending a best fit line through the points. The results are shown in Figure 4. It is expected that diamond grinding will provide a smooth ride for about 5 years after construction and an acceptable ride for another 5 years.

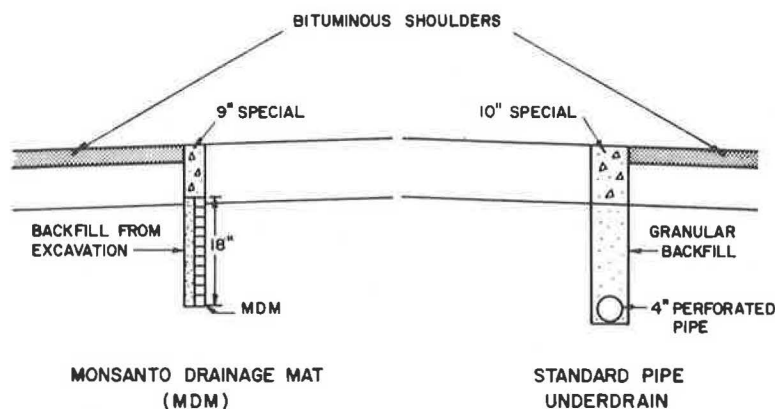
**FIGURE 5** Details of Monsanto drainage mat and standard pipe underdrains.

On Project 4, a new drainage product was included, the Monsanto drainage mat (MDM). Figure 5 shows a comparison of the design of standard pipe underdrains and the MDM.

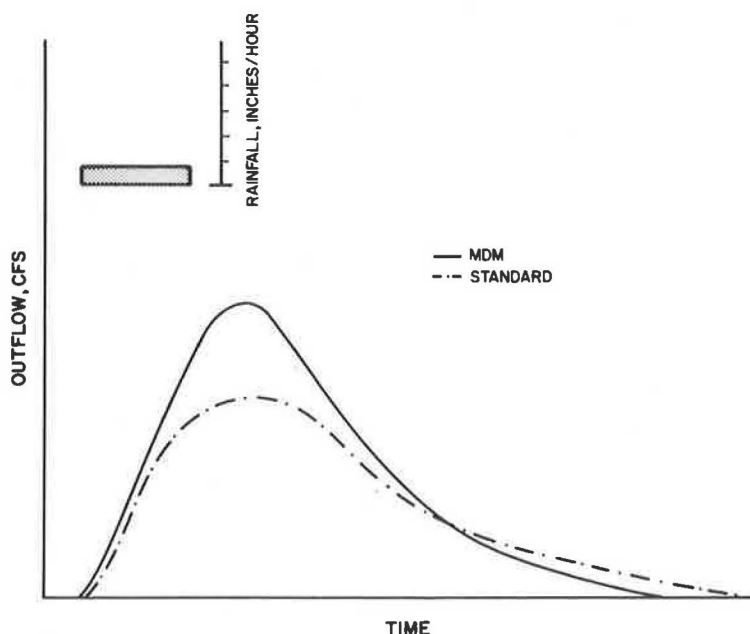
**FIGURE 6** Typical outflow characteristics of Monsanto drainage mat and standard pipe underdrains.

Sections of the pipe underdrains and MDM were monitored by use of a tipping bucket device that measures outflow with time. Figure 6 shows the typical outflow characteristics of the two underdrains.

The outflow characteristics of the MDM drain showed a desirable improvement in two areas. First, the MDM removed 1.11 to 1.87 times the water of the standard pipe underdrain. Second, the MDM removed the water from the pavement faster, whereas the standard drain continued to flow for several days.

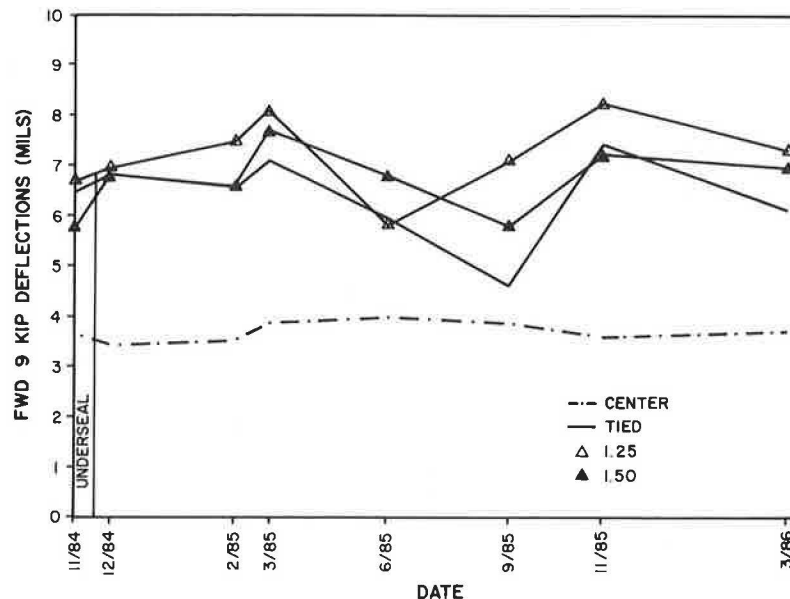
FIGURE 8 Deflection history of dowel bar size.

Evaluation of the patches was by visual inspection and deflection testing using an FWD. The visual inspection indicated that all of the experimental patches were in excellent condition, and there was no indication of spalling or any other distress. Deflection testing results are present in terms of a deflection due to a 9-kip load and load transfer across the patch joints in the outer wheelpath. Load transfer is measured by dividing the deflection on the unloaded side of a joint by the deflection on the loaded side and is reported as a percentage. Testing was conducted before the experimental patches were undersealed and again after undersealing before the roadway was opened to traffic. After the roadway was opened to traffic the patches were tested periodically. Deflection and load transfer results for dowel bar size are shown in Figures 8 and 9, and

The tied patches showed the best performance with respect to deflection and load transfer. Patches with 1.5-in. dowel bars and a 5-5 dowel bar arrangement performed second best. Although patches with 1.25-in. dowel bars and a 3-3 dowel bar arrangement performed the worst relative to the other designs, the deflection measurements and load transfer percentages were still good. Grout type appeared to have no influence on deflections or performance. It is thought that the sealed transverse joint is very important for a successful patch, not to keep water out of the patch but to prevent spalling. When 1.5-in. dowel bar, a 5-5 dowel bar arrangement, a sawed and sealed joint, and a 6-ft minimum patch are used, a low maintenance life of 10 or more years can be expected compared with 1 to 3 years for the original 3-2 patch design.

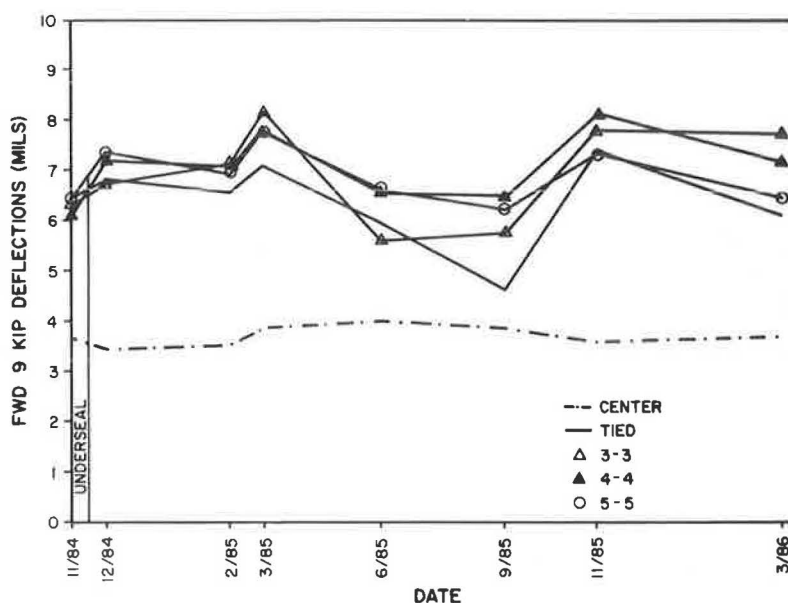
FIGURE 10 Deflection history of dowel bar arrangement.

results for dowel bar arrangement are shown in Figures 10 and 11. Also shown on the deflection plots are center of slab tests, which are taken at least 6 ft away from any joints or cracks and give an indication of subgrade support. At the end of the evaluation, all deflections and load transfers indicated that the patches were performing outstandingly.

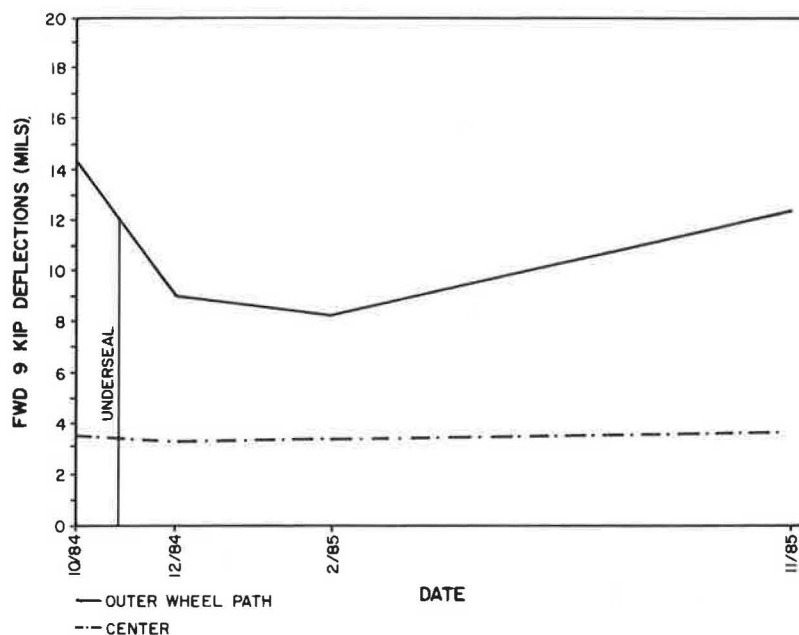
FIGURE 15 Deflection history of patch undersealing on Project 3.

Project 3 was also undersealed in the fall of 1984 at all patch locations to arrest pumping and spalling of the patches. Before undersealing, a group of 21 patches was selected for evaluation. Deflection testing results using the FWD are shown in Figure 15, which again shows that patch undersealing was effective for about 1 year.
