Construction of a Thin-Bonded Portland Cement Concrete Overlay in South Dakota

DANIEL JOHNSTON

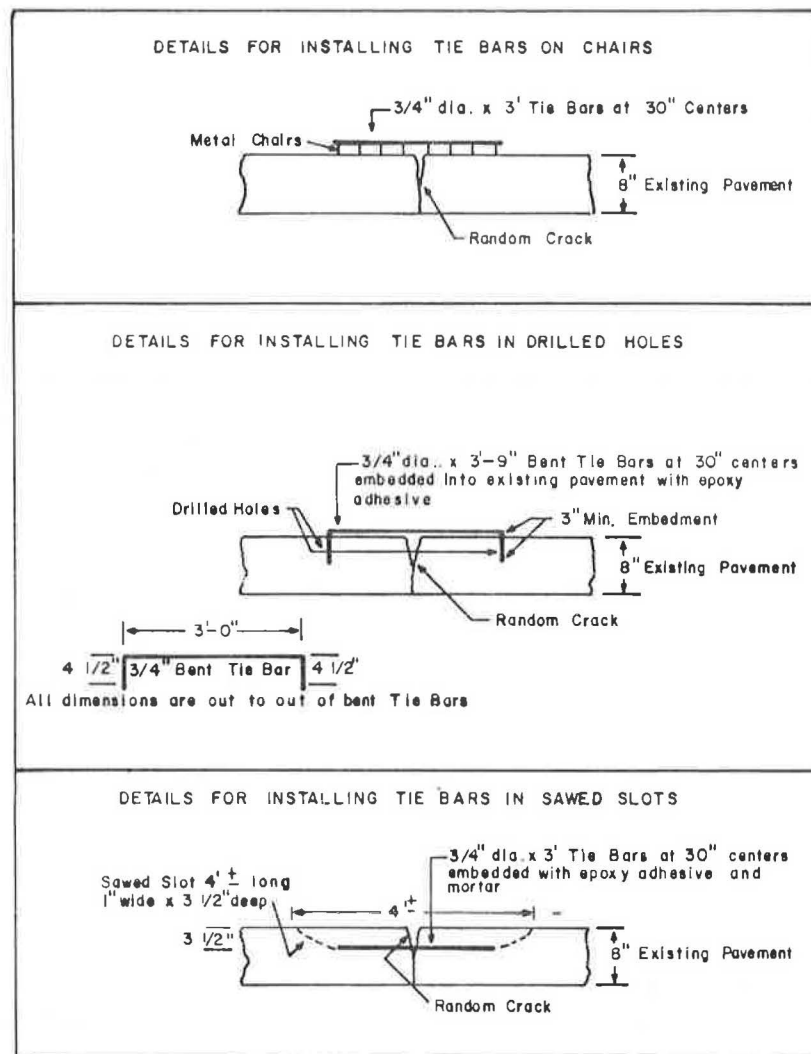
FIGURE 2 Crack reinforcement treatments.

The high incidence of severe longitudinal cracking on the project presented a particular problem because normal full-depth patching, if applied to all the longitudinal cracks, would not be economically feasible. Three different methods of attaching the broken sections onto the original slab were to be tried. These included (a) tie bars on chairs, (b) bent tie bars in drilled holes, and (c) tie bars in sawed slots. The tie bars were

to be installed perpendicular to the crack along a longitudinal or transverse crack and were to be $3/4$ in. by 3 ft. Details of the proposed stabilization techniques are shown in Figure 2. A fourth method, using $5/8$ -in. reinforcing steel rails running parallel along either side of a crack to which the tie bars were attached, was added at the time of construction.

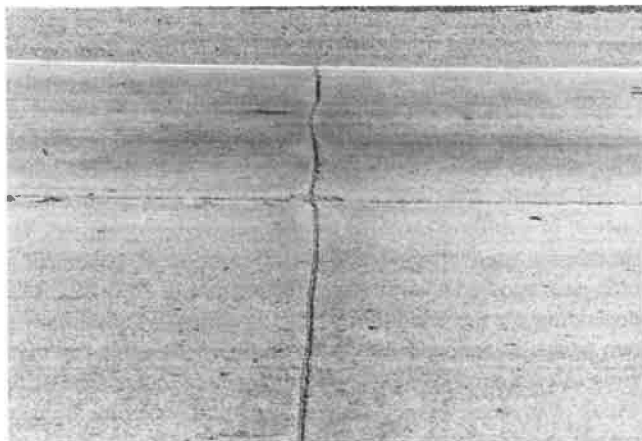
FIGURE 3 Typical crooked transverse joint.

The original transverse joints on the project were formed using redwood inserts and were, unfortunately, extremely crooked. The original design called for the placement of 4- to 6-in.-wide masking tape over these joints before overlay placement to prevent bonding of the overlay at the old joint and to minimize any reflective cracking due to misalignment of the old joint with the new transverse sawcut, which was to be cut through the full depth of the overlay. This design was abandoned, except for a 500-ft experimental section, and was replaced with backer rod inserts and single-lane, instead of full-width, sawcuts oriented on steel pins placed on the shoulders.

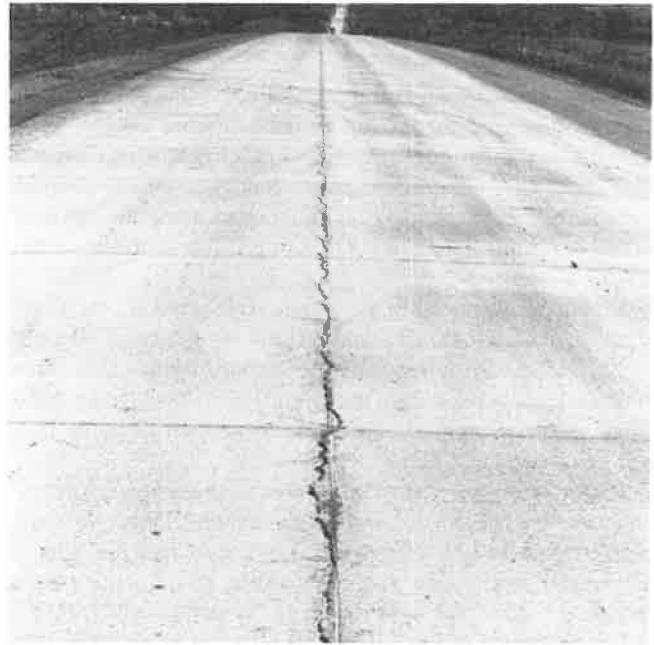
FIGURE 7 Typical random centerline cracking.

During the first day of construction, the first 720 ft of overlay suffered a random centerline crack before longitudinal sawcutting could be carried out. The original plans called for a $\frac{1}{4}$ -in.-wide by 1-in.-deep joint to be sawcut within 48 hr. The contractor sawed the longitudinal joint on the rest of the project at the same time as adjacent transverse joints were sawcut, usually as soon as the concrete was strong enough to support the sawing without raveling. Unfortunately, the overlay exhibited another 5,100 linear ft of random centerline cracking, which wandered in and out of the centerline throughout the length of the project (see Figure 7).

The random cracking along the centerline was routed $\frac{3}{8}$ in. wide wherever the crack was more than $\frac{1}{2}$ in. away from the centerline sawcut and filled with hot-pour sealant. The centerline in these areas was filled with epoxy. If the random crack was $\frac{1}{2}$ in. or less from the centerline, the concrete between the sawcut and the crack was chipped out to the depth of the centerline sawcut and sealed with hot pour.

It is also recommended that the initial sawcuts for both transverse and longitudinal joints be done as soon as feasible because there is a critical need to relieve drying shrinkage stresses in the overlay. In addition, the longitudinal joint sawcut depth should be at least one-half of the overlay thickness, and provision should be made to ensure proper alignment of the new sawcut over the old joint.

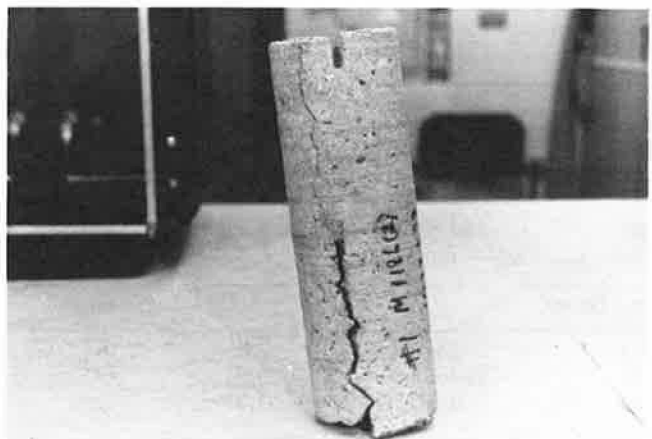
FIGURE 8 Core taken along centerline.

Four-inch cores were taken throughout the project length. The average depth of the overlay was adequate in both the 3- and 4-in. sections. Cores taken of the random centerline cracking showed several possible contributing factors that could have led to the cracking (see Figure 8). They include

1. Inadequate depth of sawcut: A 1-in. centerline sawcut was specified and proved to be too shallow to direct proper crack propagation.
2. Coarse mix: The use of a 1.5-in. maximum-size aggregate instead of the $\frac{3}{4}$ -in. originally specified could have contributed to the cracking in conjunction with the shallow sawcut.
3. Inadequate debonding of centerline: No provisions were made to assure debonding of the centerline as it was believed the hot-pour sealant would act as a bonding agent. The grout, as well as the spalling of the centerline that subsequently filled

with grout, could have interfered with proper cracking. Interestingly, the 500-ft test section where no grout was used did not suffer from random centerline cracking.

4. Improper orientation of the new centerline cut over old: The machine used for sawcutting the centerline aligned itself with the pavement edge. Considerable difficulty was experienced in cutting a uniformly straight centerline for any distance and the resulting lack of proper alignment along the old centerline was undoubtedly a contributing factor to the cracking.
