Corrosion Performance of Weathering Steel Structures

R. HEIDERSBACH

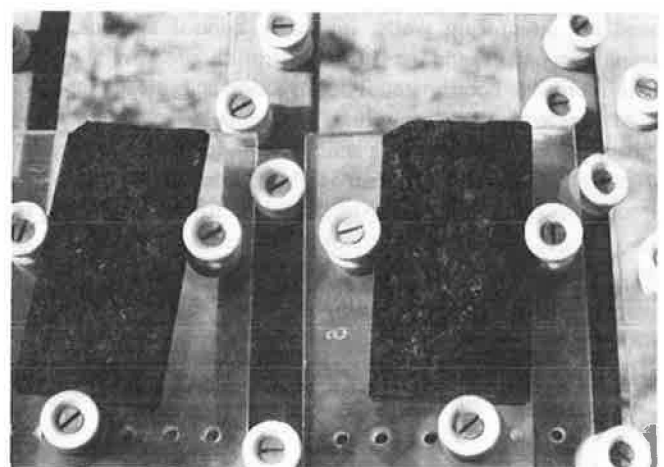
Weathering steels were developed using standard ASTM test procedures for determining atmospheric corrosion resistance of alloys. Figure 1 shows a typical atmospheric exposure test site with flat panel specimens exposed at an angle (neither vertical nor horizontal). While a number of other atmospheric corrosion test arrangements are possible, the specimen geometry and exposure methods shown in Figure 1 were used for most of the research and development testing for weathering steels (2, 8).

FIGURE 1 Corrosion test panels at atmospheric corrosion test site, Kure Beach, N.C.

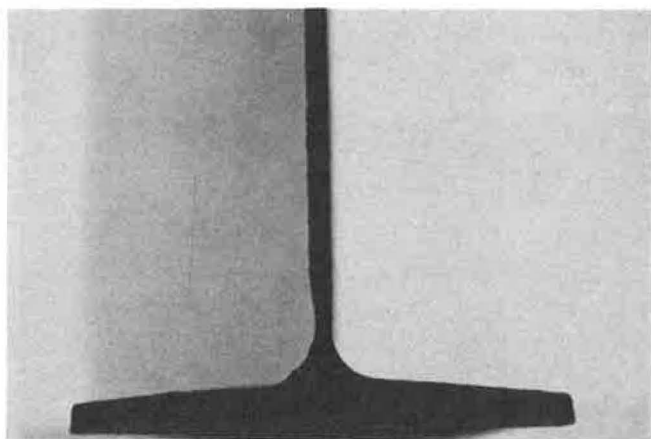
Figure 2 shows corrosion of the lower half of an I-beam that was exposed to atmospheric corrosion. The vertical web has corroded more at the bottom than at the top. The reason for this is quite simple: some of the corrosion products falling from the upper portions of the vertical web accumulated at the bottom and provided a moisture trap that kept the steel at the bottom wet for longer periods of time. This wetter steel corroded more than adjacent well-drained surfaces. Corrosion of complex-geometry weathering steel structures will not be uniform, as illustrated by Figure 2. Thus extrapolations of service life based on exposures of simple flat specimens may be misleading and may not predict the accelerated corrosion experienced on actual structures.

FIGURE 2 Corrosion of lower half of weathering steel I-beam exposed to atmospheric corrosion.

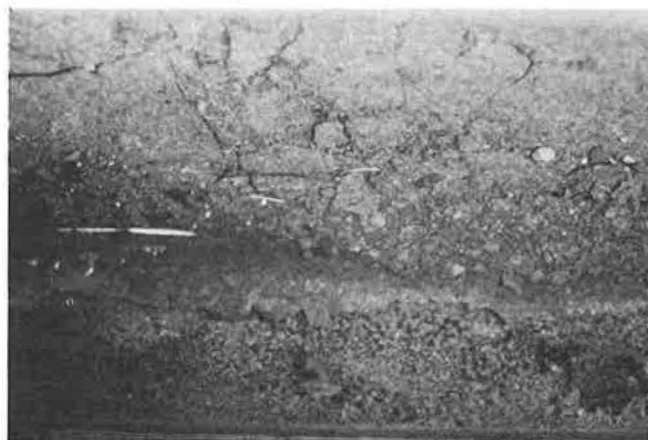
Figure 3 shows laminar corrosion on a horizontal bridge member from the New Jersey Turnpike. Other areas on the same bridge were in generally good condition with no evidence of loose, flaky rust or progressive corrosion. This highway is heavily traveled and receives heavy salt applications (3). The corrosion shown in Figure 3 is due to poor drainage and not to deicing salts—if deicing salts were causative, other portions on the same bridge would have had the same problem.

FIGURE 3 Laminar corrosion on poorly drained horizontal surface of New Jersey Turnpike highway separation bridge.

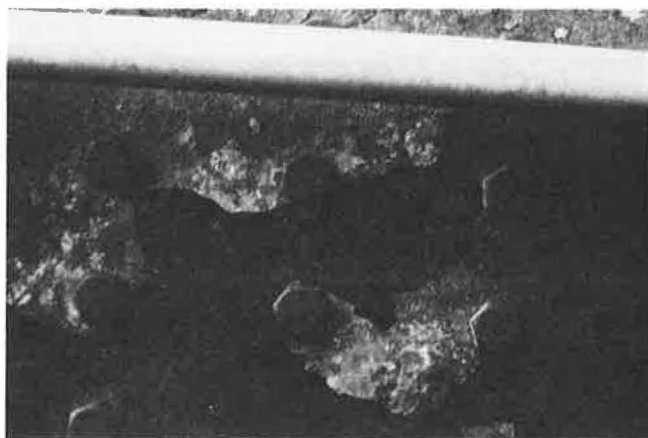
FIGURE 4 Loose, flaky rust on interior surface of Luling Bridge across the Mississippi River near New Orleans.

during bridge construction in 1983, shows loose, flaky rust on the Luling Bridge across the Mississippi River near New Orleans. Prewelded box sections of this bridge were shipped across the ocean on the deck of a ship. The corrosion shown in Figure 4 started during the shipping process and cannot be attributed to the environmental conditions at the bridge site.

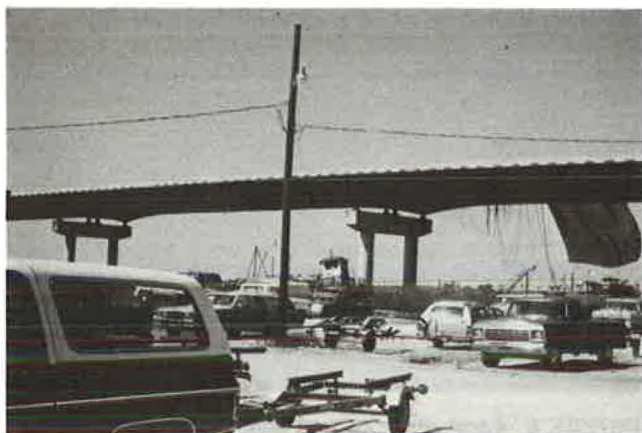
Figure 5 shows safety nets used during sandblasting operations before painting on the Dollut Canal bridge, a smaller highway bridge south of New Orleans. This bridge was involved in a widely publicized lawsuit between a painting contractor and the Louisiana Department of Transportation (13). The condition of the steel on this bridge was alleged to be worse than that of conventional painted bridges and to require more sandblasting, painting, and so on, than other bridges (13). The steel surfaces are shown in Figures 6 and 7. The rough surface can be noted, even on the vertical members where debris cannot accumulate, as can the discoloration from the galvanized steel bolts used to mount the sample rack on the bridge.

FIGURE 5 Safety nets below Dollut Canal bridge in Louisiana.

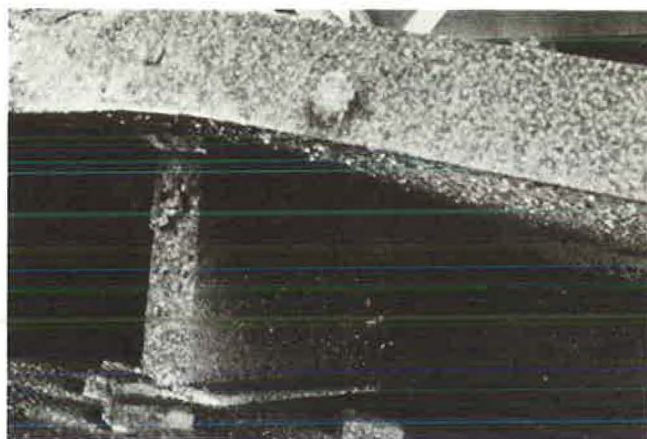
FIGURE 6 Rusty surfaces on bottom of Dollut Canal bridge before sandblasting.

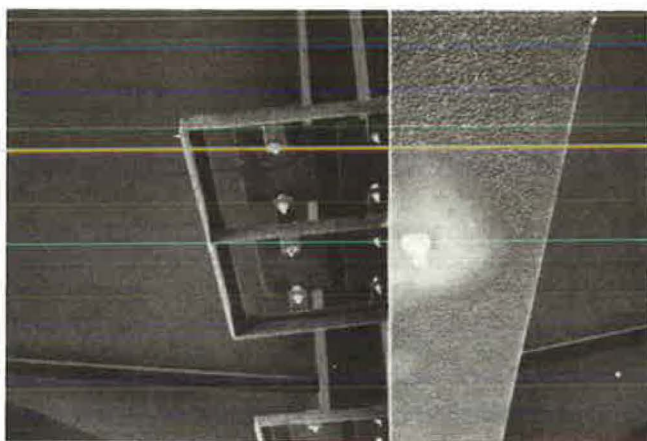
Galvanized steel hardware is also shown in Figures 4 and 7. Although this hardware is not as rusty as the nearby weathering steel, it is obvious that it is also weathering, and galvanizing would not be a permanently protective coating for these harsh, moist environments.

FIGURE 7 Flat horizontal test panel located underneath Dollut Canal bridge.

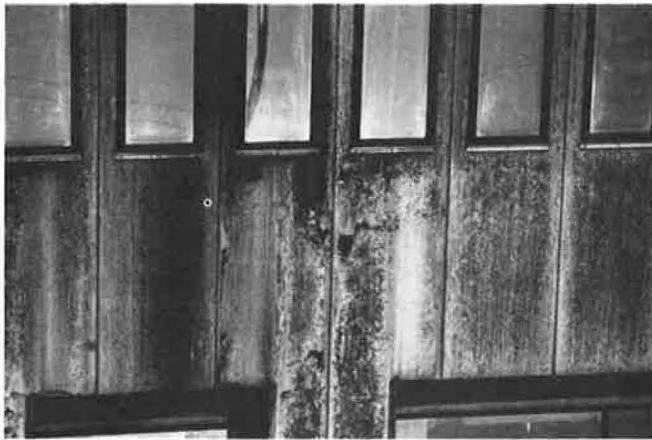
Painting the inside of steel panels to protect against corrosion was recommended in the 1960s (6) but these recommendations were not always followed. Figure 8 shows corrosion from the inside out on the exterior wall panels of a university building in Illinois. These wall panels, which were not painted on the inside, corroded from the inside because of trapped condensation collecting on the inside metal surface. Corrosion damage occurred at locations where breaks in the plastic foam insulation prevented drainage. This type of weathering steel wall panel is no longer manufactured.

FIGURE 8 Weathering steel wall panel that corroded from the inside out.

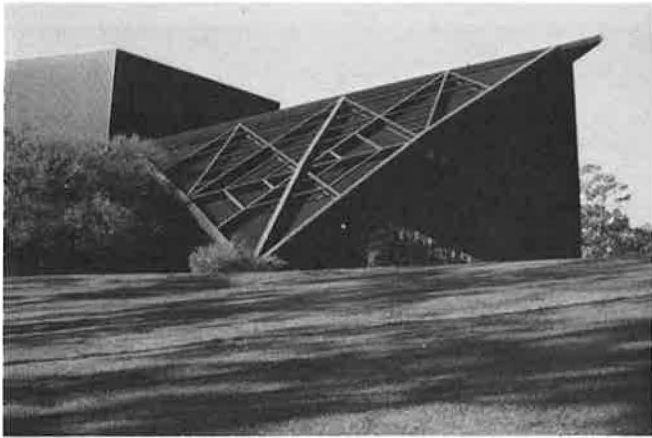
Figure 9 shows a public theatre in Texas that won an American Institute of Steel Construction (AISC) design award in 1969 (11). Figures 10 and 11 are closeup views of the roof where

FIGURE 9 Weathering steel structure with corrugated metal roof.

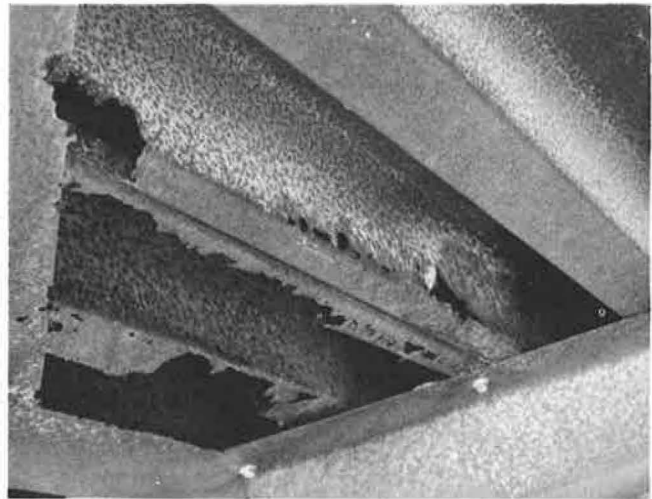
it corroded through. The entire roof of this building has been replaced, but this failure could have been predicted before construction. Corrugated roofing, similar to the one shown in Figures 9, 10, and 11, was one of the earliest tests for precursors of weathering steels (8). Recommendations were available in the 1960s indicating that painting or sealants would be required at loose joints between structural steel members (6). Corrosion products from the roof shown in these figures have negligible salt levels.

FIGURE 10 Corrosion of the corrugated metal roof shown in Figure 9.

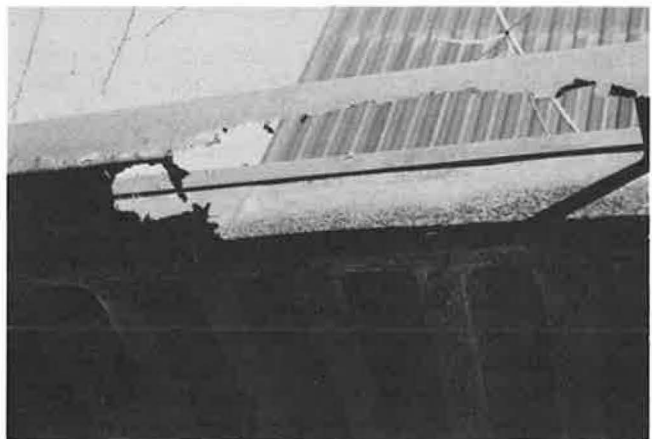
FIGURE 11 Corrosion of horizontal gutter on the same building shown in Figures 9 and 10.

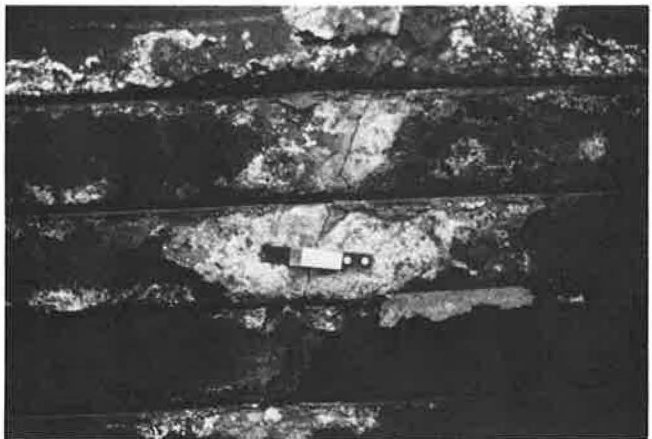
Figure 12 shows corrosion of permanent-form decking underneath the floor slab of a parking garage. The corrosion at this location has progressed from the inside out. The corrosion is associated with long-term wetting of the top (adjacent to the concrete) surface of the corrugated weathering steel. The metal in the center of the photograph shows a strain gage used to measure movement of the cracked concrete above the corrugated metal. The crack allowed the wetting that caused the corrosion. Voids in concrete were associated with corrosion at other locations. The building shown in Figure 12 is located in a seaport city. The boldly exposed, and well-drained, portions of the building do not have excessive corrosion despite exposure to a marine-atmosphere environment (14).

FIGURE 12 Corrosion of permanent-form decking underneath the floor slab of a parking garage.

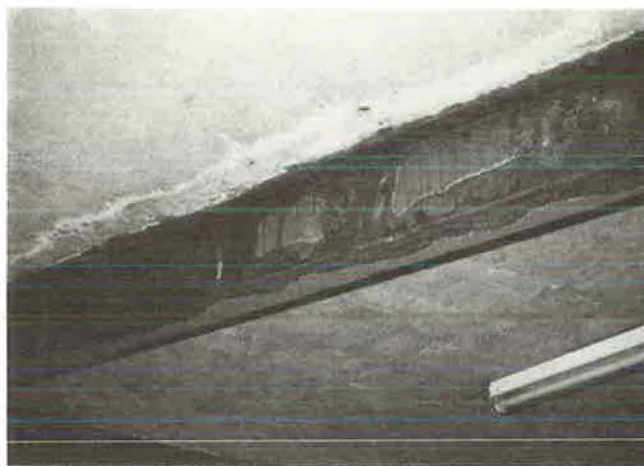
FIGURE 13 Salt stains and corrosion patterns on a weathering steel parking garage in Cleveland, Ohio.

recent report shows similar problems on European buildings (15). Most of this type of corrosion on buildings is due to crevices and inadequate drainage. Salts are not involved on most of these buildings, although they can have a major effect in parking garages (Figure 13).

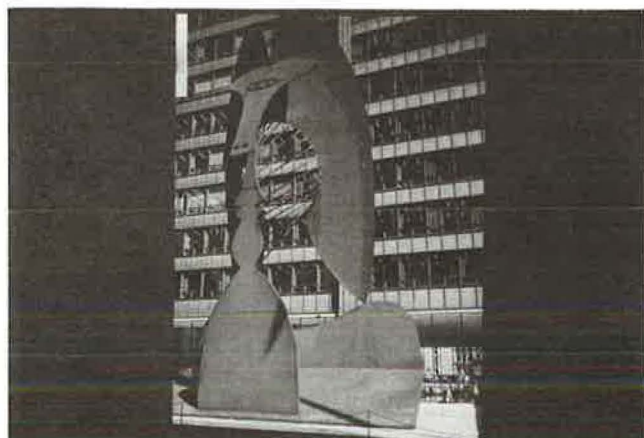
Figure 14 shows a well known statue in front of a public building in downtown Chicago. This early photograph of the statue shows light-colored rust and streaking that develops on many new weathering steel structures. The statue in question is located near heavy deicing salt applications. Despite the presence of these salts, most of the structure has developed a protective patina and is safeguarded against excessive corrosion. The only portion of the statue where nonprotective thick scales have formed is on the flat floor of the hollow statue. Figure 15 shows standing water on the floor of the statue. Corrosion products as thick as 1 to 2 cm can be removed from this location. These nonprotective scales are due to the poor drainage at this location and are not the result of deicing salts.

FIGURE 14 Weathering steel statue located in downtown Chicago.

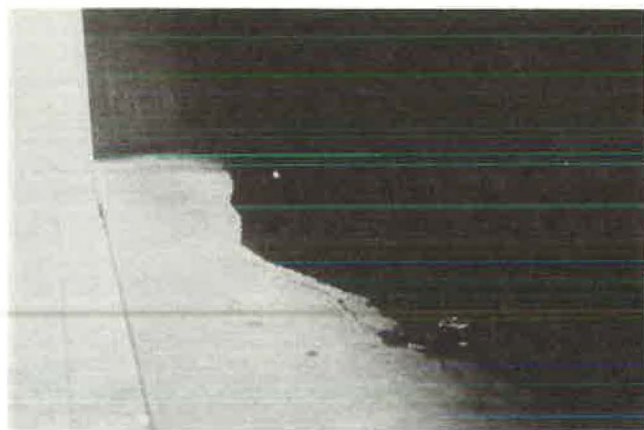
FIGURE 15 Standing water on flat floor of the statue shown in Figure 14.

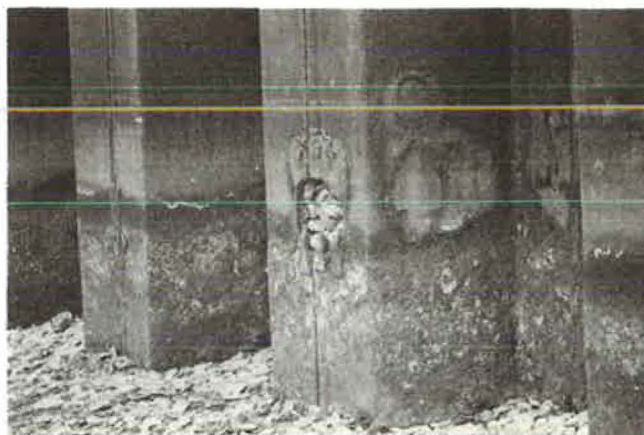
FIGURE 16 Corroded sheet piling along a tidal creek in Annapolis, Maryland.

unsuccessful, and most steel companies no longer promote weathering steels for marine applications. Figure 16 shows sheet piling alongside a tidal creek in Annapolis, Maryland. Most of the sheet piling has not corroded through, but there are perforations of the steel in many areas. Corrosion from the (continuously wetted) back side of the steel has caused these perforations. Similar corrosion patterns can be noted on sheet piling in other marine locations such as Port Canaveral, Florida, and Galveston, Texas. Salts from the marine environment could be expected to cause corrosion in these locations, and doubtless they do contribute to the corrosion that does occur, but most of the corrosion is caused by the lack of drying. Sheet piling along the Detroit River (freshwater) in Michigan shows the same corrosion patterns as the marine locations in Maryland, Florida, and Texas.
