Review of Field Measurements for Distortion-Induced Fatigue Cracking in Steel Bridges

JOHN W. FISHER, BEN T. YEN, AND DAVID C. WAGNER

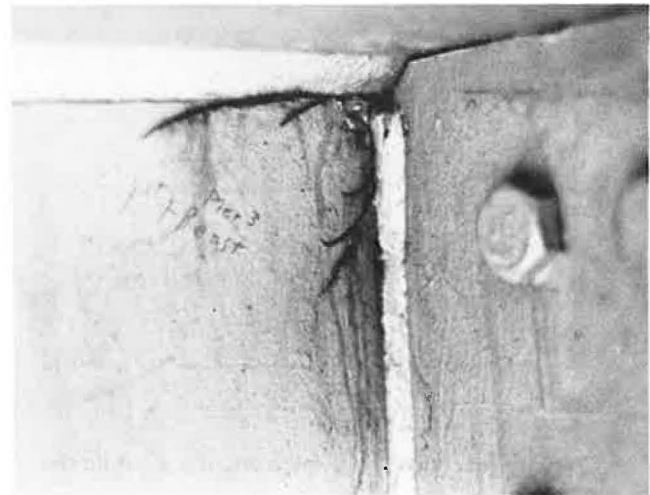
Extensive cracking has developed in girder web plates at the ends of floor beam connection plates. Results of studies indicate the cracking to be the direct result of cyclic, secondary bending stresses that are generated through relative out-of-plane movement. These displacements, though often less than 0.005 in. (0.130 mm), concentrate in gaps between the floor beam connection plate and the girder tension flange. Figure 1 shows the crack developed in a web gap at a floor beam-to-girder connection plate in the girder's negative moment region. As is common practice, the connection plate is cut short of the

FIGURE 1 Typical cracks in web at floor beam-to-girder connection.

tension flange. The gap containing the crack is bounded by the web-to-flange and connection plate-to-web fillet welds.

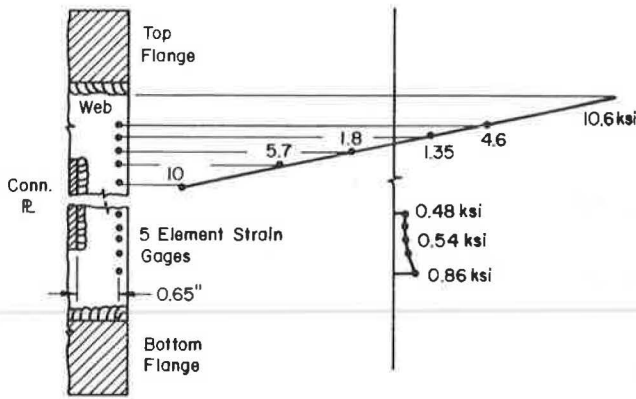
This mode of fatigue cracking was found at numerous gaps on the web of main girders on the Woodrow Wilson Bridge (1). The structure consists of 19 continuous multiple-girder spans ranging from 62 ft (18.9 m) to 212 ft (64.6 m) in length. Floor beams are 25.7 ft (7.8 m) and 36 in. (914 mm) deep. No positive attachment was made between either flange and the connection plate. The deck slab was cast directly on the outside main girders and supported by stringers and floorbeams in the interior. Thus, the deck restrained movement of the top flange of the main girders and, as the transverse floor beam deformed, caused out-of-plane distortion of the web within the web gap. The stress gradients from measured strains next to the gap are shown in Figure 2. The gradient shows that double-curvature web plate deflection exists in the short gap length. When extrapolated, a stress of 10.6 ksi (68.9 MPa) is expected at the longitudinal weld toe at the top. Within the gap, the surface stress at the weld toe can be two to three times greater than those recorded just outside the local region, as calculated by finite element analysis.

FIGURE 2 Measured and extrapolated stress gradient on web surface.

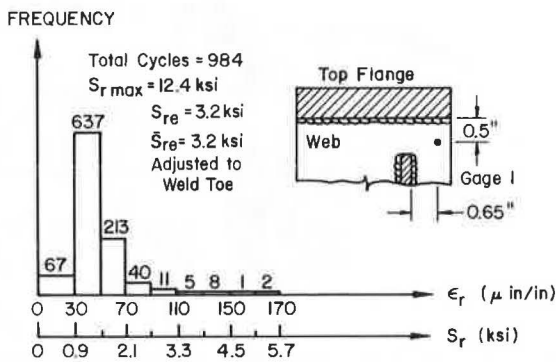
The stress range spectrum for the first gauge at the gap is shown in Figure 3. Also shown are the maximum and effective stress ranges at the weld toe, by adjusted extrapolation. Results of case studies indicate that the maximum stress range often

FIGURE 3 Stress range spectrum of a point on the web.

exceeds 12 ksi (82.7 MPa) and a Miner's effective stress range of 3 ksi (20.7 MPa) is quite common. These out-of-plane deflection-induced stress ranges are high enough for fatigue cracking in the web plate.

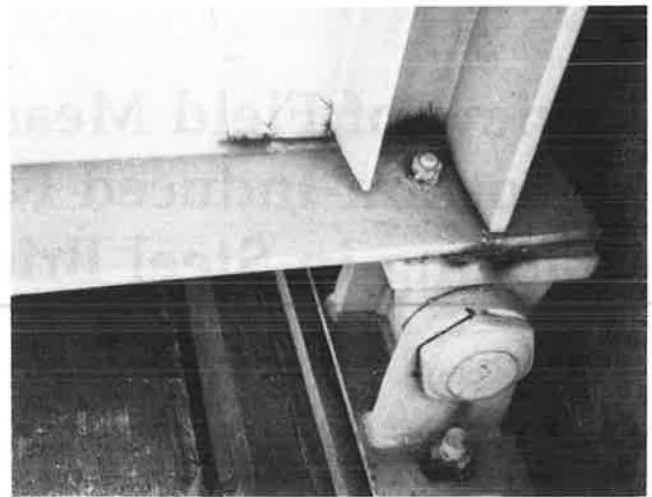
Typical cracking at the base of a bearing stiffener and within the gap of an adjacent transverse stiffener is shown in Figure 4. Nine bearing stiffener-to-floor beam connections were monitored. Cracking prevailed at the toe of the longitudinal flange-to-web weld and through the throats of the transverse connection plate-to-web welds. Representative stresses at the top flange of one connection are plotted in Figure 5. The back-to-back gauges "N" and "25" had stresses of -6.0 ksi (-41.4 MPa) and 4.2 ksi (28.9 MPa), respectively. These magnitudes

FIGURE 4 Cracking at base of bearing stiffener and adjacent transverse stiffener.

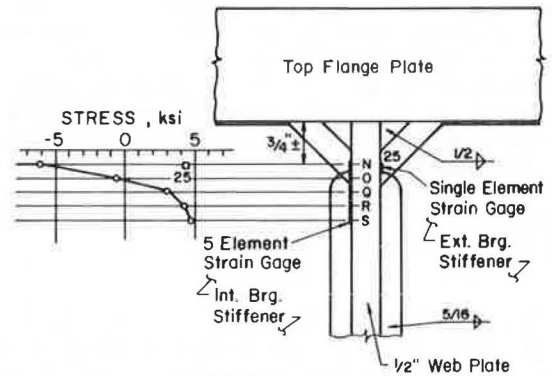
FIGURE 5 Typical stress gradient of web at bearing stiffener gap.

For the case of Figure 5, the projected stress was -14.0 ksi (-96.5 MPa) at the longitudinal weld toe. A list of selected results from field measurements at some bearing stiffeners is presented in Table 1. The web stresses have been adjusted to the flange-to-web weld toe by linear extrapolation.

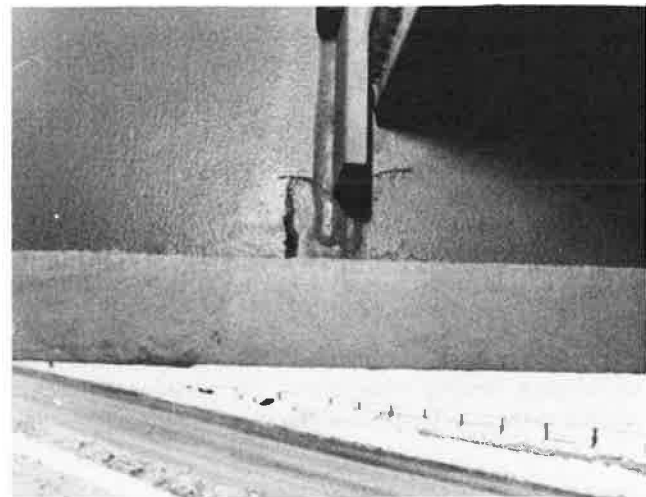
Cracks in the web plate at the gap develop along the toe of the flange-to-web weld and at the weld across the ends of the transverse connection plate in both the positive- and negative-moment regions of girders. Figure 7 shows a crack in the positive-moment region of a simple-span structure. Figure 8 shows cracks at the stiffener weld and at the web-to-flange weld at a diaphragm connection plate in the negative-moment region of the continuous-span Beaver Creek Bridge (3).

FIGURE 7 Cracking across transverse welds at diaphragm connection plate in the positive-moment region.

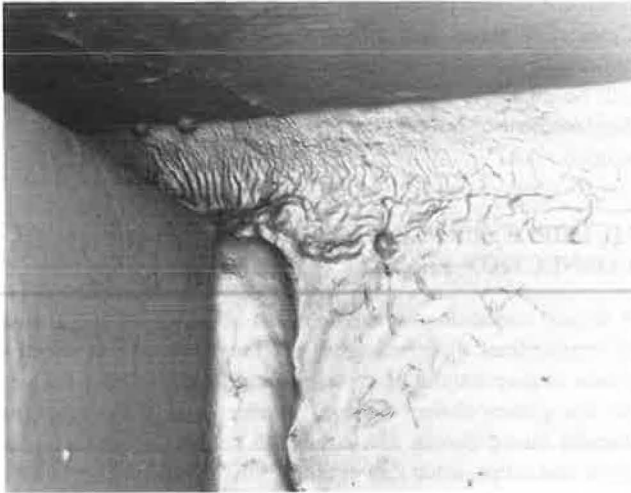
FIGURE 8 Cracking at the diaphragm connection plate gap in the negative-moment region.

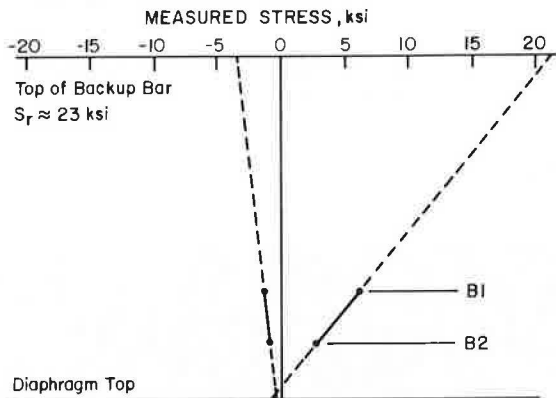
Out-of-plane displacement generates a stress gradient within the gap. Stress gradients at the instant of maximum and minimum stress in gauge B1 during a high-magnitude stress cycle are constructed in Figure 13. The difference between the maximum and minimum is the stress range for this cycle of

FIGURE 13 Stress gradients at top outside gap of box.

instantaneous stress excursion. Extrapolation (dashed lines) to the backup bar root shows that stress ranges could be on the order of 23 ksi (159 MPa). Such a magnitude of live-load stress can cause cracking at the root of the backup bar.

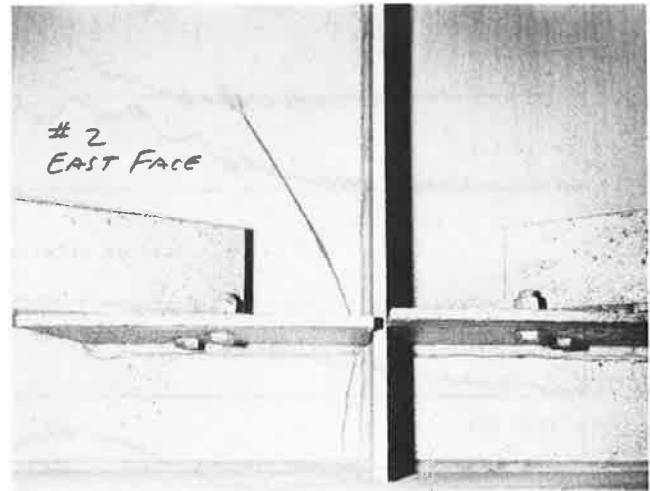
FIGURE 14 Typical crack growth from gusset plate gap.

The gusset plate may be welded, bolted, or cut free of the transverse stiffener in addition to being connected to the web. Figure 14 shows one case of two separate gusset plates welded to the web only. The gap bounded by the weld toe of the transverse stiffener and the near end of the gusset plate is less than 1/4 in. (6.4 mm) in length. The out-of-plane displacement and cyclic bending stresses have caused the crack development and growth.

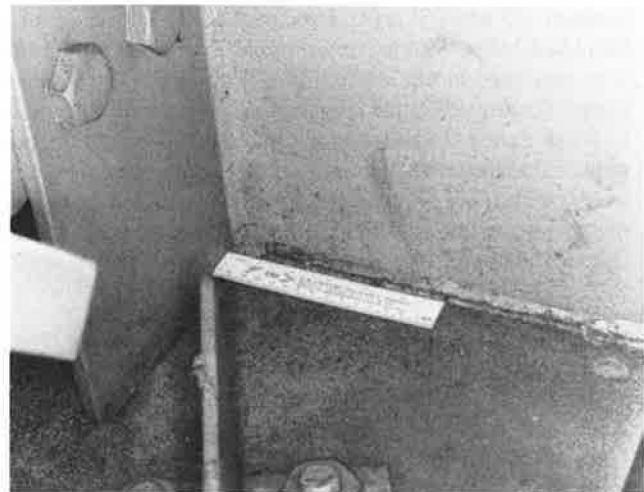
Cracking in web plates at the lateral gusset plate gaps has developed in I-79 Bridge 2682 over Big Sandy Creek (4). The twin bridge is supported by two main steel girders with four stringers resting on transverse floor beams. The continuous girders have three spans of 120, 130, and 120 ft (36.6, 39.6, and 36.6 m). The lateral bracing members at a floor beam location are bolted to a gusset plate welded to the girder web, but not to the floor beam connection plate, forming gaps such as that shown in Figure 15. The gaps vary from 1/4 to 1 in. (6.4 to 25.4 mm) in length. The prevailing condition has resulted in the formation of vertical cracks on the outside surface of the web plate along weld toes of the transverse stiffener.

FIGURE 15 I-79 Bridge 2682 lateral gusset plate connection detail.

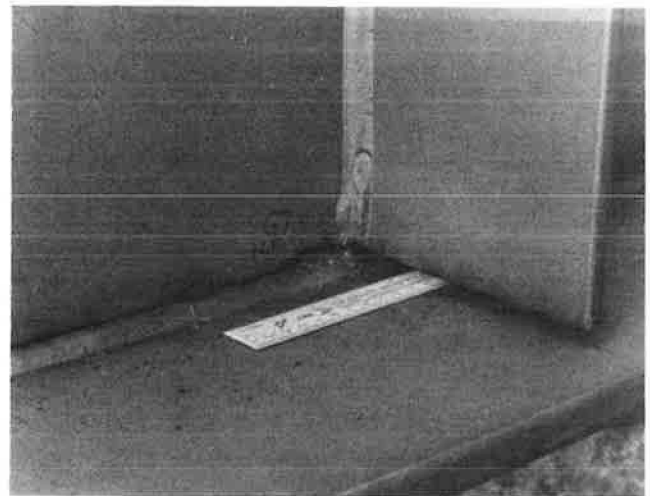
Numerous cases of cracking at intermediate transverse stiffeners of girder webs have been reported with the causes traced to the transportation of the girders. One such crack that was investigated is shown in Figure 17. The crack initiated at the termination of the transverse stiffener welds and extended

FIGURE 17 Cracking at a transverse stiffener web gap adjacent to a field splice.

along the web-to-flange weld parallel to the longitudinal axis of the girder. Because of the comparatively slender and flexible web, there may often be a relative movement between the top and bottom flanges during transportation. The support points of girder segments during transportation are usually directly under intermediate transverse stiffeners. At these locations, the lateral movement is accommodated by the flexible gap between the stiffener and flange. Hence, the out-of-plane lateral deformation and corresponding stresses are again introduced in the gap. This condition has led to cracking at the end of transverse stiffener welds and at the web-to-flange fillet weld. These cracks are often unnoticed until an in-service inspection is performed.
