# Field Study of a Pedestrian Bridge of Reinforced Plastic

FRED C. MCCORMICK

A discussion of the behavior of the superstructure of a pedestrian bridge fabricated with glass-reinforced plastic under a field load test is presented. Experimental measurements of elastic vertical deflections were 1.8 times greater than those predicted by means of a finite element solution. A live load of 3.5 times the dead load of the superstructure and polymer concrete deck was used for the elastic load test. Elastic strains were uniform among the different elements of the superstructure and computed stresses did not exceed 10,000 lbf/in.<sup>2</sup> at full live load. A residual deflection in the superstructure of 0.10 in. on removal of the live load was concentrated in the supports. Creep deflection and strain measurements recorded over 61 days indicated that negligible creep occurred under a load of 2.6 times the dead load. Air temperature variations produced pronounced changes in deflection and strain readings, but were reversible. The overall structural behavior of the bridge and resistance to handling abuse exceeded expectations.

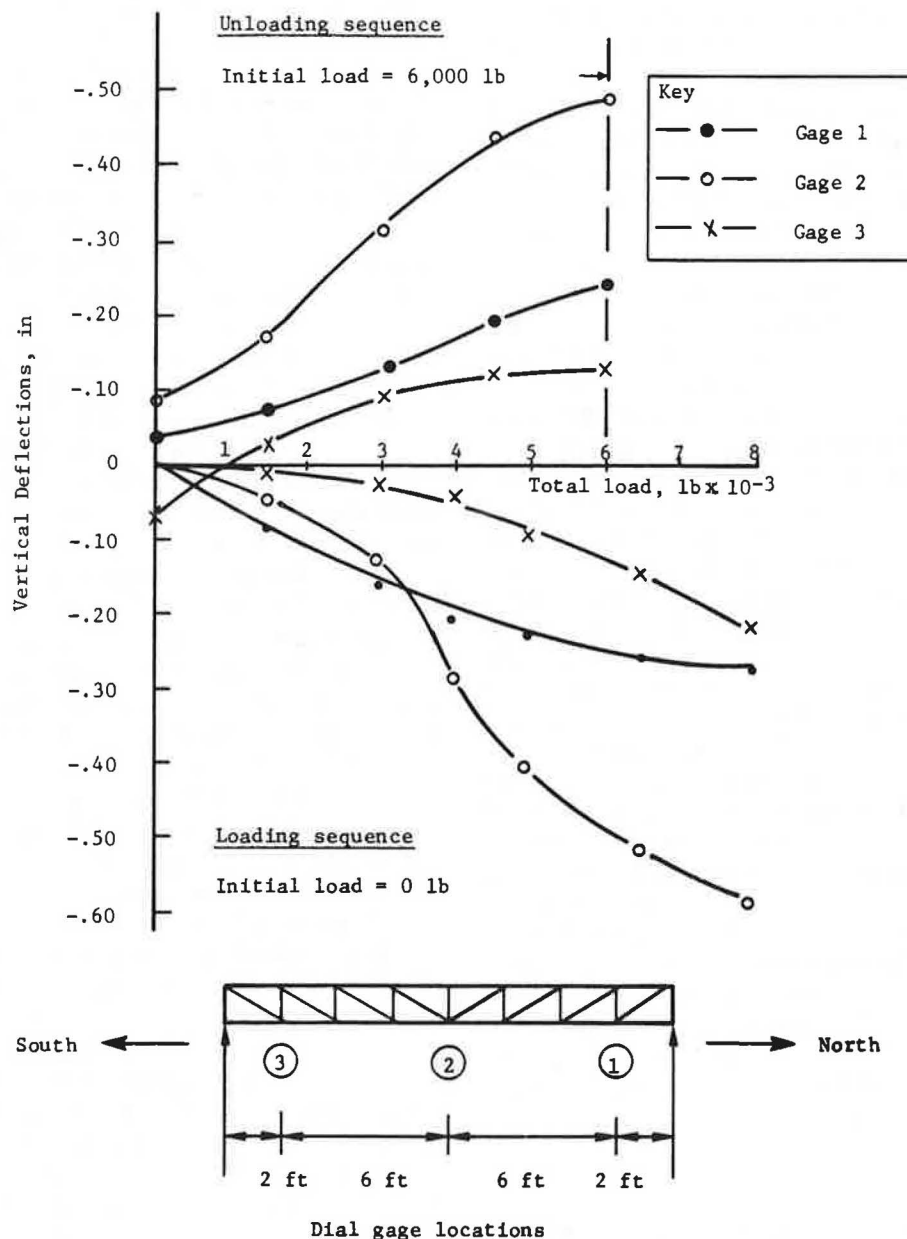
**FIGURE 6** Deflections of the lower chord of the center girder as a function of live load.

pads and distortion of the stiffeners in contact with the bearing surfaces. It was not possible to evaluate these components of the measured deflections separately, but they are believed to be a significant part of the values measured by gauges 1 and 3. This supposition is supported by the deck deflection data discussed later. The larger deflection, shown by gauge 1 as compared with that by gauge 3, resulted from the application and removal of the load progressively from the northern end of the bridge to the southern end.

It was expected that the deflection at gauge 3 would reach that of gauge 1 when the full load was applied, because an effort was made to distribute the filled drums symmetrically about midspan. However, a check of the positions of the drums on the deck after they were filled indicated that the loads on the southern half of the bridge were approximately 4 in. closer to the center of the bridge than were loads on the northern half. Thus, it is believed that the off-center loading, plus probable differences in the settlement characteristics of the supports, completely explains the difference of 0.06 in. in the measured deflections.

The difference between the average measured deflections of the end gauges (1 and 3) and gauge 2 was 0.324 in. for the full load of 8,000 lb. If it is assumed that approximately one-half (0.12 in.) of the average deflection (0.24 in.) of the end panels was caused by the settlement of the bearing pads and support stiffeners, the centerline deflection of the girder due to flexural action would be 0.44 in. The estimated center deflection of 0.44 in. results in an L/S value of 435 for a span of 16 ft. This is approximately twice the AASHTO limit for pedestrian bridges. The deflection of 0.44 in. compares with a range of values from 0.25 to 0.30 in. computed from a theoretical analysis of the bridge. McCormick and Alper (3) describe the finite element model and solution for the three-girder bridge configuration.

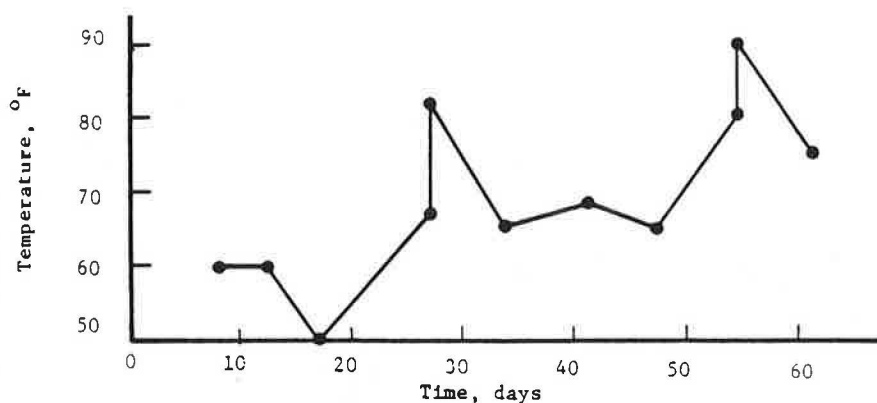
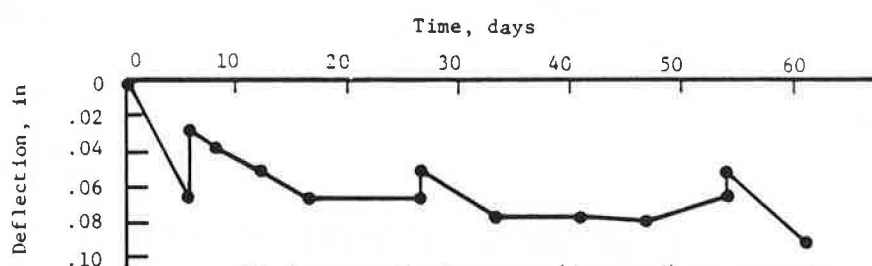
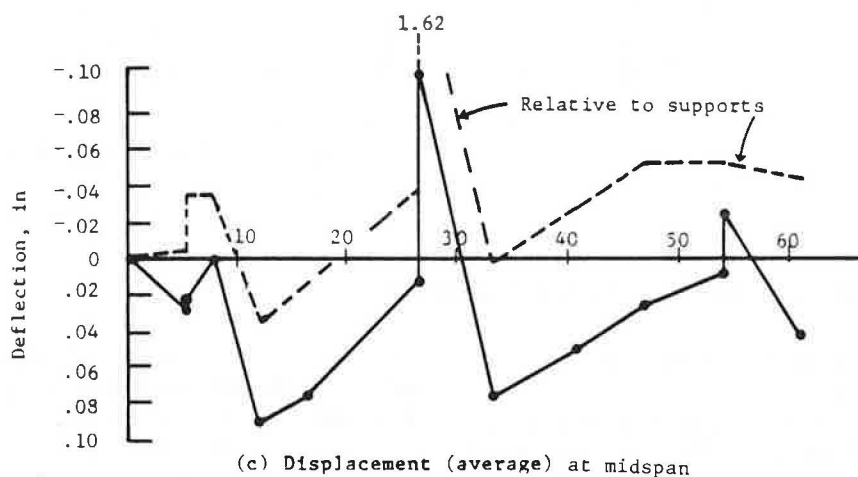
Initial creep readings taken within 30 min after the final load increment was applied correspond to the zero deflection value at time zero in Figures 7b and 7c. The deflections shown in Figure 7b may be attributed principally to the distortion of the elastomeric bearing pads beneath the supports. The data of Figure 7c are plotted as movements of the center span with reference to the benchmarks (solid lines) and also with reference to the supports (dashed lines). Dual data points shown on three different days reflect the reduction of load from 8,000 to 6,000 lb on Day 6 and readings taken in early morning and late evening for temperature fluctuation effects on Days 26 and 54.

In general, the deflection data of the supports and the center span clearly follow the ambient temperature fluctuations—when the temperature increased, the deck rose; when the temperature decreased, the deck fell. As might have been expected, the movement of the midspan was more pronounced than the movement of the supports. The supports were shaded from direct sunlight by the bridge superstructure and the abutments but the deck surface was exposed to heating from the sun during the day and rapid cooling during the night. Because of the continual movement of the deck, it was difficult to determine from the available data whether any viscoelastic creep occurred in the superstructure, but if so, it was not detectable during the 61-day test period.

**FIGURE 7 (a) Air temperature fluctuation, (b) Deflections of deck at supports, and (c) Deflections at midspan.**

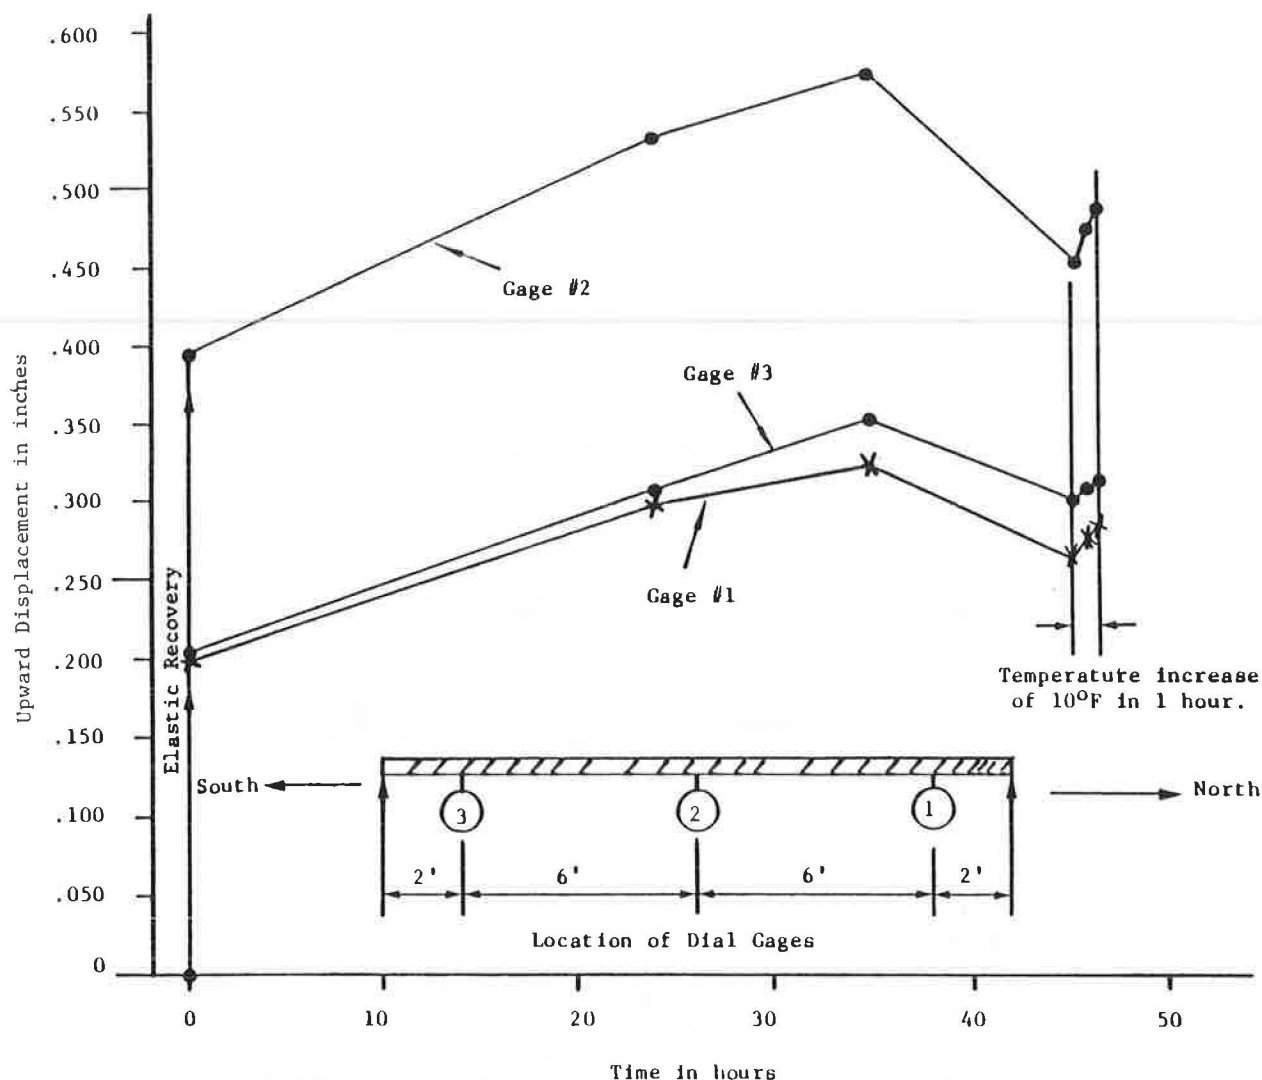
Figure 8 shows the creep recovery, sometimes referred to as an "elastic aftereffect," of the bridge following removal of the live load. Also indicated is the considerable influence of ambient temperature variations on the deflected position of the lower chord of the bridge. The plotted points indicate gauge readings at times of 0, 24.0, 37.0, 45.5, 46.0, and 46.5 hr. Lines connecting the points are not intended to represent the variation in readings, except for the period from 45.5 to 46.5 hr, when the gauges were monitored continuously. Two phenomena were at work to influence the deflection measurements: creep recovery and temperature variation. Regrettably, a careful record of the ambient temperature was not maintained during the test period, principally because temperature changes were not considered to be such an influential factor as they (in hindsight) apparently were. The effect of temperature was clearly demonstrated by the upward movement of the lower chord over a period of 1 hr (from 7 to 8 a.m.), during which time the ambient temperature increased from 60° to 70°F. Values of 0.02, 0.03, and 0.01 in. occurred at gauges 1, 2, and 3, respectively, during that period of time. The movement due to temperature in 1 hr represents approximately 15 percent of the maximum creep recovery measured in 37 hr. Although the change in geometry of the

Analyses of the measurements for deflection recovery indicated that essentially all of the movement of the structure occurred at the supports. That is, after allowing for temperature fluctuations, the movement of gauge 2 relative to gauges 1 and 3 was nearly equal over the observation period of 46.5 hr. Therefore, it appears that little, if any, viscoelastic creep occurred in the bridge itself and that the measured rebound of the structure was due to the recovery of the elastomeric bearing pads. A similar observation was made in the creep study of a single girder over a period of 3 months (1).

FIGURE 8 Deflection recovery of bridge following load removal.

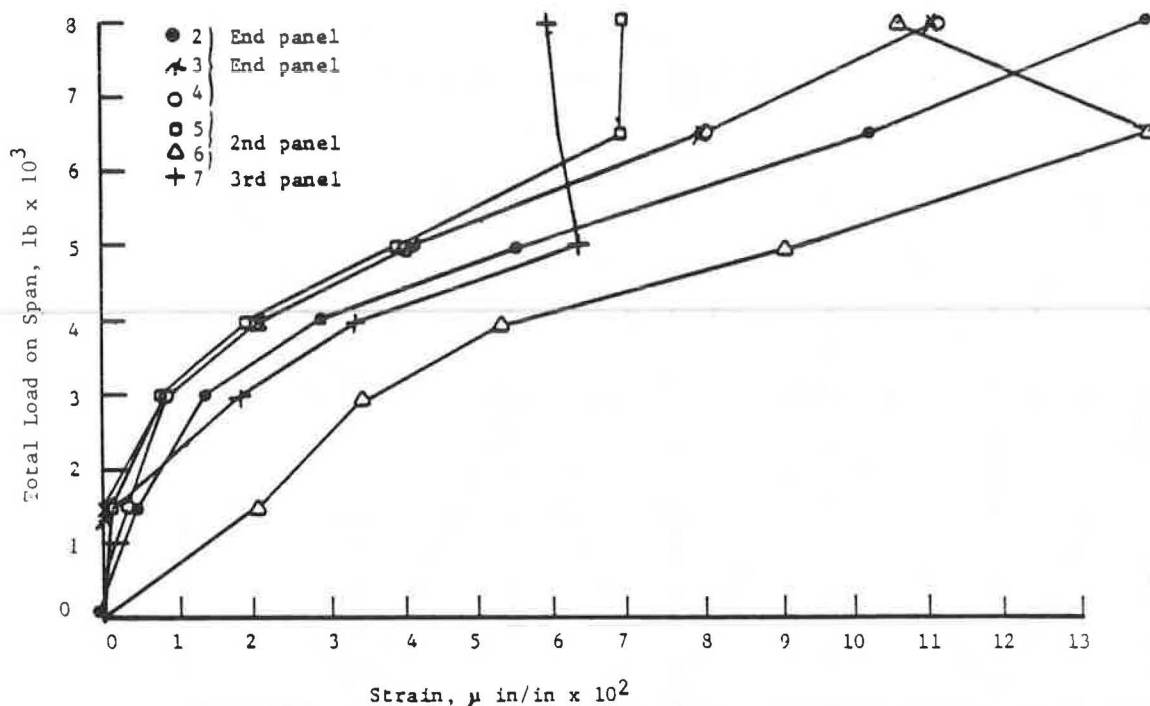
Figure 10 presents data from six gauges mounted on the inclined web elements. Gages 2, 3, and 4 in the southern end panel tracked each other closely during the period of loading and ranged from 11,000 to 14,000  $\mu\text{in./in.}$  when the total load was applied. These three gauges indicated no reversal of strain increase in the end panel. The difference in strains between gauges 2 and 3 is indicative of a possible load-carrying discrepancy between one of the outside girders and the inside girder, whereas the data from gauges 3 and 4 indicate similar load distributions between the center girder and the other outside girder. Gages 5, 6, and 7 in the second and third panels from the southern end indicated approximately the same increased rate of strain with the application of the load as did gauges 2, 3, and 4 until loads were applied directly to their respective panels. At that time, the strains reversed direction. This change in direction reflected the change in magnitude of the negative shearing force in the interior panels as the load was increased and more uniformly distributed along the length of the bridge.

FIGURE 10 Elastic strain in inclined web elements in the girders due to application of loads.

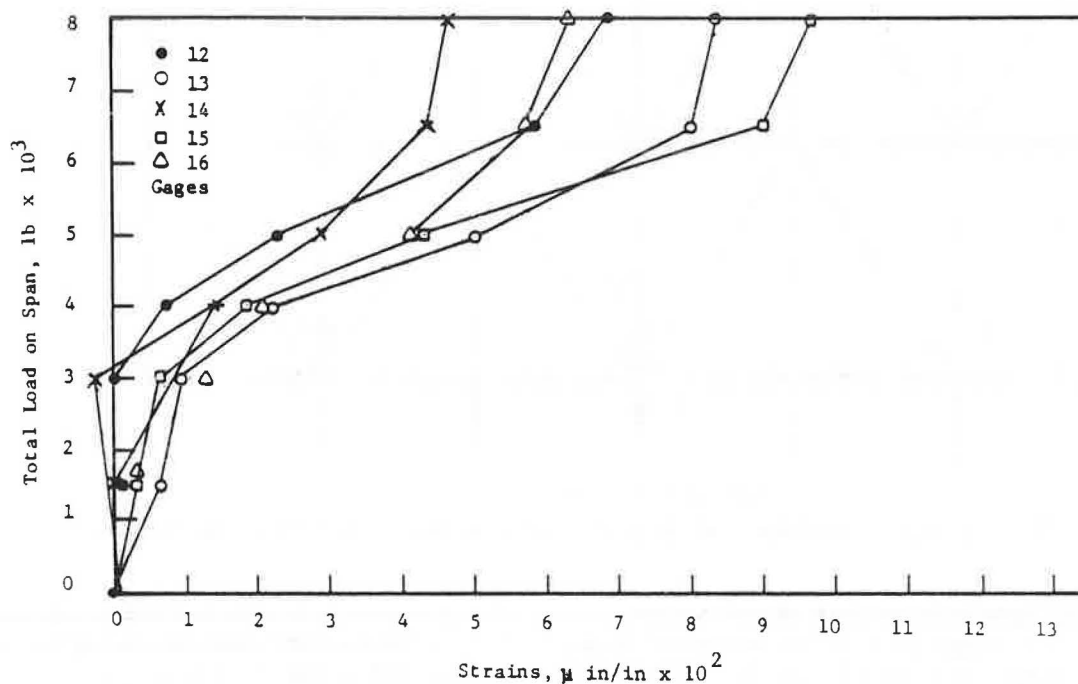
Figure 11 presents strain data from five gauges mounted on the lower chords. All gauges indicated increasing strain values

as the load was increased on the bridge. As expected, a sharp reduction in the strain rate in all five gauges was noted with the application of the last increment of load. As noted previously, the last load increment was applied in the southern end panel and, therefore, should not have affected the flexural stresses in the girders as much as the prior load increments had. Figure 11 shows that a relatively narrow range of strains was measured throughout the four panels and two girders monitored by the gauges, particularly through the application of the first 5,000 lb of load. The narrow range of strain values indicates that the lower chord elements were stressed as uniformly as might be expected with the nonuniform arrangement of the test load. The relative uniformity of stress indicates that the design procedure used to dimension the chord elements produced an efficient structural configuration. Also, the lateral transfer of the load and the interaction between girders during the load test appeared to be satisfactory as indicated by the random variation in strain values in the chords of the inside and outside girders.

FIGURE 11 Elastic strain in lower chord elements in the girder due to application of loads.

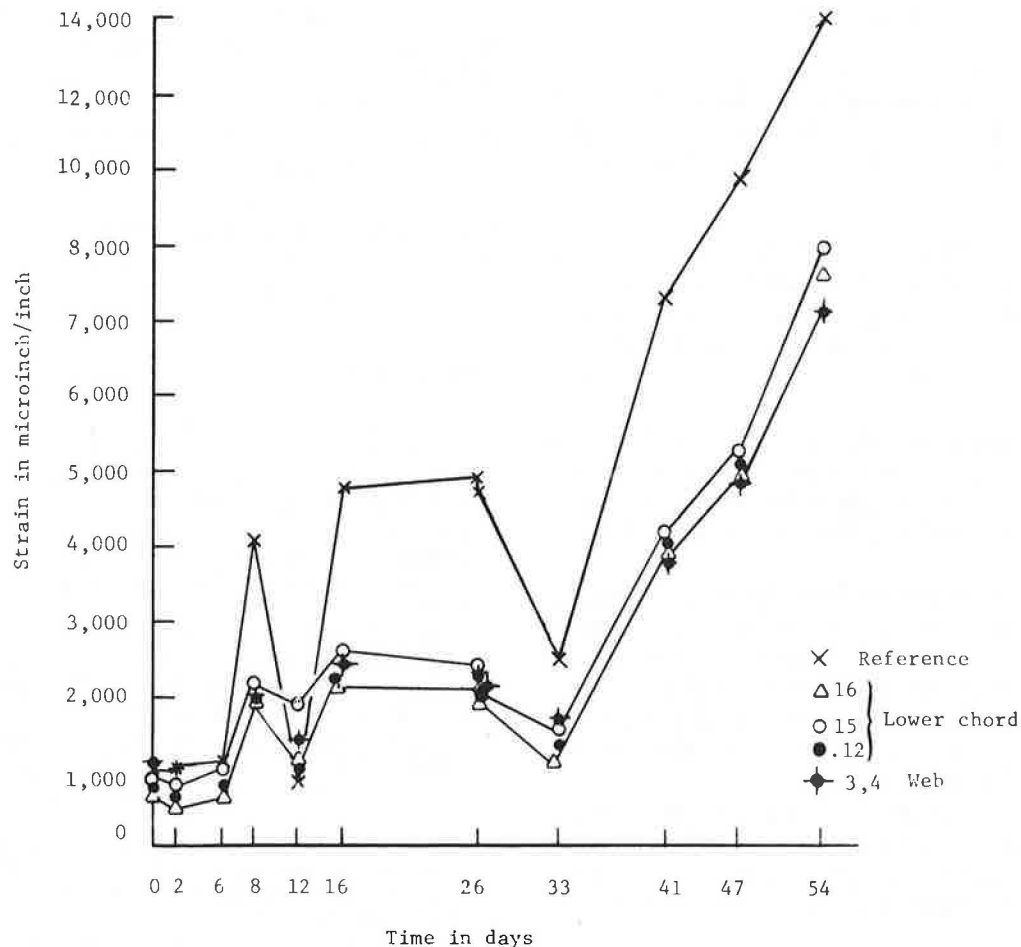
Figure 12 presents representative strain data from five active strain gauges and a fixed reference circuit over the duration of the creep test. The reference circuit was fixed at 1,000  $\mu$ in./in. as a check on the stability of the measuring indicator. As can be seen in Figure 12, the reference circuit remained essentially unchanged for the first 6 days of the creep test. Thereafter, wide fluctuations appeared in the data until, finally, the drift in the reference circuit exceeded the range of the indicator. Also, note

that the magnitude of variations in the reference considerably exceeded those of the measuring circuits, even though the directions of the deviations were the same. Efforts were made to correct the obvious malfunction of the instrument as soon as the deviations were noted, but to no avail. Apparently, moisture penetrated the switching units and altered an internal resistance common to all of the gauge circuits to produce the results obtained. The measurements were discontinued after 54 days.

FIGURE 12 Strain in selected elements versus time with full live load.

considered reliable, it appears that no measurable creep occurred in the three lower chord and two web elements shown in Figure 12. The absence of detectable creep strain in the individual elements of the girders corresponds to the deflection measurements of the lower chord and the deck as discussed previously. The relatively low stresses developed in the elements due to the full live load accounts for the absence of creep in the composite material.

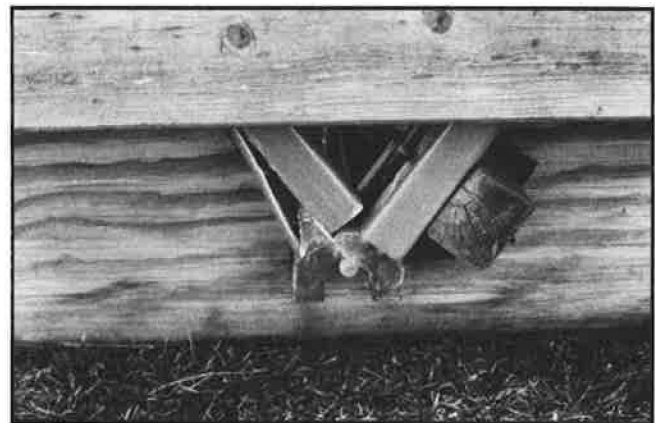
Unexpected but valuable information was obtained when the superstructure was moved to the test site. The bridge was loaded onto a lowboy by means of a front-end loader and transported approximately 8 mi to the erection site. During loading and handling, the outside stiffeners at both ends of the center girder were broken where a lifting chain made contact. The extent of the damage to a stiffener may be seen in Figure 13. Aside from some abrasion on the edge of the cover plate on the deck, no other damage to any of the structural elements was observed. The displaced stiffeners were realigned manually with the lower chord connector and reinforced by cutting and bonding a pultruded GRP plate  $\frac{1}{2}$  in. thick to the mating

FIGURE 13 Damaged web stiffener at the end of the center girder.

stiffeners. The repaired members showed no distress during the load tests.
