Tunnel "Daylighting" on the Alaska Railroad

F. C. WEEKS, T. B. TRUEBLOOD, A. KRAUSE, AND D.C. WYLLIE

In June 1984 routine scaling of loose rock from above the north portal of the 175-ft-long Tunnel 5 on the Alaska Railroad's Seward-Anchorage line revealed some large cracks and very unstable rock. Before stabilization work could be started, a 10-ft length of the tunnel collapsed, burying the track. Traffic was stopped for 48 hr while the track was cleared and an assessment was made of stability conditions. In this paper are described the emergency procedures that were undertaken during the next month to correct the hazardous rock stability conditions in this area. The stabilization procedure consisted of blasting to daylight the 150-ft-long tunnel, thus forming a steep rock cut as much as 120 ft high. Because of the very unstable condition of the rock, it was necessary to remove the tunnel in a single blast consisting of about 600 holes. Most of the holes, with lengths of up to 80 ft, were drilled on the slope above the tunnel on a 6-ft-square pattern. Exceptions were the shear line holes, which were drilled on 2-ft centers, and two rows of holes drilled from the tunnel into the o

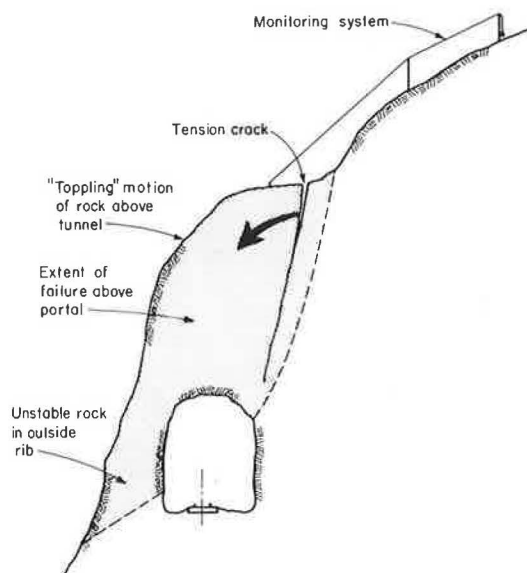
On Thursday, June 21, 1984, a collapse occurred involving a 10-ft length of the north portal, with a volume of about 1,000 yd³, that buried the track to a depth of 12 ft. A front-end loader was immediately mobilized to remove the fallen rock, and by Saturday morning the track was cleared. However, observation of the new portal face revealed areas of very loose, hazardous rock, and there was concern that vibration produced by the passage of a train could cause a further collapse. This loose rock occurred both in the rib on the outer side of the tunnel and on the slope surface above the portal where there were a number of open tension cracks as much as 10 in. wide

FIGURE 2 Extent of instability above portal.

(Figure 2). Fortunately, the area of instability was confined to the north portal; the rest of the tunnel was stable.

The primary cause of the instability at the portal was the partial failure of the narrow rib of rock on the outside of the tunnel. The canyon wall at this point is as steep as 70 degrees, and the outer rib varied in width between about 10 and 20 ft. The rock in this pillar had been somewhat damaged by blasting in the original construction, and at the portals the rock had loosened and relaxed as a result of the pillar being unconfined on three sides. This weakening of the rock in the pillar resulted in a "toppling" of the rock above the tunnel into the canyon.

The instability at both portals was so extensive that a major stabilization program was required to make the track safe. The only two alternatives considered were either to construct reinforced concrete portals at both ends of the tunnel or to remove the tunnel entirely to form a 120-ft-high slope. The merits of these two alternatives are discussed next.

It was decided that the daylighting option would be adopted, mainly because it could be done within a month with no disruption to traffic while the blastholes were drilled. Another important factor in this decision was that examination of the rock showed that it would be possible to cut a steep slope in the rock and minimize the volume of the blast.

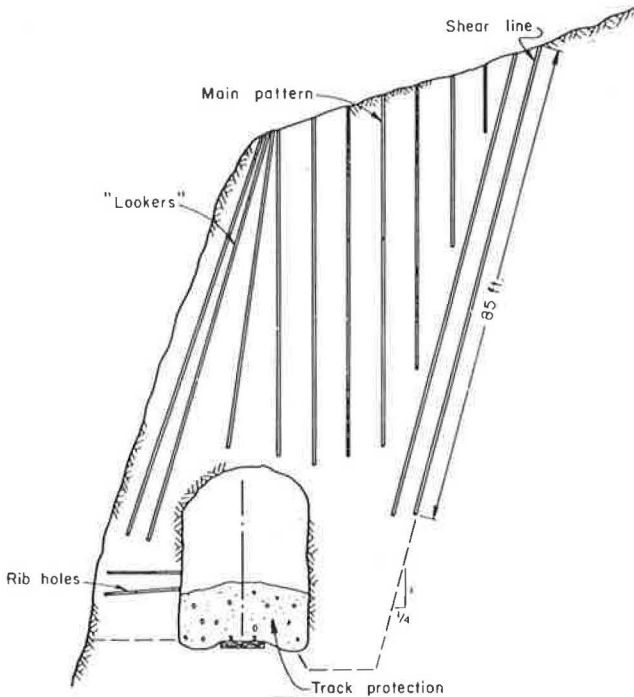
It was decided that it would be possible to cut the slope at the steep angle of $\frac{1}{4}$:1 after a close examination of the rock conditions (Figure 3). The bedding planes have continuous lengths of as much as 100 ft, but they are nearly vertical and strike across the tunnel. Therefore it was not possible for any large blocks of rock to slide on these fractures. The joints have continuous lengths of only 2 to 3 ft, so they will have no effect on overall stability. Any small, loose blocks formed on the joint surfaces could be readily scaled from the slope.

FIGURE 3 Blast hole layout.

The achievement of these results depended mainly on two factors: First, it was essential that the drillholes be evenly spaced so that there was a uniform distribution of explosive throughout the rock. This required detailed design of the more than 600 holes in the blast and then accurate location of each of these holes on the hillside with survey stakes, each marked with the inclination and depth of the hole. Also, drills would have to be carefully positioned and aligned to keep deviation to a minimum. It was decided that the maximum hole depth should be about 80 ft, because at greater depths deviation was likely to be excessive. Figure 3 shows a typical drillhole layout; note that the holes, except for the "lookers," extend only as far as the springline of the tunnel (i.e. a depth of about 80 ft). The rib pillar beside the tunnel was broken with two rows of holes drilled from the tunnel on 2-ft centers.

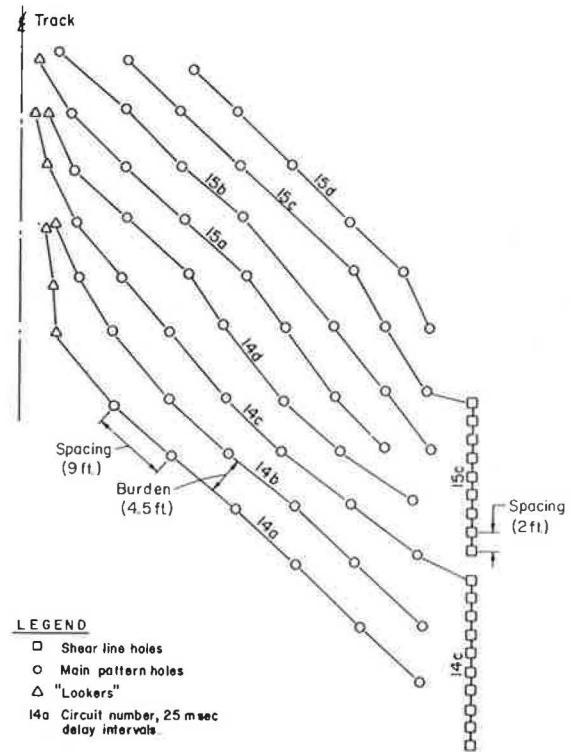
FIGURE 4 Blast hole detonation sequence.

delay caps were used to arrange the holes in a series of rows at approximately 45 degrees to the track centerline (Figure 4). Because the blast was initiated at the cut face to the north of the tunnel and the rows were detonated on 25-msec delays, every row broke to a free face. This delay sequence also moved the rock away from the bridge at the south end of the tunnel.

The shear line was detonated as a "cushion blast" with each 20-ft length of the shear line detonated with every fourth row of the main pattern. In this way, the shear line fired after the pattern holes in front of it. It was decided that a "pre-shear" would not be used because there was a high risk that concussion produced by the detonation of this back row of holes might displace the rock and cause cutoffs in holes of the main blast.

Correct sequencing of the detonation of all 600 holes was achieved by the use of an electronic sequential timer. Four rows of holes were wired into each circuit of the timer, and the interval between timer circuits was set to 100 msec. This created a uniform 25-msec delay between each row of holes.

The final holes to be detonated were the two rows in the tunnel rib that were detonated with 4,000-msec caps but were energized with the first timer circuit so that they would not be cut off by the main blast above. The rib holes were detonated last in the sequence so that the rib formed a buttress to protect the track from the impact of the blasted rock. A summary of the explosive loads follows:

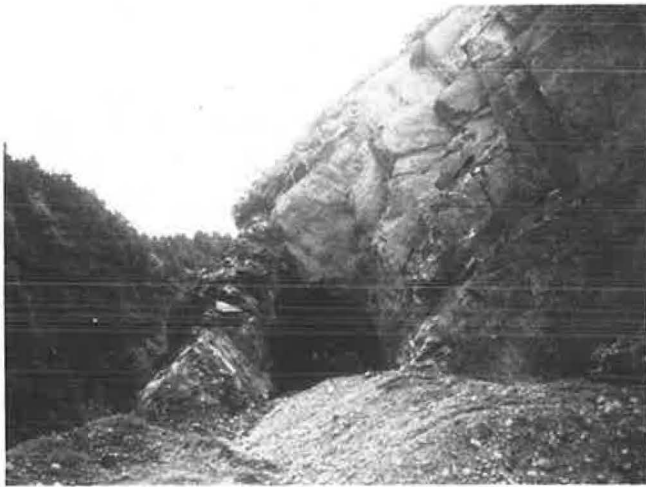
FIGURE 5 North portal showing tension crack and track protection.

protected during the blast with a 6-ft-thick layer of gravel (Figure 5), and a bridge about 50 ft from the south portal was protected with heavy timbers.

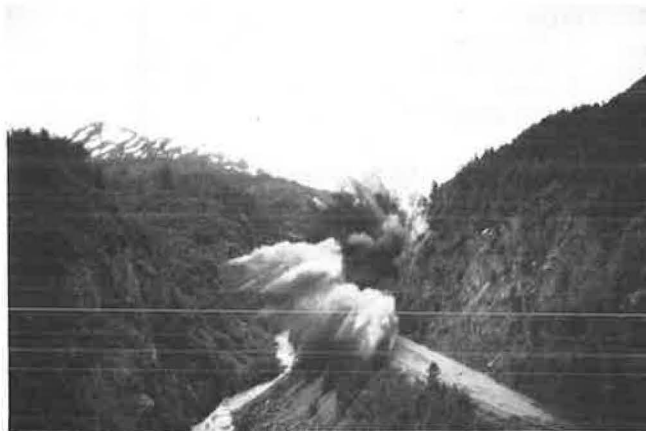
FIGURE 6 Blast detonation initiated above north portal.

Loading of the explosives started on Saturday, July 21, using five two-man crews and was completed by midafternoon on July 22, after about 18 hr of working time. It was decided that no trains would operate while the loading was in progress as a precaution against accidental detonation. The blast was finally detonated at about 6:19 p.m. on Sunday, July 22 (Figure 6).

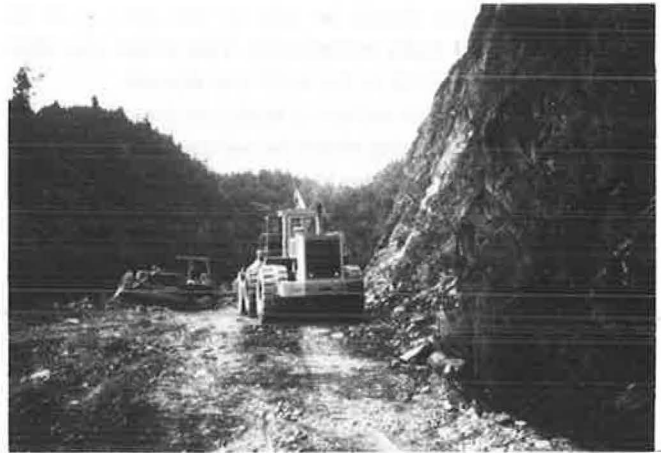
FIGURE 7 Removing broken rock from track.

As soon as the dust had cleared, two bulldozers (a D6 and a D8) and a loader started to clear the broken rock, which had formed a muckpile about 30 ft high, from the tracks. These three pieces of equipment operated throughout Sunday night, and by 10 a.m. Monday morning the track was clear—after a total closure time of about 50 hr (Figure 7).
