Water-Induced Distress in Flexible Pavement in a Wet Tropical Climate

T. F. FWA

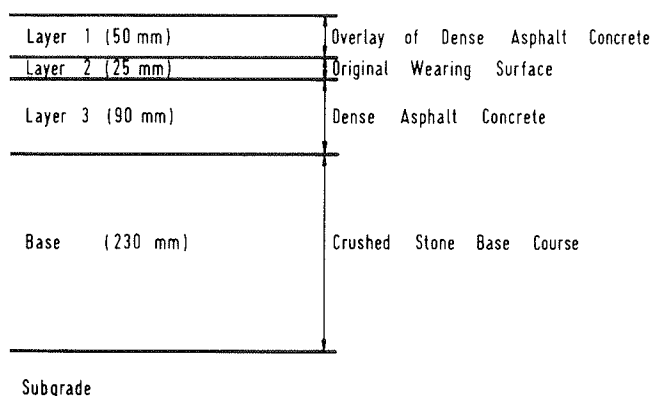
The construction history of the roadway revealed the pavement structure shown in Figure 1. There was a 230-mm-thick base course of crushed stone. A 90-mm dense asphalt concrete layer was constructed above it, followed by an open-graded 25-mm asphalt wearing course. After about 5 years in service, a 50-mm overlay of dense asphalt concrete was laid in July 1984. Records showed that the overlay construction was carried out during a dry period. Figure 2 shows the profile of a typical core sample of the pavement structure.

FIGURE 1 Profile of pavement structure.

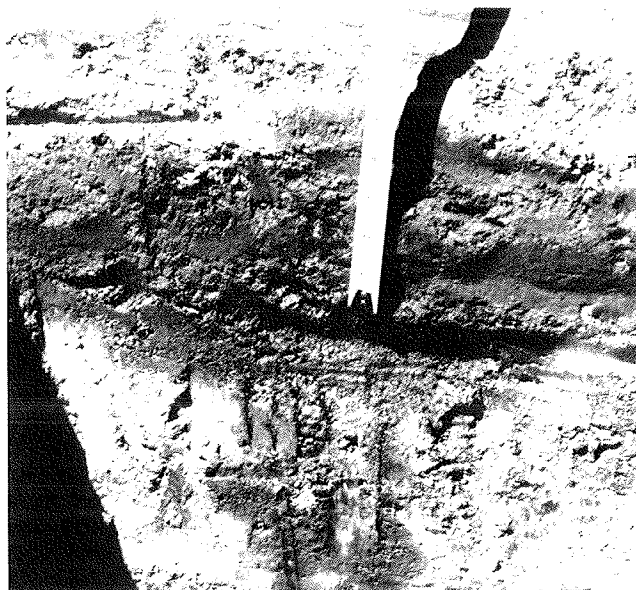
Several 600- by 600-mm pits were excavated to the base course for inspection. Typically, the uppermost overlay and the bottom 90-mm asphalt concrete layers were dense and intact. The intermediate 25-mm old wearing course was damp, soft,

and disintegrated as shown in Figure 3. Aggregates and bituminous binders of this second layer could be easily separated and extracted by bare hands. The water table was approximately 900 mm below the pavement surface. There was no sign of accumulated water within the base course, which was found to be dry and free draining. On the walls of each of these pits, as shown in Figure 4, water could be seen seeping out from the interface plane between the second and third layers. Pits were also excavated at the locations of swelling spots where only the top overlay layer was removed. There was no effective bond at the interface between this and the disintegrated layer below it. In about 15 to 20 min, approximately 40 mm of water would be

FIGURE 3 Soft damp material sandwiched between dense asphalt concrete layers.

This water-induced problem required prompt correction because pavement deterioration in the form of potholes and surface disintegration was occurring at an accelerated pace under moving traffic. Surface treatments or additional overlay could not eliminate the problem. The only logical solution was to remove the sandwiched water-logged layer together with the top overlay surface for the entire length of the pavement. Measures were also taken to improve the drainage conditions of the area to avoid standing rain water on the borders of the roadway.

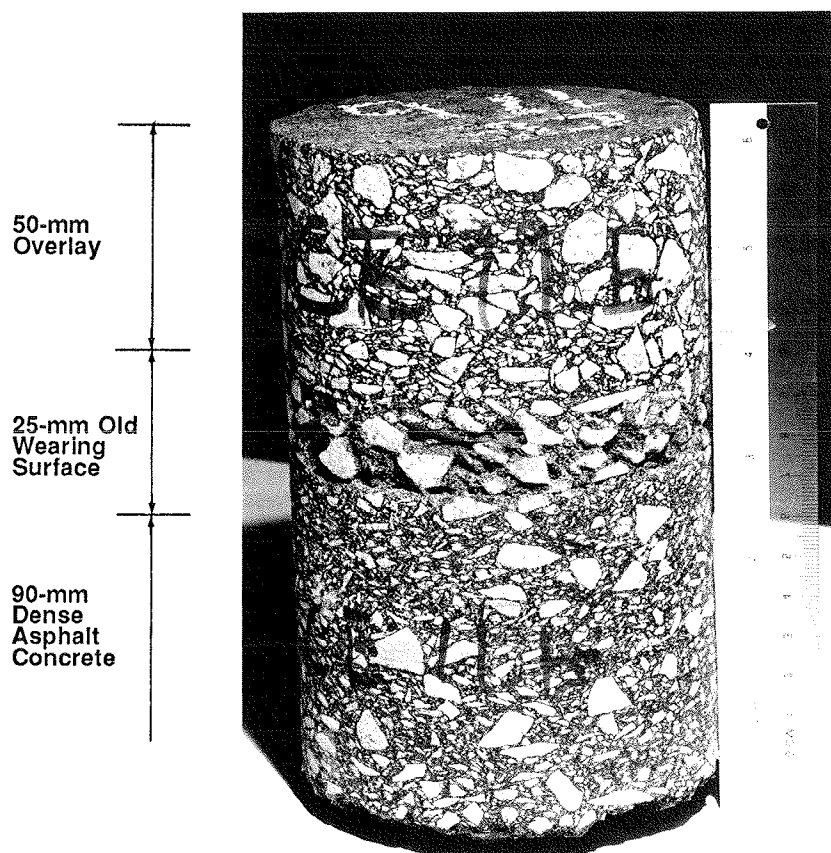
FIGURE 2 Core sample showing new overlay constructed on weathered old wearing surface.

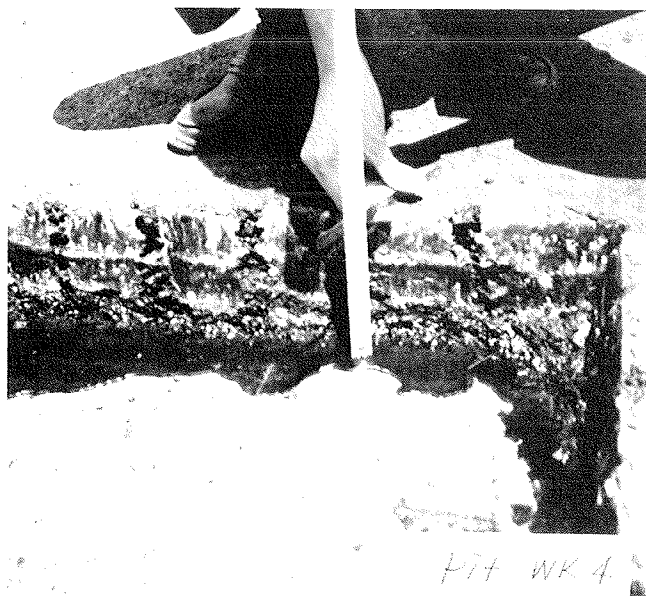
collected in these pits from seepage from the underlying porous layer. A laboratory falling-head permeability test on cored samples indicated that the top and the bottom layers were practically impermeable, whereas the intermediate layer had horizontal permeabilities ranging from 2×10^{-5} to 5×10^{-2}

FIGURE 4 Water seeping out from sandwiched damp layer.

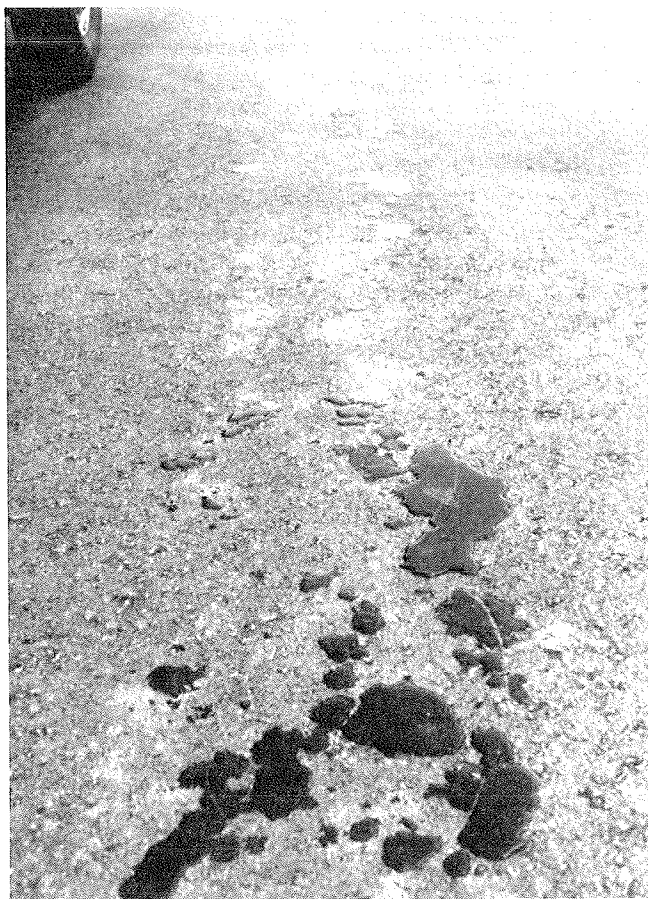
A divided primary road, with two lanes in each direction, had badly deteriorated surface due to stripping and rutting. A 35-mm overlay of dense bituminous mix was applied in April 1984. Problems began to surface in September 1984 on the northbound pavement. Light brown stains in a straight-line pattern were observed on the pavement. Up to 2 weeks after a heavy rainfall, small patches of water were seen forming approximately in a straight line on the pavement surface during the warmer part of the day. Stains were left behind when these patches of water evaporated, as shown in Figure 5. Although no cracks were visible on the surface along the straight line on which stain marks were left, the line was later identified as the longitudinal joint between two neighboring overlay applications. Crack sealing was performed on locations where stain marks appeared.

Approximately 1 month after crack sealing, small patches of water and stains reappeared on stretches along the longitudinal joint. In addition, a series of longitudinal cracks with lengths varying from 200 to 450 mm was found on the wheelpaths adjacent to the longitudinal joint. Removal of the overlay layer revealed that the interface bond was ineffective at these wheel-path locations, and there were signs of accumulated water on the original deteriorated surface. It was estimated that stripping of the old surface had caused loss of binder to a depth of 20 mm. Failure to patch and seal or to mill off these stripped materials during the overlay operation had unknowingly incorporated a water-collecting layer within the pavement structure.

It was believed that after initial infiltration through the longitudinal construction joint, water worked its way along the plane of interface and collected in the stripped and rutted areas of the old surface. The disruption of interfacial bond and spreading of trapped water were aided by the pressure buildup due to rising temperature during hot afternoons as well as compression caused by traffic loadings. The initial sealing of longitudinal joints might have forced the trapped water to move sideways during a pressure buildup.

FIGURE 5 Patches of water emerged from pavement in hot afternoon and left stains behind when evaporated.

Because of budgetary constraints and possible inconvenience to the traveling public, repairs were carried out at night and only a few patches of areas that showed signs of distress were repaired at a time. At each location, as much as 60 mm of material was milled off to ensure that the deteriorated surface of the old wearing course was removed.

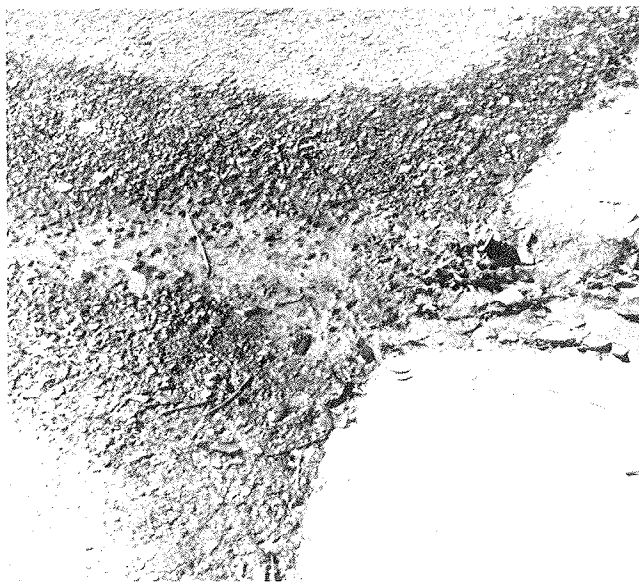
Cracks in a pavement surface provide excellent storage space for surface water. A random survey, which was conducted on a secondary road after a 2-hr rainfall with a precipitation of 46 mm, indicated that many cracks, especially those wider than 0.5 mm, were still damp 24 hr after the rain had stopped. If these cracks are not repaired or sealed off, water that enters the cracks each time it rains tends to erode the interior of the pavement. Figure 6 shows a crack that could admit so much rain water that water was seen flowing out from the crack for several hours during the warmer part of the day after a heavy rainfall.

FIGURE 6 Water flowing out from crack after rain had stopped.

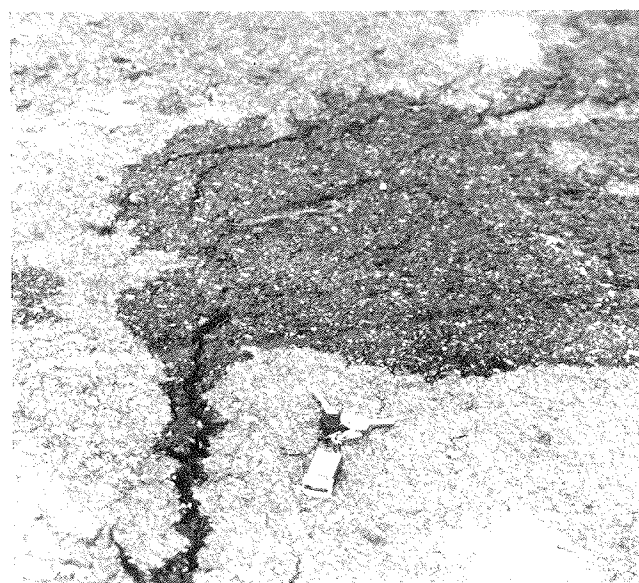
Given the presence of cracks and imperfect joints, it is possible that a pavement may become more permeable than the underlying base or subbase materials, thereby leading to a holding up of free water within the pavement structure during and after a heavy rainfall. Pressure buildup due to wheel load impacts or thermal changes could lead to erosion and disintegration of the pavement materials. Figure 7 shows a curb joint from which outflow of water and fines continued for more than 8 hr after a rainstorm had stopped.

FIGURE 7 Outflow of water and fines from curb joint.

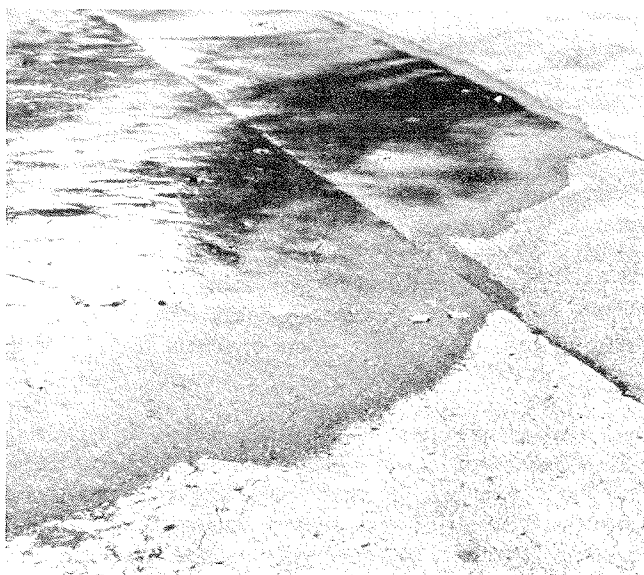
The first sign of pavement distress, as shown in Figure 8, was cracks in the surface at each wet location. A slight heaving of the surface material could sometimes be observed. This was followed by breaking up of the surface layer and disintegration of the bituminous mixture. Shallow patching, which does not correct the subdrainage condition, would not offer a solution to the problem. Because reconstruction of the relatively new pavement was costly and the request for additional funding was difficult to justify, a "repair as it occurs" policy was adopted. Deep patching that involved replacement of drainage layers had to be carried out rather frequently.

FIGURE 8 Water-induced cracks in pavement before formation of pothole.

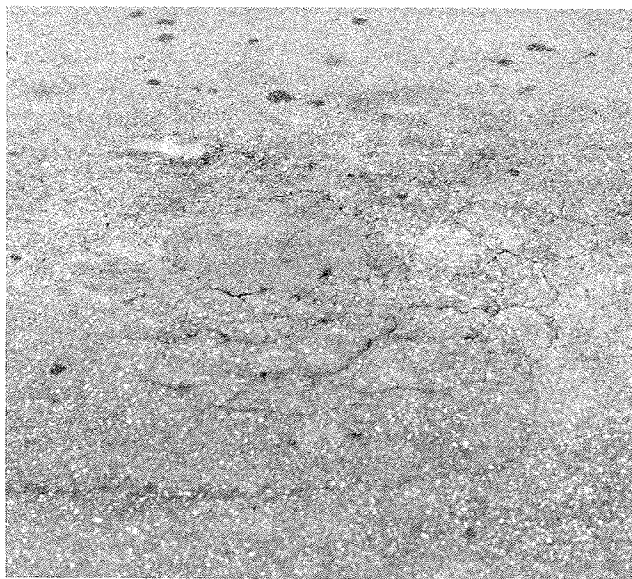
FIGURE 9 Water bleeding from utility trench joint; photo taken 9 hr after rain had stopped.

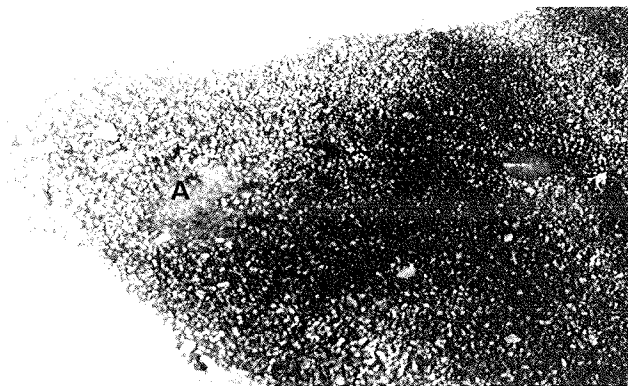
Cracks would gradually develop around the point of outflow under the action of traffic. Further deterioration eventually would lead to the formation of potholes. During a spell of heavy rainy weather in December 1985, potholes occurred in such numbers in a matter of a few days that maintenance crews simply did not have the time to patch them properly. Figure 13 shows one of the repair patches where outflow of subsurface water still occurred long after a rain had stopped.

FIGURE 11 Water oozing from Point A after rainstorm.

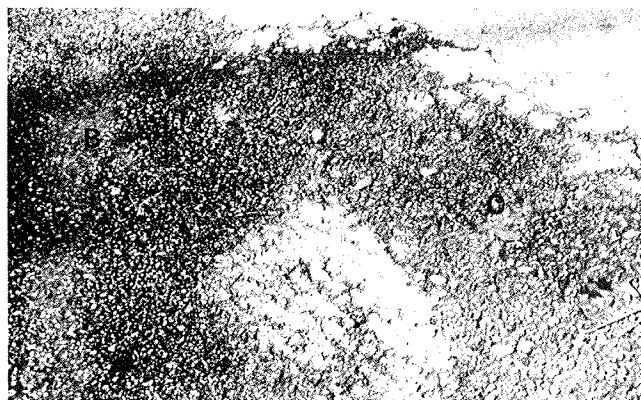
FIGURE 12 Water oozing from Points B and C after heavy rain.

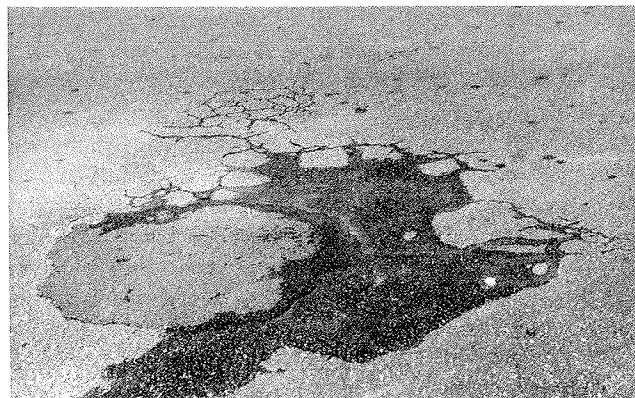
FIGURE 13 Water flowing from a poorly repaired patch.

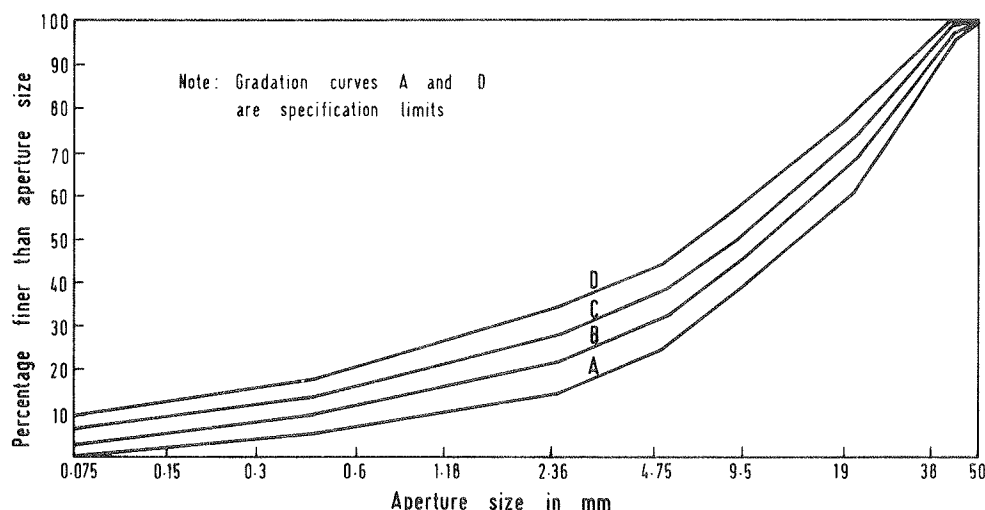
Figure 14 shows one of the crushed-stone gradation limits commonly adopted in Singapore and Malaysia. Laboratory falling-head permeability tests were conducted using four different sets of samples with Gradations A, B, C, and D as shown

FIGURE 14 Aggregate gradations for base course materials.

in Figure 14. The results of these tests are given in Table 2. It is noted that materials that fall within the specified gradation limits could have permeability values varying from 1.57×10^{-1} cm/sec to 2.42×10^{-3} cm/sec. It appears that the gradation specification alone is insufficient from the point of view of pavement drainage.
