W-Beam Approach Treatment at Bridge Rail Ends Near Intersecting Roadways

M. E. BRONSTAD, M. H. RAY, J. B. MAYER, JR., AND C. F. McDEVITT

This paper is concerned with guardrail approach treatment at bridge ends near the intersection of two roadways. A state design was evaluated by full-scale crash tests. Based on the findings of this test, design modifications were made and subsequent crash tests were conducted. Success in the later crash tests was realized although the current testing criteria do not give a clear definition of recommended tests for evaluating this unique construction detail.

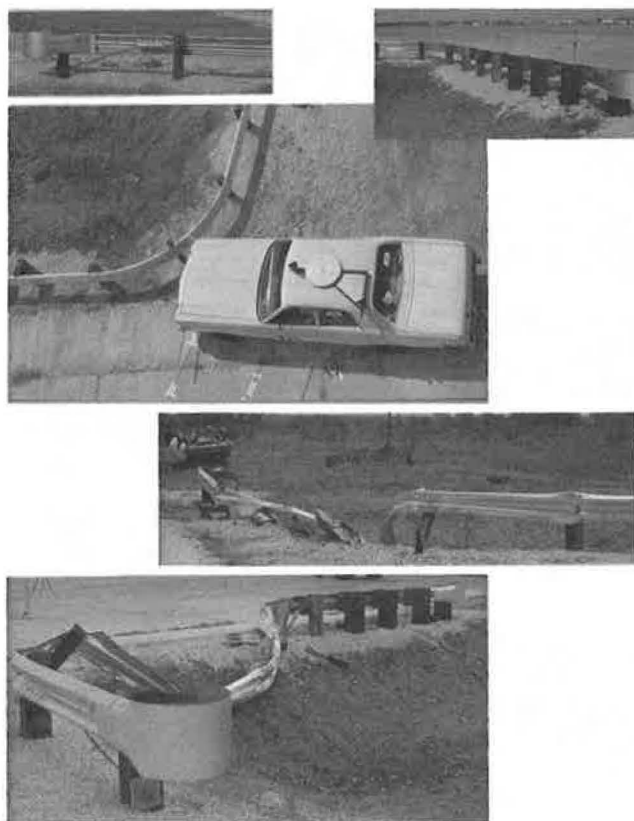
FIGURE 2 Test WA-1.

The test installation (Figure 2) included a 12-ft 6-in. (3.8-m) tangent section on the intersecting road, an 8.5-ft (2.6-m) radius section, and a 25-ft (7.6-m) tangent transition section leading up the bridge. As shown in Figure 2, a shallow-angle, 60-mph (95-km/hr) impact was selected for the first test of the system. A steep 2:1 embankment was simulated by excavating behind the installation.

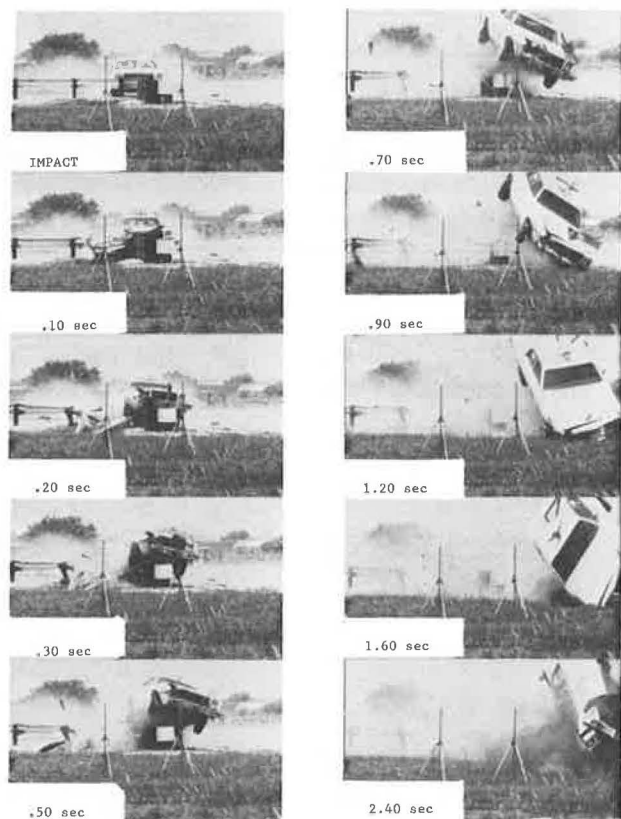
FIGURE 3 Sequential photographs, Test WA-1.

As shown in Figure 3, the vehicle struck the transition, fractured several wood posts, and was then launched into a

rollover-tumbling mode by the system. Pocketing in the system and the leaning of posts in the soil contributed to the launching of the vehicle over and behind the system.

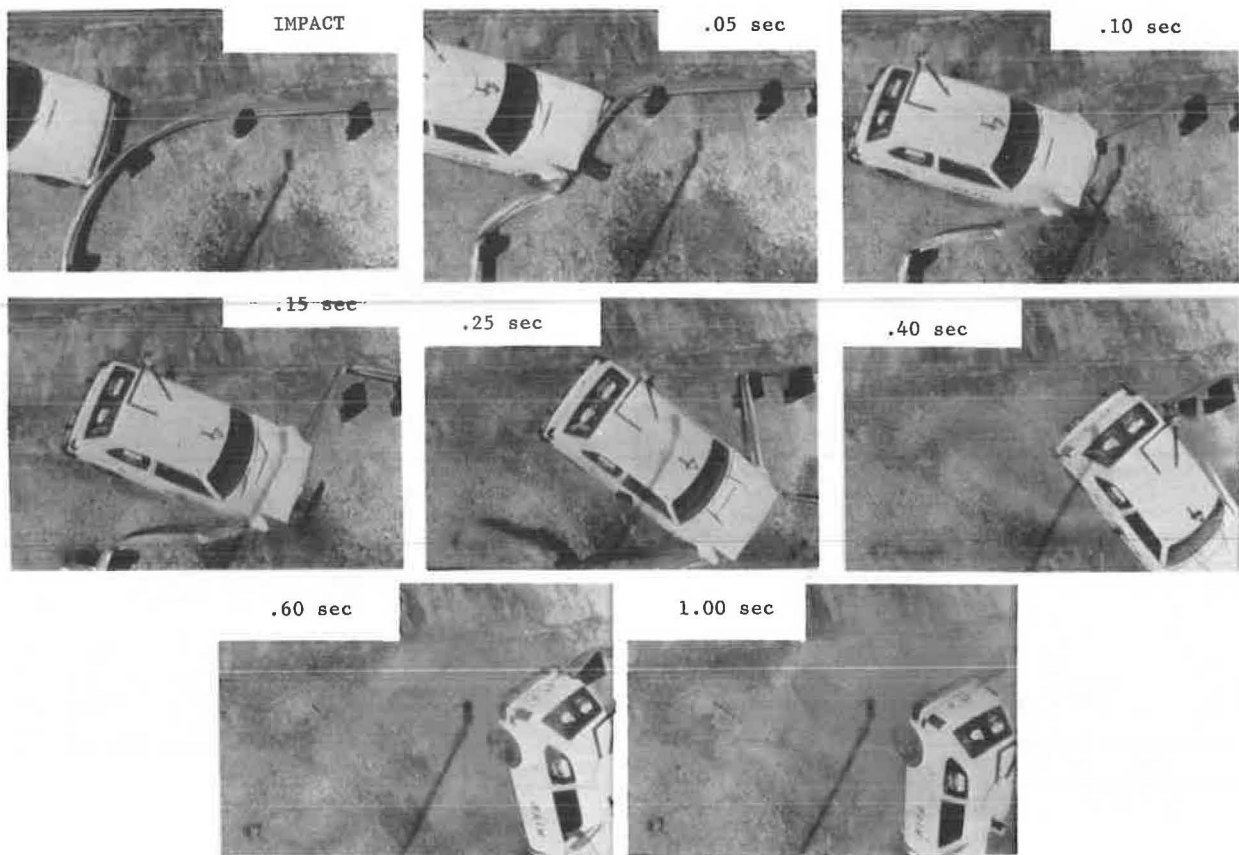
FIGURE 5 Sequential photographs, Test WA-1M.

Impact conditions selected for this test were 60 mph and a 25-degree angle with an 1,800-lb car. The purpose of this test was to examine the containment capacity of the modified design and determine the occupant risk values. As shown in Figure 5, the vehicle was contained by the system, although the 37-ft/sec (11.3 m/sec) longitudinal ΔV -value exceeded the 30 ft/sec (9 m/sec) recommended in NCHRP Report 230 (2).

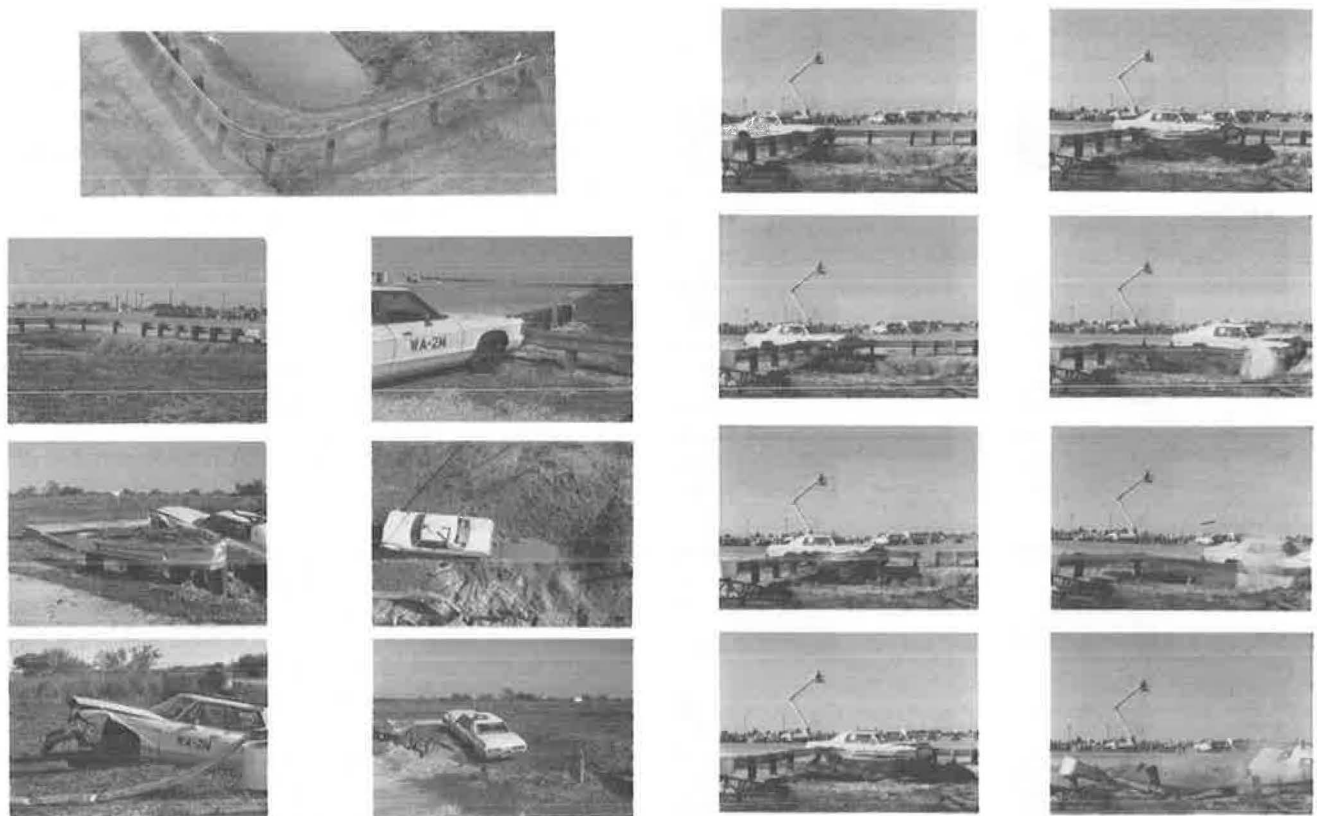
FIGURE 6 Test WA-2M.

the length of the simulated embankment, the vehicle was partially stopped by the slope of the downstream end of the excavation as shown in Figure 6.

On the basis of the results of the previous test, it was obvious that the containment capacity of the system would not be sufficient to restrain a 4,500-lb car striking at 60 mph. Accordingly, an additional 12.5 ft of beam was added to the secondary roadside to give the system more "stroke" as shown in Figure 6. Conditions for this test included a 4,500-lb car striking the nose of the system at 60 mph and a 15-degree angle. As shown in Figure 7, all the posts, including the end anchor, on the secondary roadside were fractured during the impact, thus allowing penetration of the system by the vehicle. Because of

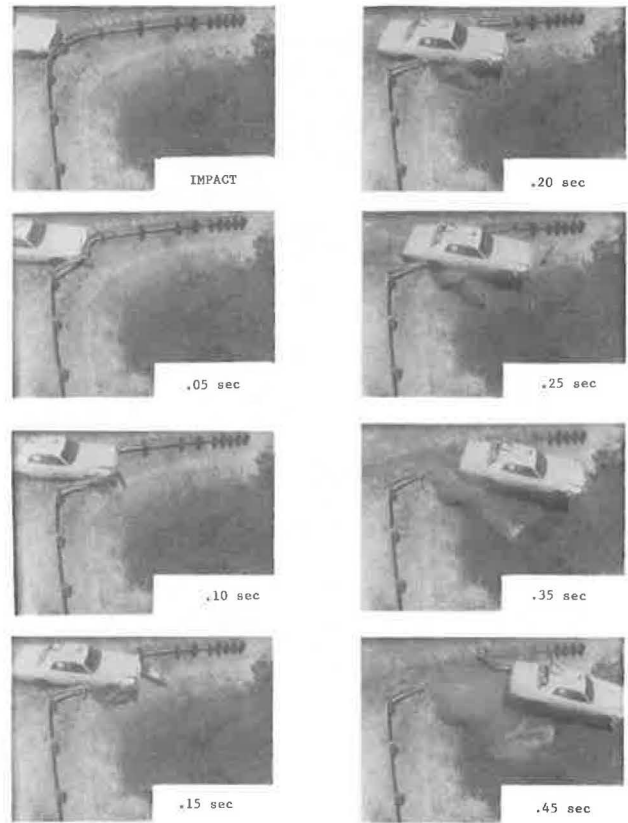
FIGURE 9 Sequential photographs, Test WA-3M.

Test conditions were the same as in the previous test. As shown in Figure 9, the vehicle broke through the railing early in the event because of beam failure at the first post struck. The failure of this beam was attributed to snagging of the bolt head in the slot of the beam, which initiated tearing.

Because of the beam tearing that occurred in Test WA-3M, the bolt was omitted at Post 6, where the beam tearing had occurred. This bolt is not required for support of the beam and on the basis of Tests WA-1M and WA-2M, the beam tearing was considered to be a freak occurrence that could only be attributed to the bolt. All other details were identical to those in the previous test.

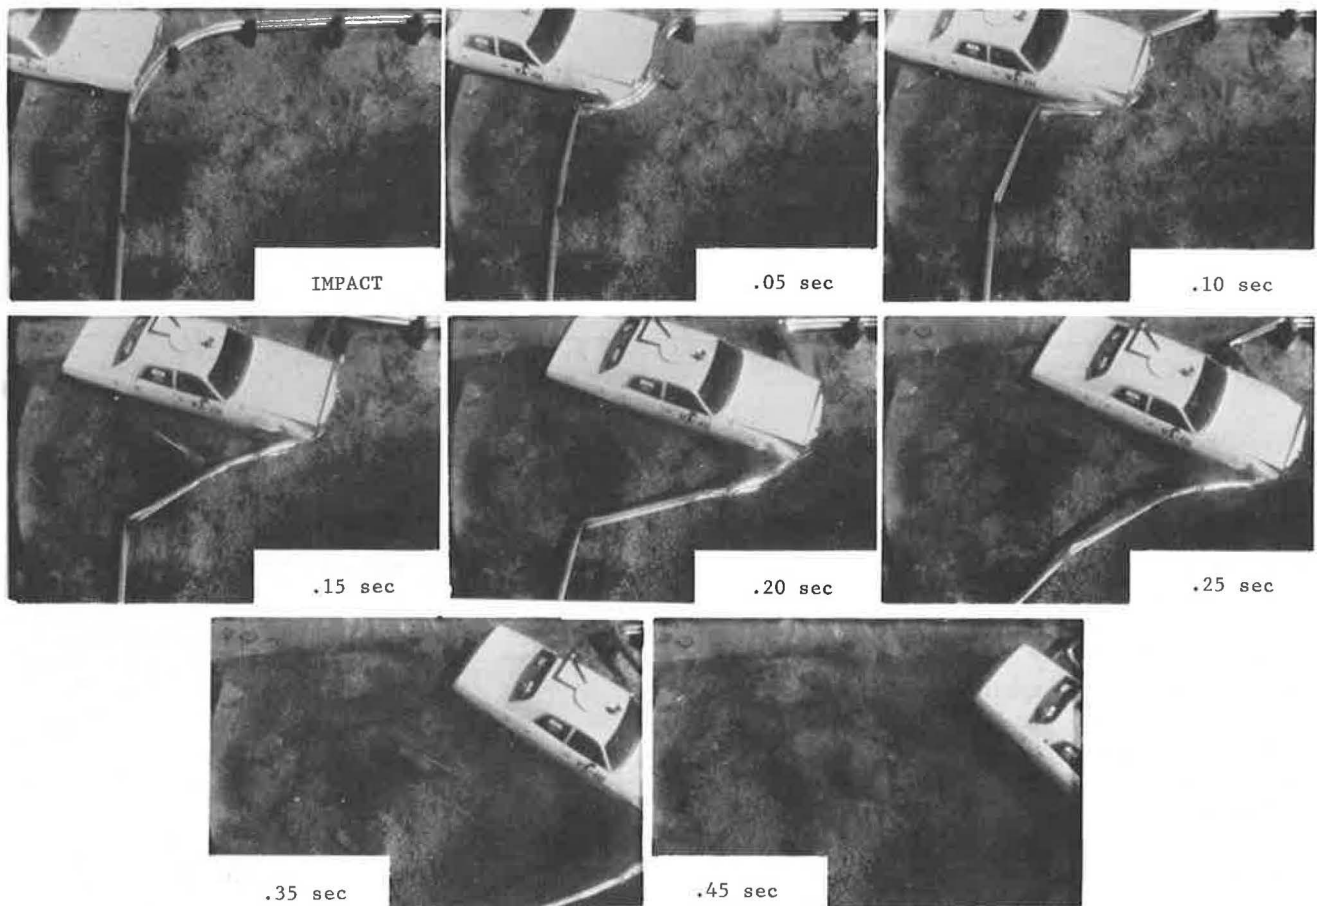
FIGURE 10 Sequential photographs, Test WA-4M.

The vehicle struck the barrier with the same conditions as in the two previous tests and was contained by the system. The vehicle began a clockwise (looking down) yaw during the event, as shown in Figure 10, and the rear end eventually yawed over the barrier before coming to rest as shown in Figure 11, with approximately one-third of the vehicle protruding beyond the end of the bridge. The beam and anchorage system remained intact and successful containment of the vehicle was achieved.

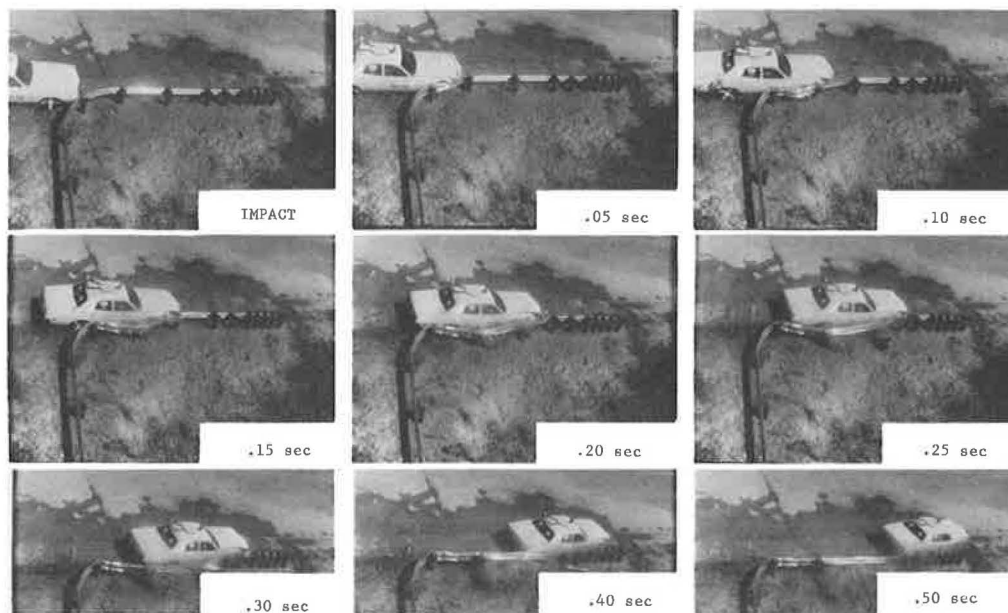
FIGURE 13 Sequential photographs, Test WA-5M.

The vehicle struck the barrier as shown in Figure 13 and was smoothly redirected. All elements of the barrier performed as designed.
