# Nine-Year Performance Evaluation of Arizona's Prestressed Concrete Pavement

RICHARD L. POWERS AND JOHN P. ZANIEWSKI

The Arizona Department of Transportation constructed an experimental prestressed pavement in 1977 and has monitored its condition for the past 9 years. The traffic volume on the pavement has greatly exceeded the design assumptions. Experiments conducted at the time of construction provide valuable data on curling and warping, shrinkage, elastic shortening, and so forth. Annual measurements of roughness and friction number have been collected, and periodic condition surveys have been made. The condition survey conducted in 1986 found that distress had developed in the pavement since the last survey in 1983.

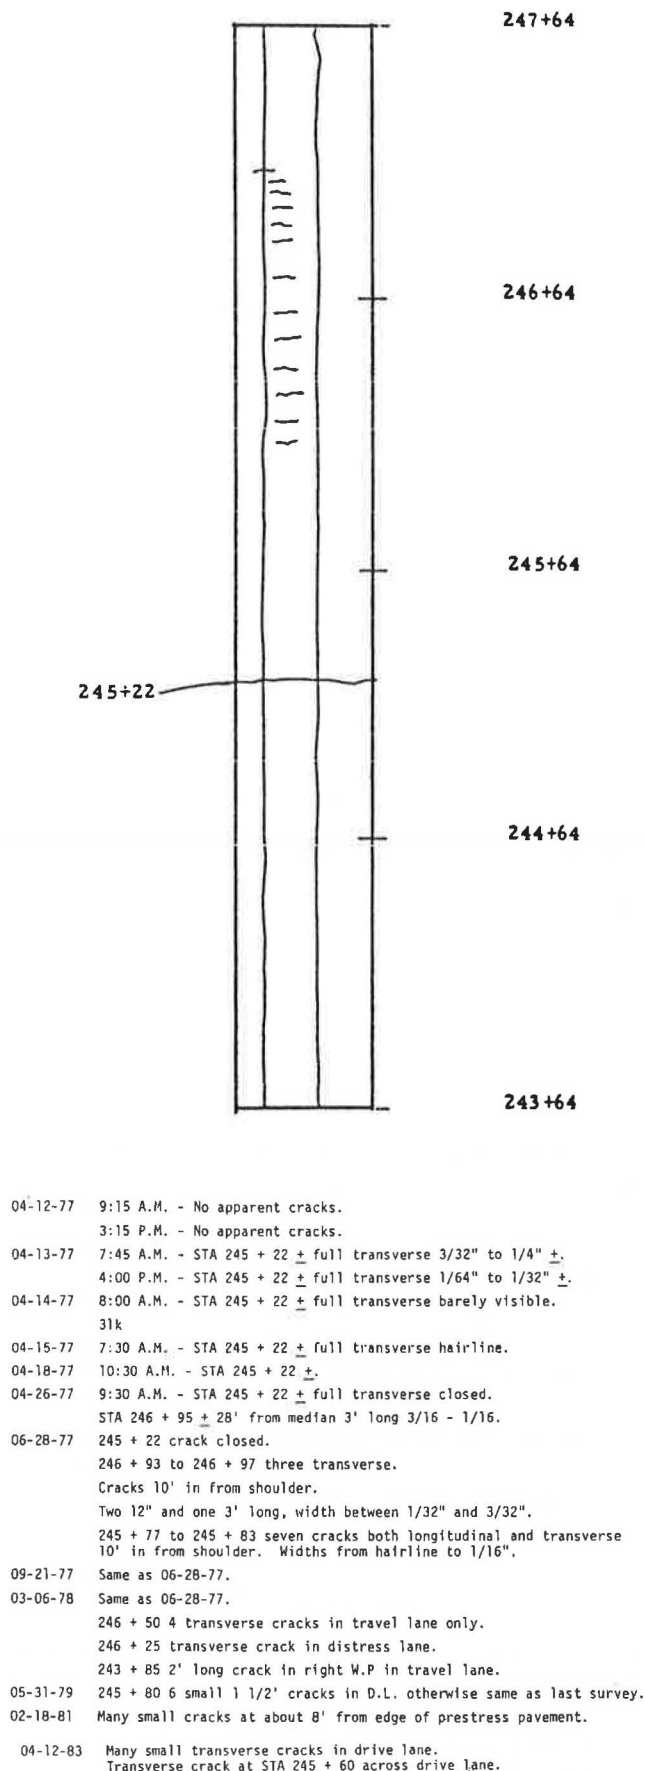
example of the crack survey information for one slab is shown in Figure 4. As shown in the figure, the cracks were measured and recorded twice daily after placement of the concrete and periodically after final prestressing. This example shows two longitudinal joints and several transverse cracks. The longitudinal joints were formed between lanes and between the driving lane and shoulder by placing plastic strips in the pavement at the time of construction. The transverse crack widths are small, on the order of 1/64 to 1/4 in. The final prestressing force closed several of the transverse cracks as indicated in Figure 4.

FIGURE 4 Example of crack survey data (westbound Slab 23).

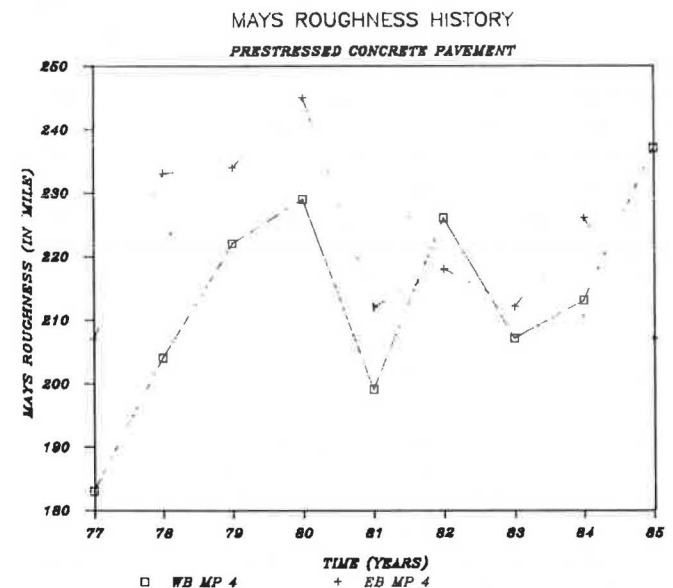
The variation of surface roughness with time for the prestressed section based on Mays meter results is shown in Figure 5. For 3 years after construction, the roughness apparently increased significantly. In 1981 the roughness measurements dropped significantly and then were stable but highly variable from year to year. Much of the variability in the roughness measurements may be attributed to variations

in the Mays meter. ADOT has an active program for maintaining the calibration of their Mays meter, so the measurements shown in Figure 5 are on a common scale.

FIGURE 5 Roughness versus time for the prestressed pavement.

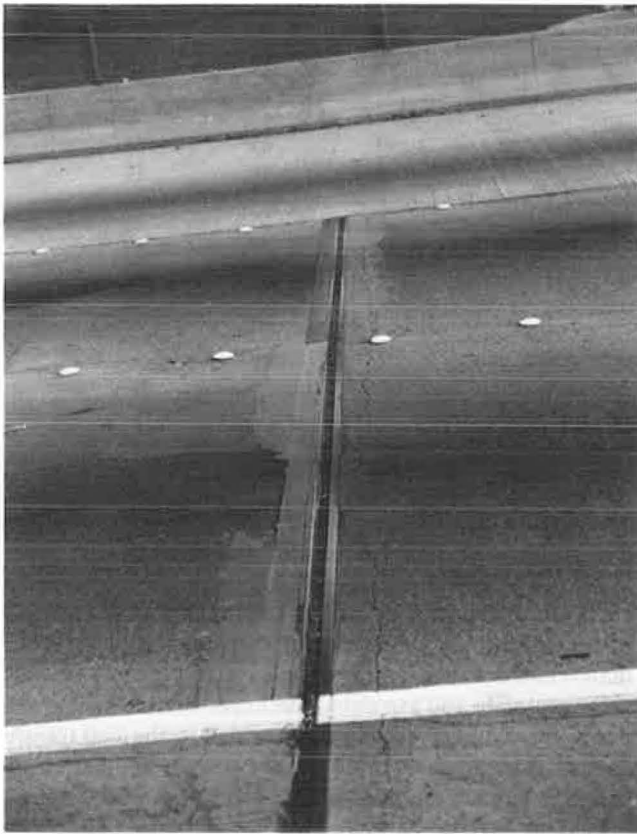
**Eastbound Roadway Section** The most notable problem with the eastbound section was the number of joints patched the entire width with epoxy. This condition was probably caused by impact loading at the joints and underconsolidation of the concrete around the joint hardware, which resulted in premature cracking and spalling along the joint. Several of the welded steel extrusions have been broken and repaired by ADOT maintenance crews. Figure 6 shows the epoxy patches and the transverse cracks near the joint indicating impending joint failure. Figure 7 shows spalling typical of several of the slabs near the joints. This figure shows the effect of underconsolidation of the concrete; the steel extrusions have caused the spalling to accelerate. The condition survey indicated that 90 percent of the joints in the eastbound direction have been repaired with epoxy patches.

FIGURE 6 Epoxy patch and transverse crack at a joint.

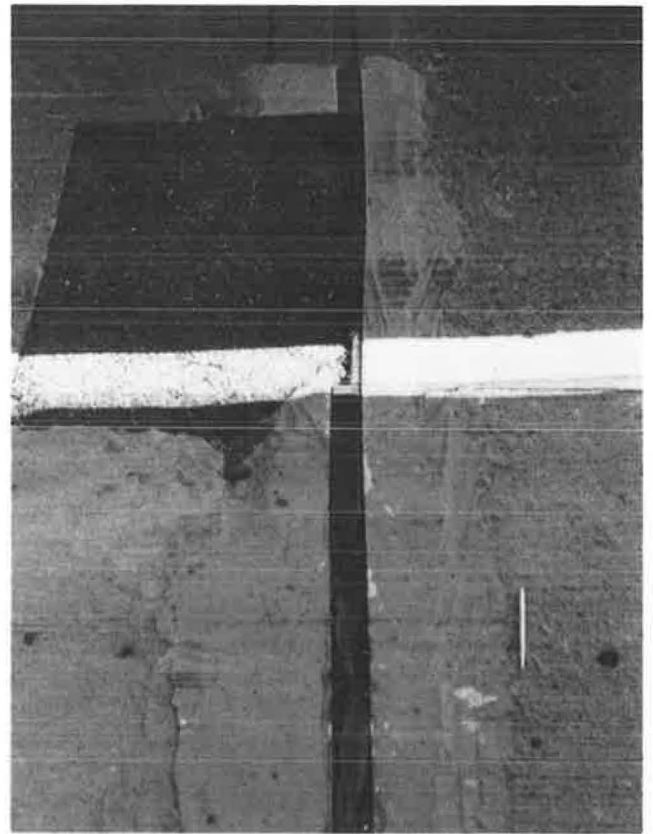
During the summer of 1985 one prestressing strand anchor failed on the east end of Slab 1. The bearing plate was removed, the strand cut, and an asphalt patch installed. This repair is shown in Figure 8. Figure 9 shows a close-up of the longitudinal crack located near the broken strand. The longitudinal crack between the shoulder and the driving lane is continuous along the section but has significantly widened near the broken strand. Heavy truck loading is applied in close proximity to the strand. It is assumed that the pre-

FIGURE 8 Repair patch at location of broken strand.

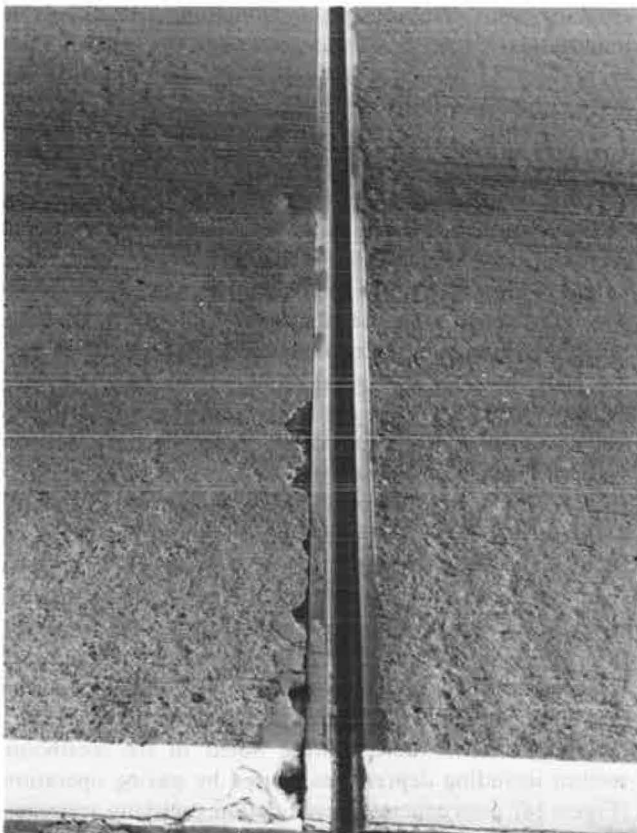
FIGURE 7 Spalling at a joint.

The predominant maintenance problem is correction of spalling at the joints. This is particularly bad on the eastbound lanes, which were the first constructed. The distress at the joints may be attributed primarily to poor

consolidation of the concrete. The joint design may further aggravate the failure problem at the joints.

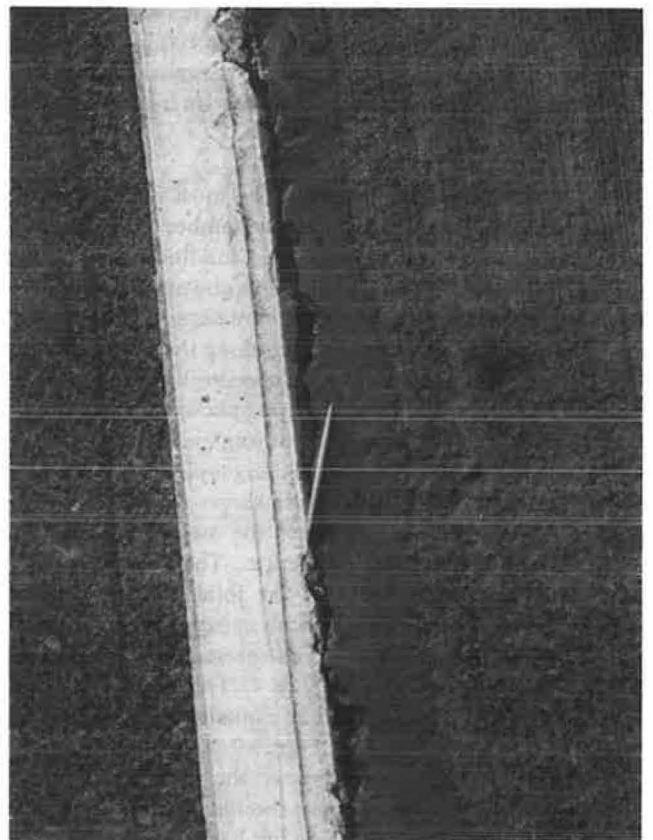
stressing force has been entirely dissipated and is not contributing to the structural capacity of the pavement section. A detailed investigation of the effects of this failure will be undertaken.

FIGURE 9 Close-up of longitudinal crack where the tendon is broken.

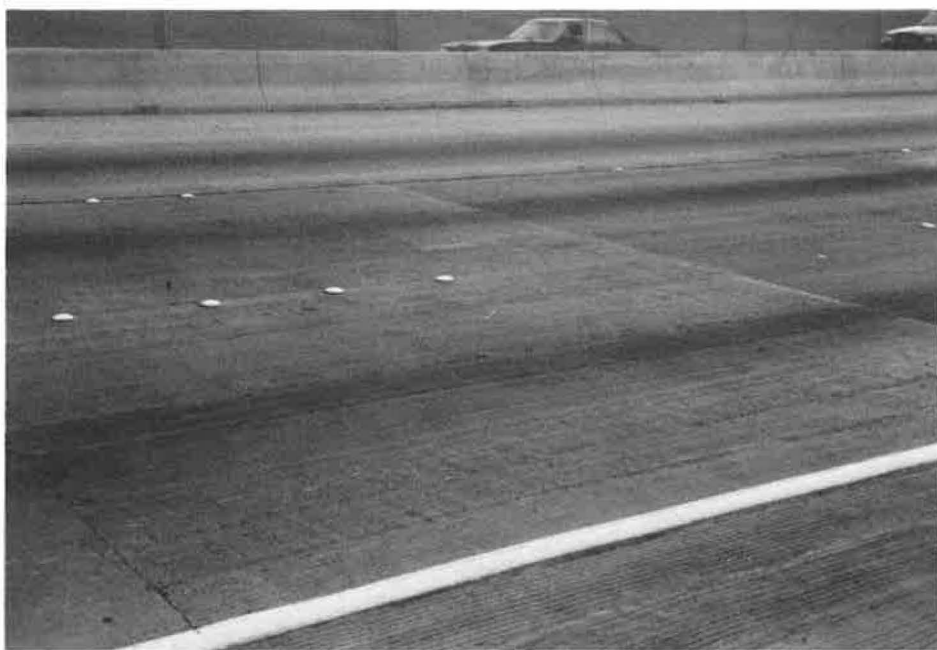
A section of prestressed concrete pavement was removed and replaced in Slab 4 as shown in Figure 10. The repair appears to be performing well although new longitudinal cracks have appeared in the original pavement on either side of the repair. The continuity of the prestressing steel was maintained for this repair.

FIGURE 10 Repair of concrete.

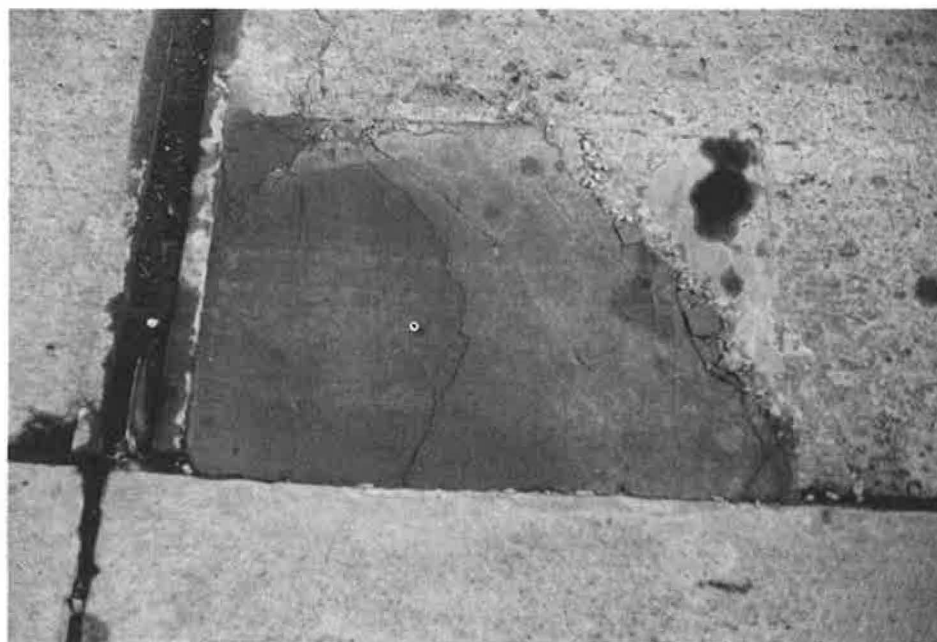
Several slabs and gap slabs have experienced corner breaks due to warping stress, restraint provided by the load transfer devices, and incompressible materials in the joints. In many cases the patches are also failing as shown in Figure 11.

FIGURE 11 Example of failed patch at corner break.

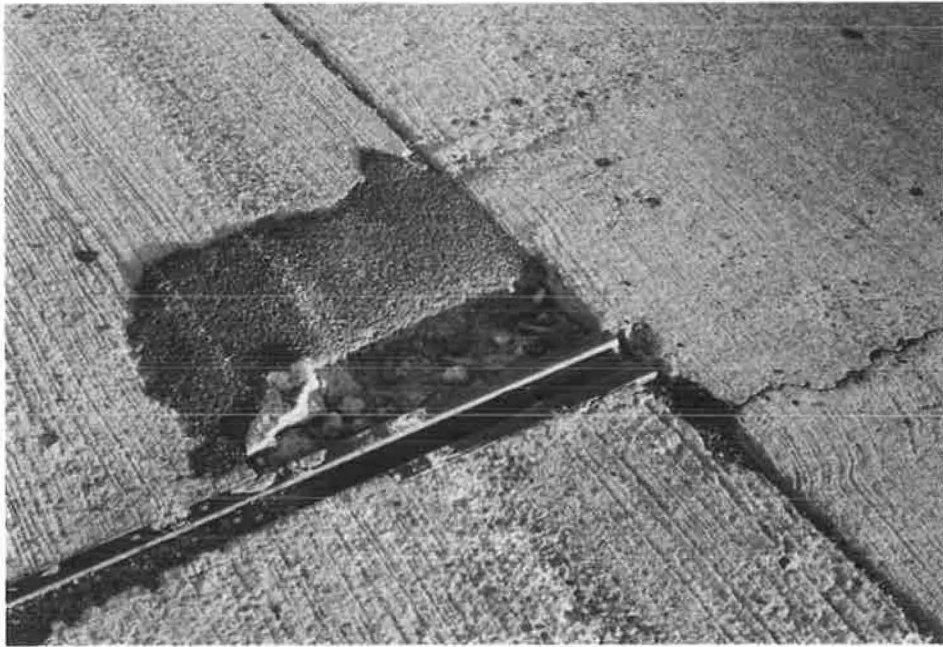
One joint had experienced a corner break and was patched with asphalt. The patching material is damaged as shown in Figures 12 and 13. Note the size of the studs and their close spacing. The studs are 1/2 in. in diameter, 6 in. long, and spaced 6 in. apart. It is hypothesized that this design has resulted in stress concentrations in a plane 6 in. from the joint. Failure of both the concrete and the steel studs indicates that this is an inadequate design for the joints.

FIGURE 12 Failed asphalt patch at corner break.

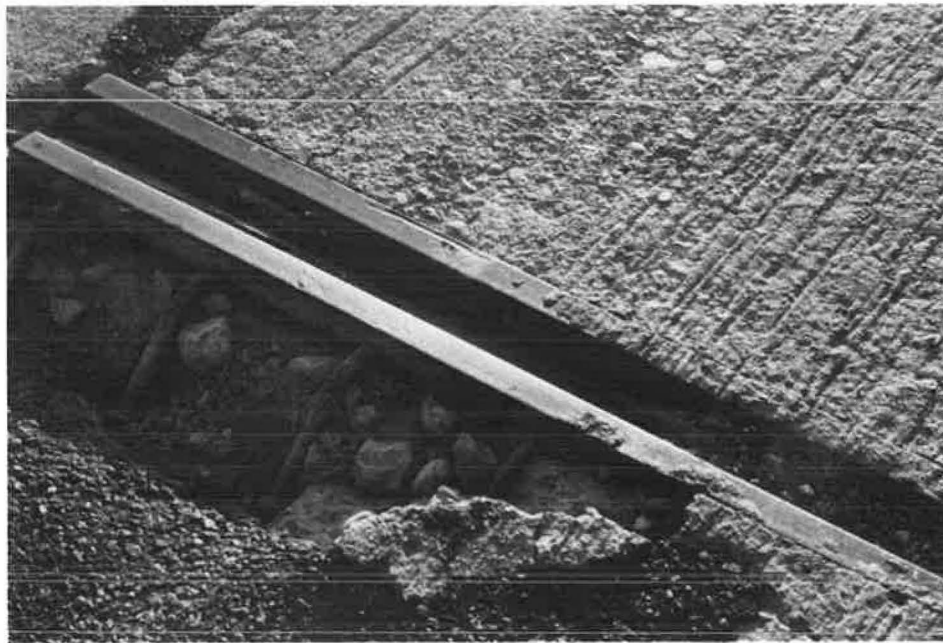
FIGURE 13 Exposed extruded steel at joint.

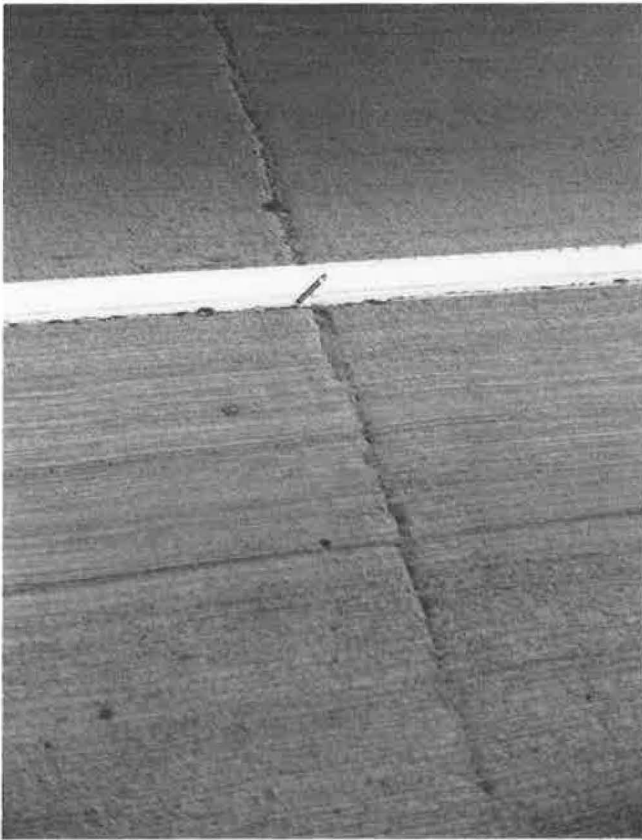
Several surface defects were noted in the westbound section including depressions caused by paving operations (Figure 14), poor concrete consolidation, polishing, transverse cracks with spalling (Figure 15), pop-outs, transverse cracks, crescent cracks in the wheel path, and longitudinal cracks.

FIGURE 14 Depression caused when paving train stopped.

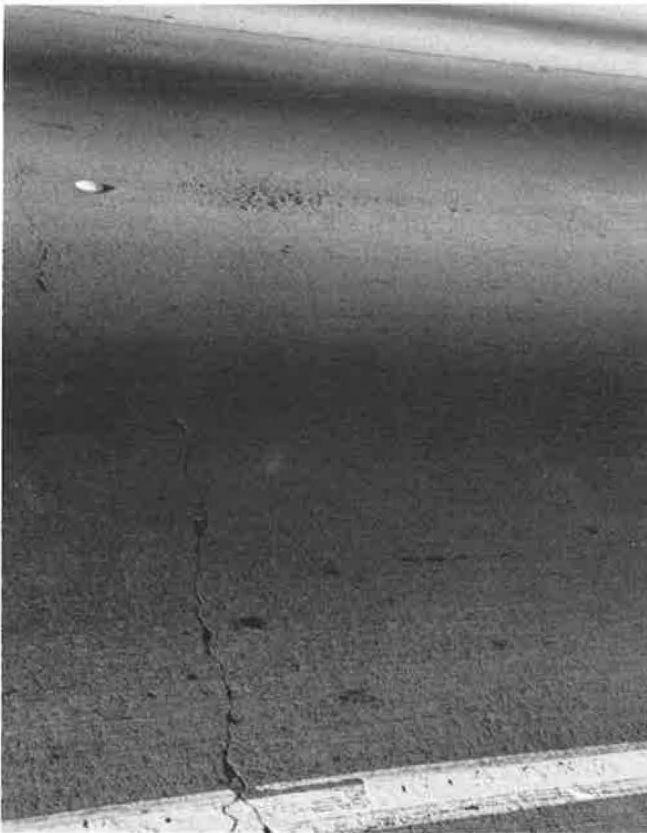
Several surface defects were noted in the prestressed pavement slabs of the eastbound lanes including pop-outs, spalling of the cracks, poor concrete consolidation, depressions caused by the paving and texturing operations, map cracking, transverse cracking, and longitudinal cracking. The longitudinal cracks have appeared since the last condition survey in 1983. Several of the transverse cracks have opened and spalled since the previous survey.

FIGURE 15 Spalling of transverse crack.
