Design, Construction, and Evaluation of West Virginia's First Free-Draining Pavement System

JOHN S. BALDWIN AND DONALD C. LONG

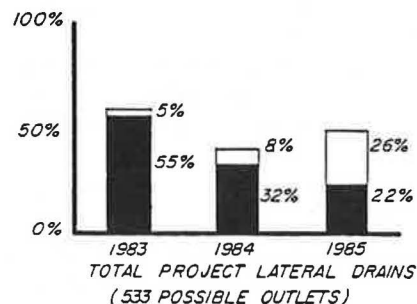
FIGURE 8 Drainage survey summary.

The summary of the drainage for the entire project is graphically shown in Figure 8. The bars depicted in the graph represent the drain adequacy for all drain outlets as surveyed in 1983, 1984, and 1985. Each total bar represents the percentage of the outlets actually found throughout the 5-mi project in each of the surveys. As shown, more of the drain outlets (60 percent) were found in the first year of the survey than in either of the subsequent survey years. The shaded portion of each bar represents the percentage of all the outlets in the project that

were found and judged to be capable of rapidly removing water from the pavement system. The unshaded area represents the percentage of outlets judged not to be performing satisfactorily. Overall, the surveys indicate a trend of decreasing effectiveness for rapidly outletting the water.

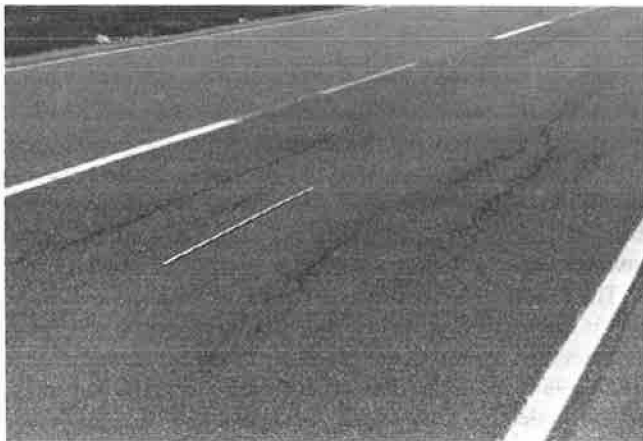
FIGURE 9 Longitudinal surface cracking.

The most noticeable surface anomaly that affected the appearance of the pavement was the occurrence of longitudinal cracks in the surface of the pavement. These cracks were prominent in several areas of the project and were mostly confined to the wheel paths of the outside lane as is shown in Figure 9.

In 1986, several of the areas exhibiting the longitudinal cracks were core drilled. Examination of the cores indicated that the fractures generally extended only through the top inch of the wearing surface. The probable cause of the fractures has been attributed to an excessively hot liquid asphalt which was used in the batching of the wearing course. Consequently, this resulted in a thin coating of the aggregate particles and a relatively brittle mix.
